Appendix A – Exmouth Coastal Defence Condition Assessment Report

Prepared by: Matthew Stannard
 Date: 24-02-2015
 Version: 1

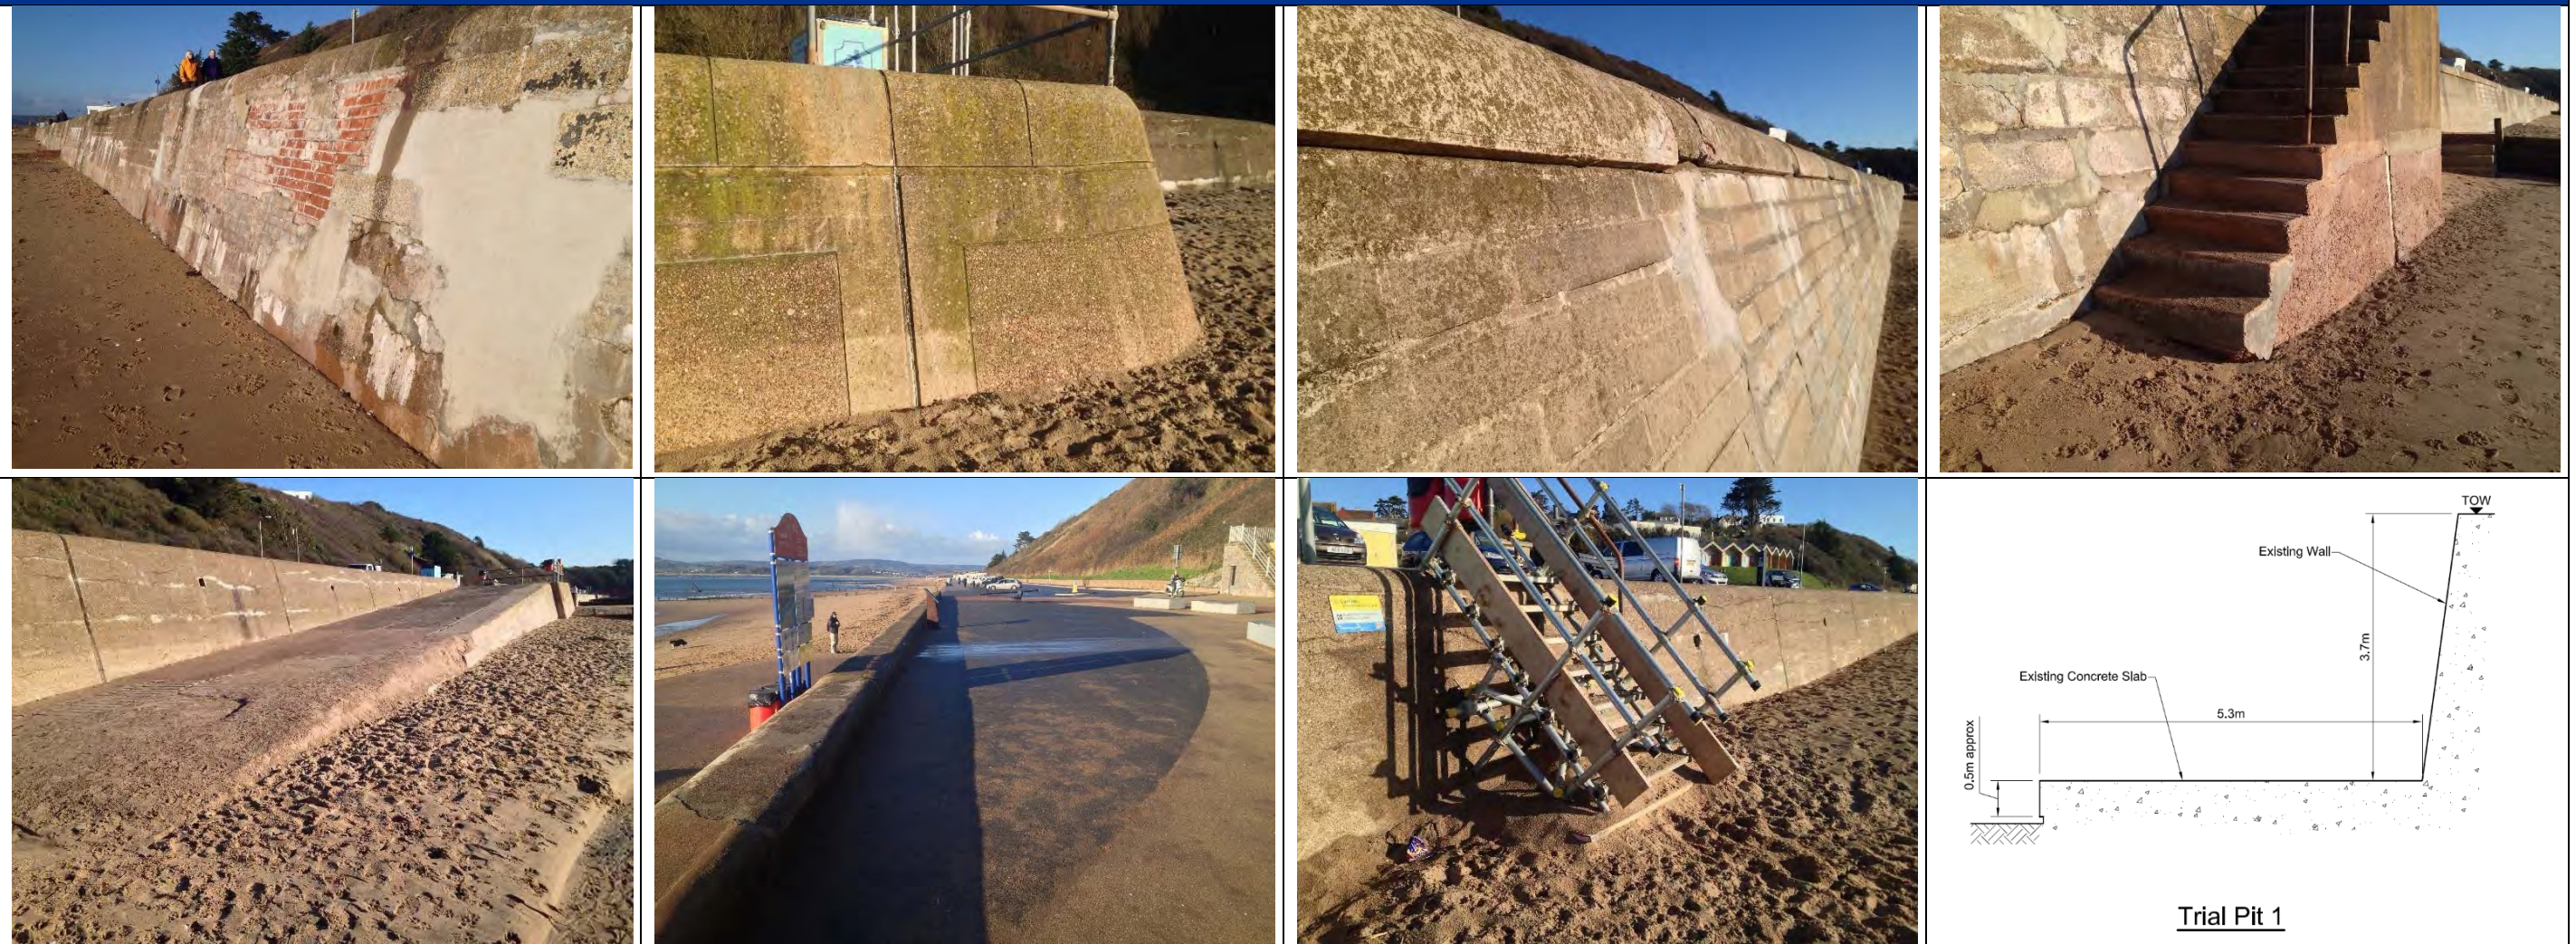
AIMS Asset Name	168679 [NFCDD ref. 113FAS3351002C01]		
Location description	Queens Drive East to Maer Rocks		
Asset Description	Vertical masonry and concrete block seawall and promenade, fronting seafront road and coastal slope.	Construction Date	1914/15
Asset Length	824m (eastern part of 1,692m asset)		
Inspection Date	8 th December 2014		
Inspection Comments	Evidence of various historic repairs to failed sections of wall along entire length, repairs remain sound. Repairs to wall undertaken with concrete blocks, brickwork and concrete rendering. More recent patch repairs to cracks and areas of spalling appear in good condition. Joint sealant at ramp in good condition. Continued areas of minor cracking, spalling of rendering, missing mortar between blocks and gaps beneath coping. Minor abrasion along lower section of wall and at base of steps. Minor onset of undermining of steps at mid-length but no evidence of structural movement. Toe of wall buried by high beach levels. Promenade surfacing in good condition, no movement cracks or signs of overtopping damage. Temporary access steps adjacent to the lifeboat station. Approximate beach level below crest: 1.3m east end, 2.4m centre, 1.6m west end. Strandline at toe of wall along central section.

Crest level:	+4.53m ODN, lowest point [from NFCDD]		
Toe level:	+0.0m to +0.8m ODN [POOR QUALITY DATA - scaled from trial pit survey]		
Overall Condition:	3 FAIR		
Residual Life:	Best estimate 45 years (slowest/ fastest estimate 30 – 90 years)		
Recommendations:	Fill cracks, repoint gaps beneath coping, repair damage to concrete rendering, monitor undermining of access steps, provide permanent replacement for temporary access steps.		
Urgency:	Routine.

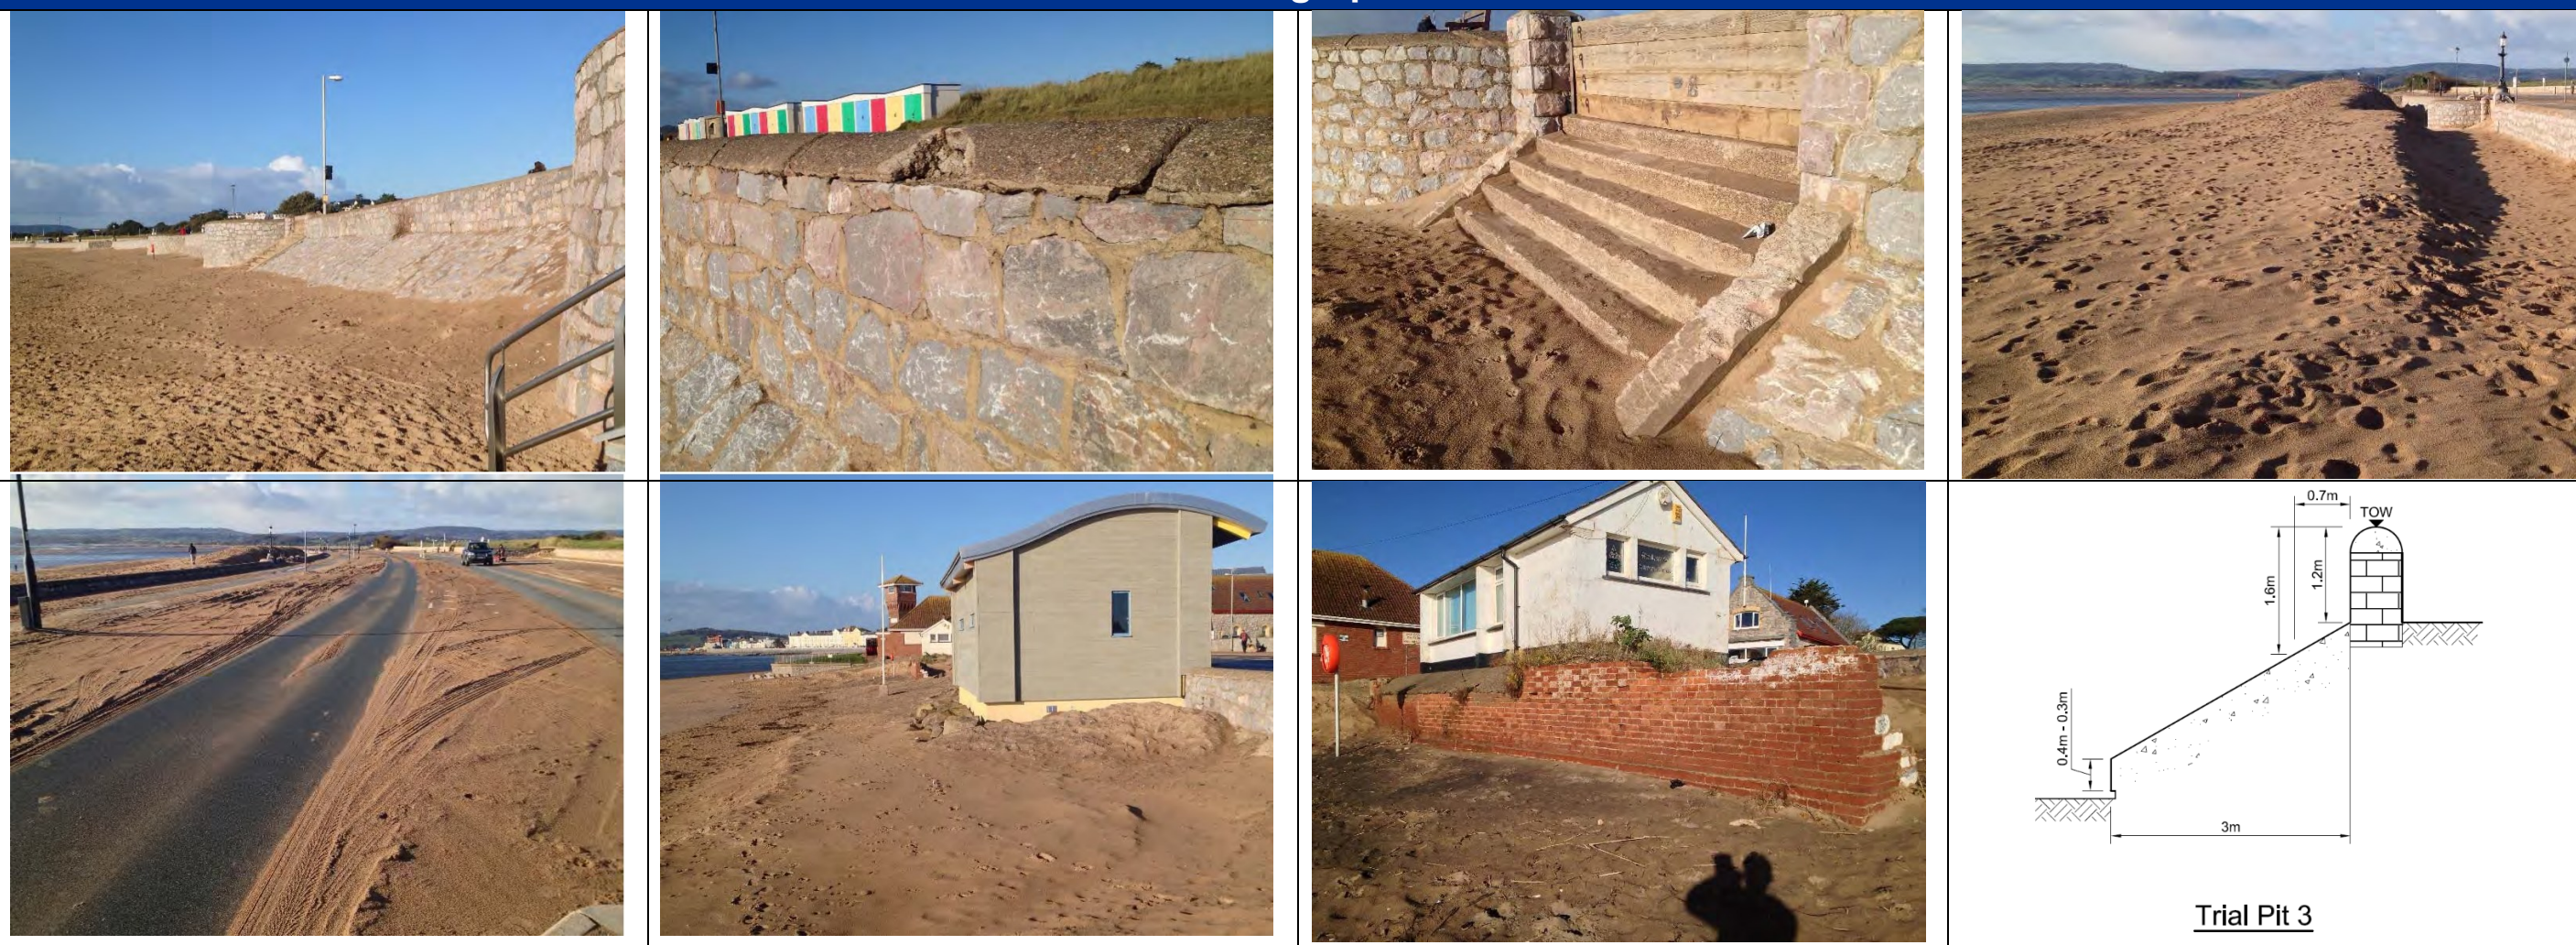
AIMS Asset Name	71549		
Location description	Maer Rocks to Queens Drive West		
Asset Description	Sloping masonry blockwork seawall with crest wall and promenade, fronting seafront road and low lying hinterland.	Construction Date	1914/15
Asset Length	868m (western part of 1,692m asset)		
Inspection Date	8 th December 2014		
Inspection Comments	Masonry wall and joint generally sound, no movement or crest settlement evident. Minor cracking and gaps between some blocks, localised cracking and minor movement at discrete locations along concrete wall cap. New wall construction in 2009 for lifeboat station. Minor abrasion and spalling to concrete steps and access ramps. Toe of wall buried by high beach levels. Near complete loss of vegetation and erosion of dune at central section resulting in significant deposits of wind-blown beach sand on promenade and main road. Loss of vegetation and erosion of dune at west end, protected with some ad-hoc rocks and rubble. Construction of new timber building adjoining seaward side of wall at west end, beach crest appears to have been re-profiled in front of this building. Dilapidated brickwork structure on beach at west end continues to collapse. Approximate beach level below crest: 0.8m east end, 1.4m central, 2m west end. Strand line typically 15-20m from toe.

Crest level:	+5.17m to +5.59m ODN [from NFCDD]		
Toe level:	+2.0m to +2.4m ODN [POOR QUALITY DATA - scaled from trial pit survey]		
Overall Condition:	2 GOOD		
Residual Life:	Best estimate 75 years (slowest/ fastest estimate 50 – 120 years)		
Recommendations:	Repair cracks in wall cap, implement dune management, clear sand from promenade and road, monitor erosion in front of new timber building, monitor dilapidated brick wall structure and remove if safety becomes an issue.		
Urgency:	Routine.

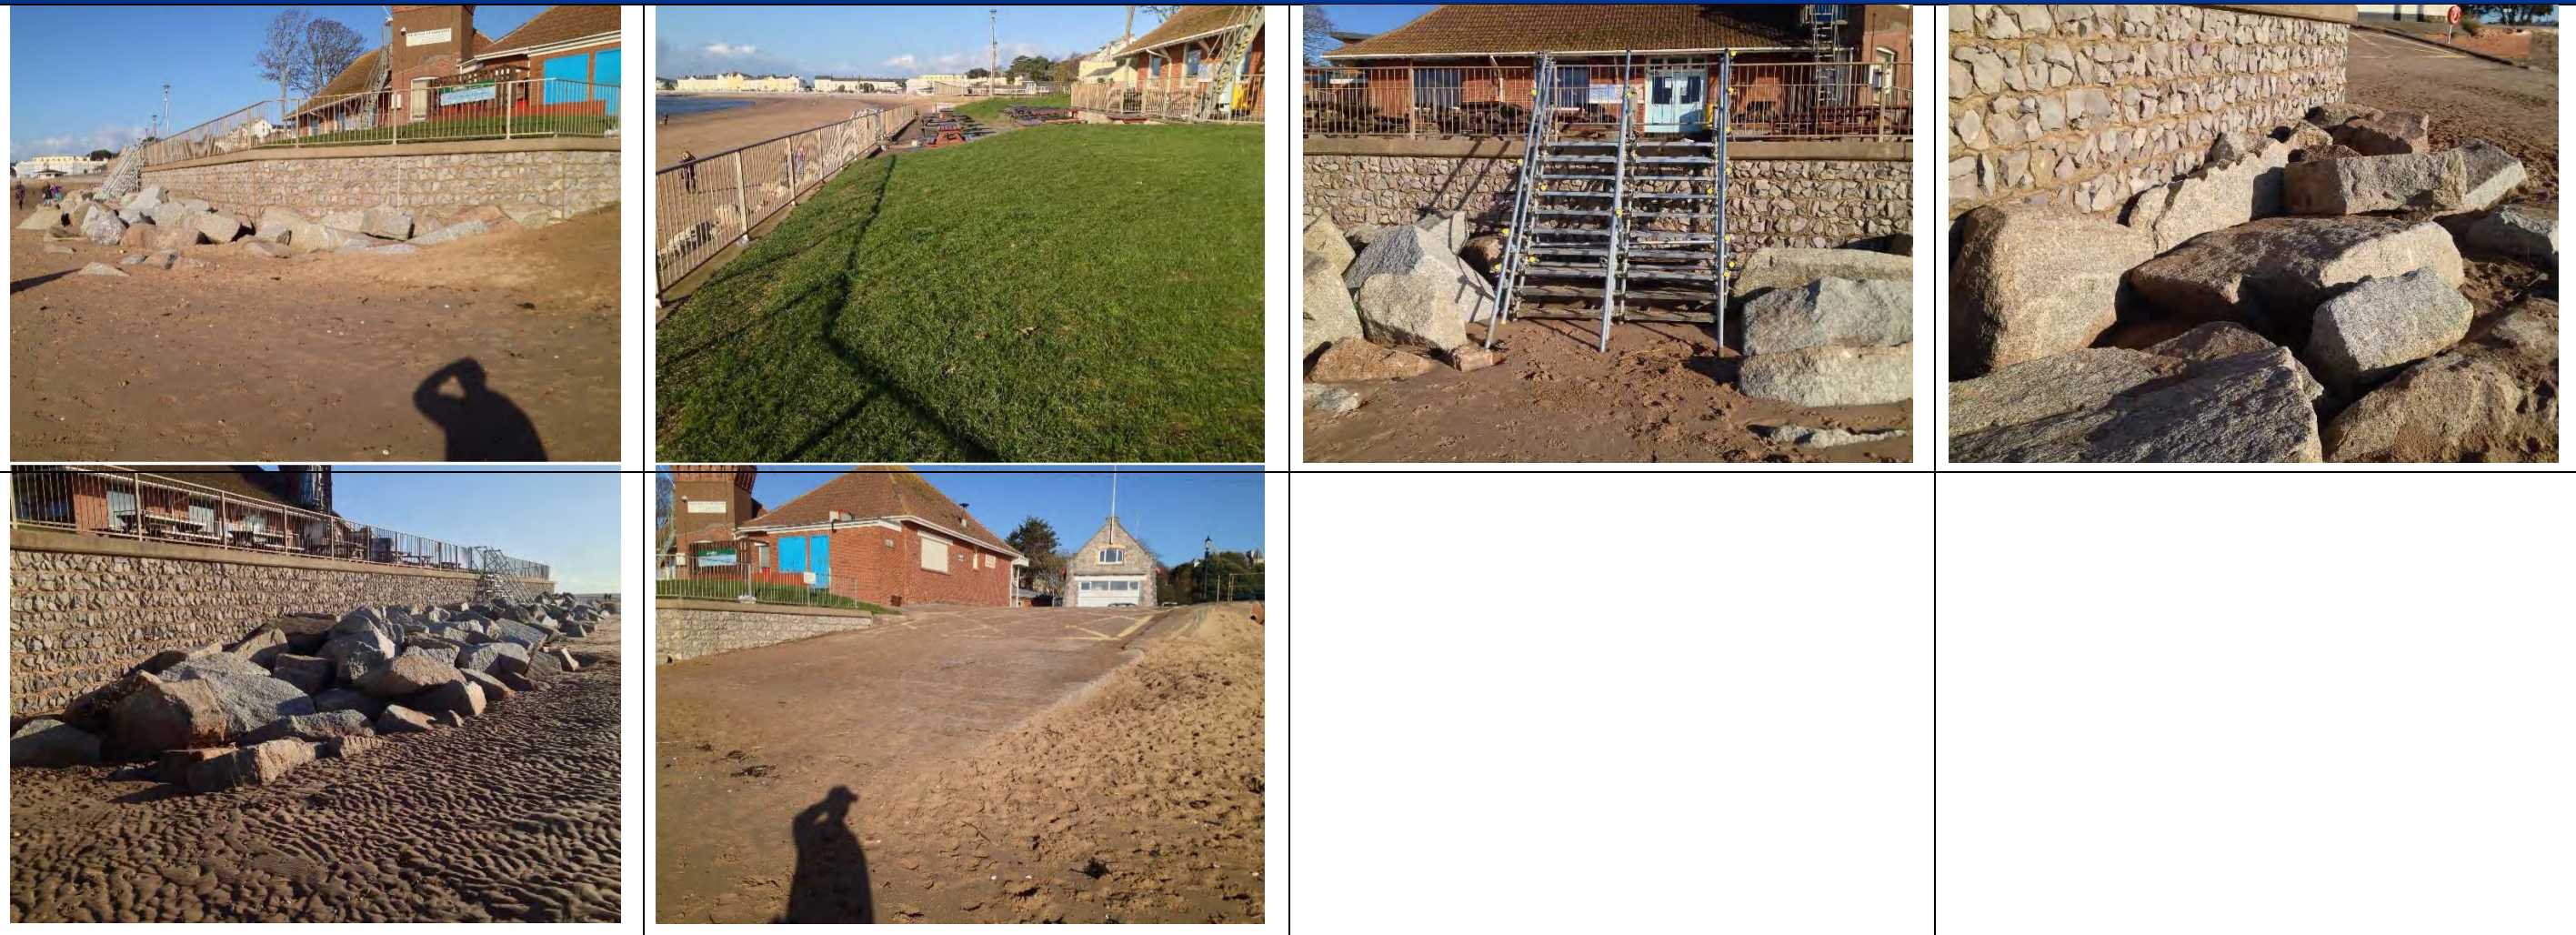
AIMS Asset Name	N/A [NFCDD ref. 113FAS3351002C02]		
Location description	Around Harbour View Café/ Lookout Station		
Asset Description	Vertical masonry blockwork seawall and rock armour revetment, fronting café and seafront road.	Construction Date	
Asset Length	61m		
Inspection Date	8 th December 2014		
Inspection Comments	Masonry and joints generally sound with no gaps evident, no movement or crest settlement apparent. Joint sealant in good condition. No cracks evident in concrete crest beam. Rock revetment constructed of hard angular rocks, generally well packed but with some loose slender rocks at east end, some large voids evident, gap in armour at mid-length where temporary steps constructed. Toe of rock armour and wall buried by high beach levels. No evidence of overtopping damage to crest. Hand railing in good condition. Temporary access steps at mid-length. Some abrasion to access ramp at east end, toe buried. Approximate beach levels below crest: 1.8m at east end, 2.1m at west end. Strand line at toe of wall.

Crest level:	No crest level data available in NFCDD		
Toe level:	No trial pit data available		
Overall Condition:	2 Good		
Residual Life:	Best estimate 75 years (slowest/ fastest estimate 50 – 120 years)		
Recommendations:	Monitor potential movement of rock armour, provide permanent replacement for temporary access steps.		
Urgency:	Routine.

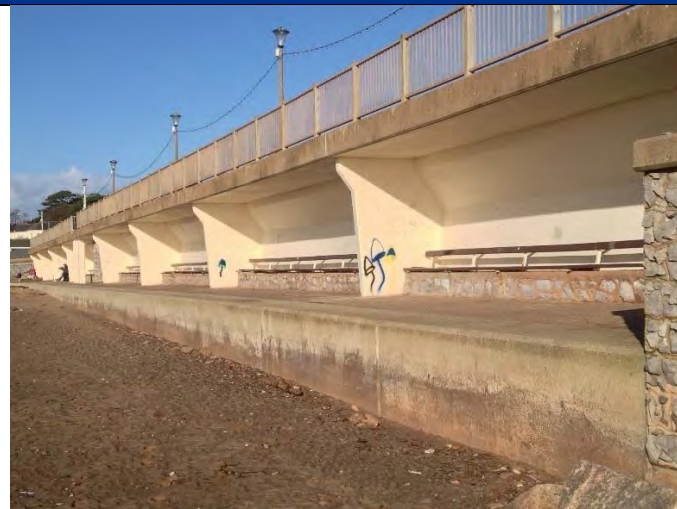
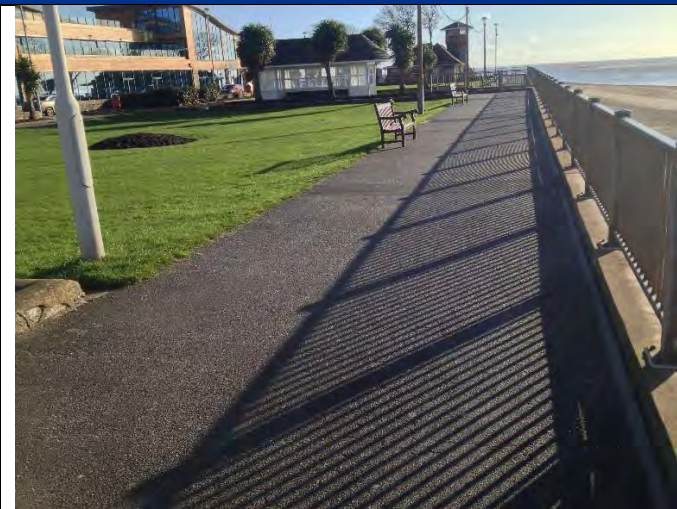
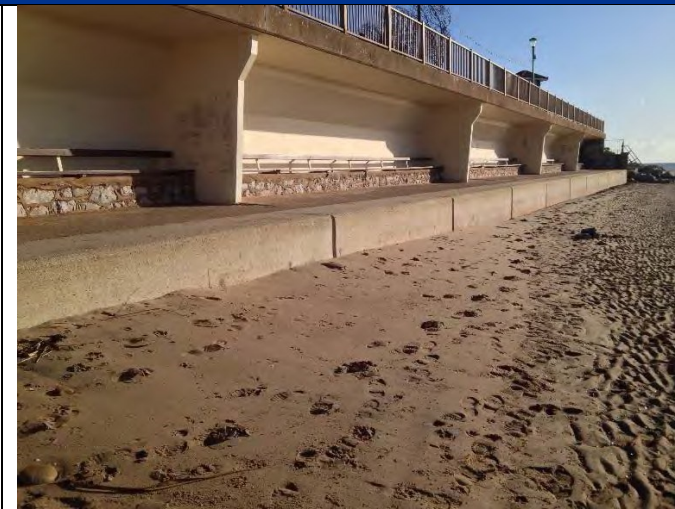
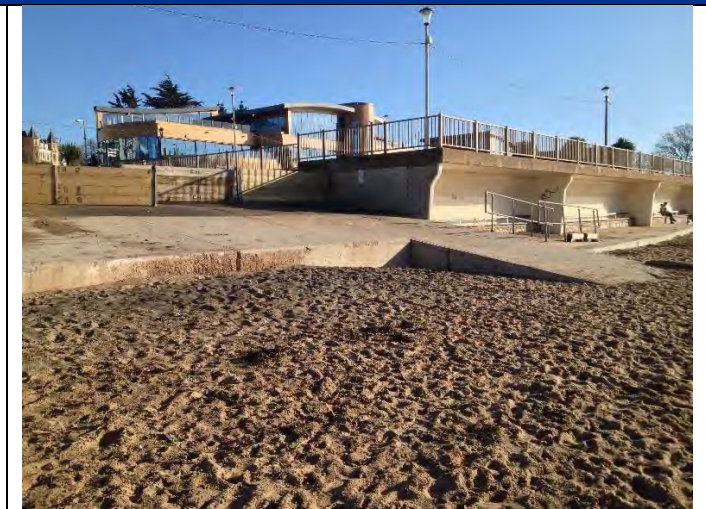
AIMS Asset Name	58351 [NFCDD ref. 113FAS3351002C03]		
Location description	From Harbour View café/ Lookout Station west to access ramp		
Asset Description	Vertical concrete seawall with seating under overhang, fronting public gardens and seafront road.	Construction Date	
Asset Length	138m		
Inspection Date	8 th December 2014		
Inspection Comments	No evidence of settlement or structural movement. Some minor cracks evident along concrete toe beam and coping. Previous grout repairs to masonry beneath seating remains sound. Wooden seating is fair condition. Hand railing and promenade surfacing in good condition. Approximate beach level 1m below toe beam at east end. Strand line at toe of wall.		
Crest level:	+5.24m ODN [from NFCDD]		
Toe level:	No trial pit data available		
Overall Condition:	2 GOOD		
Residual Life:	Best estimate 70 years (slowest/ fastest estimate 30 - 130 years)		
Recommendations:	Monitor beach levels at east end.

Urgency:	No repairs.

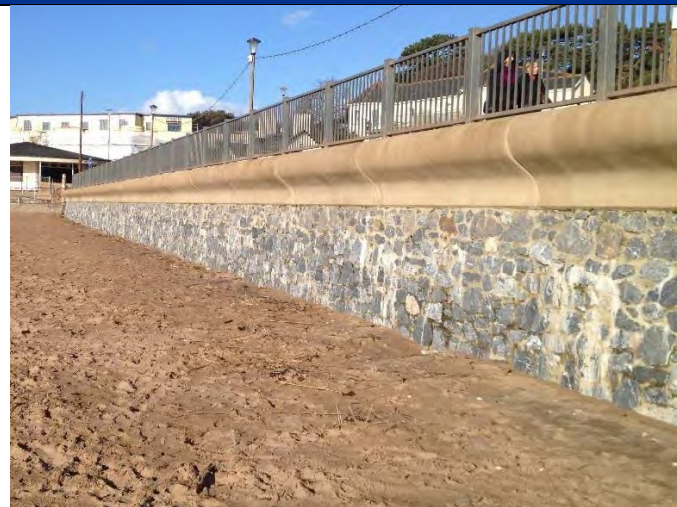
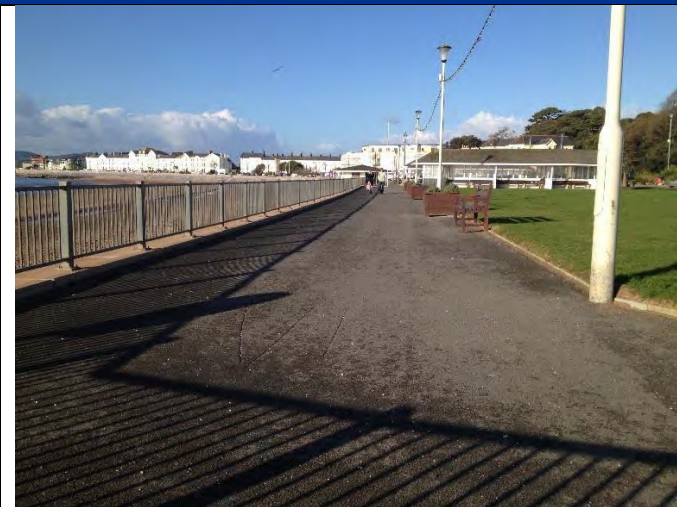
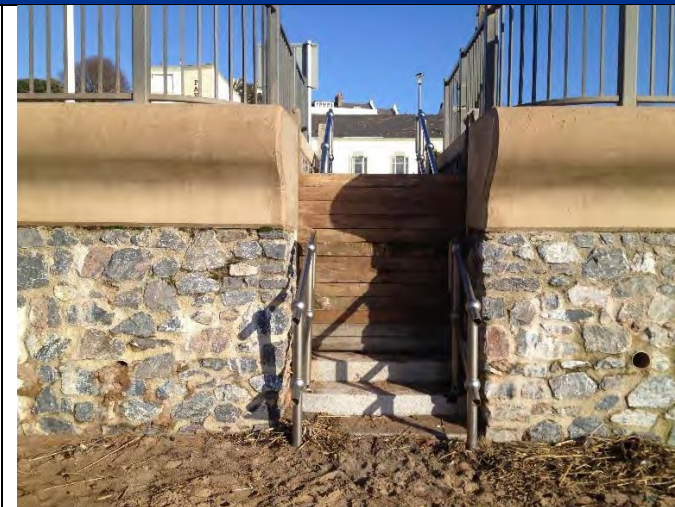
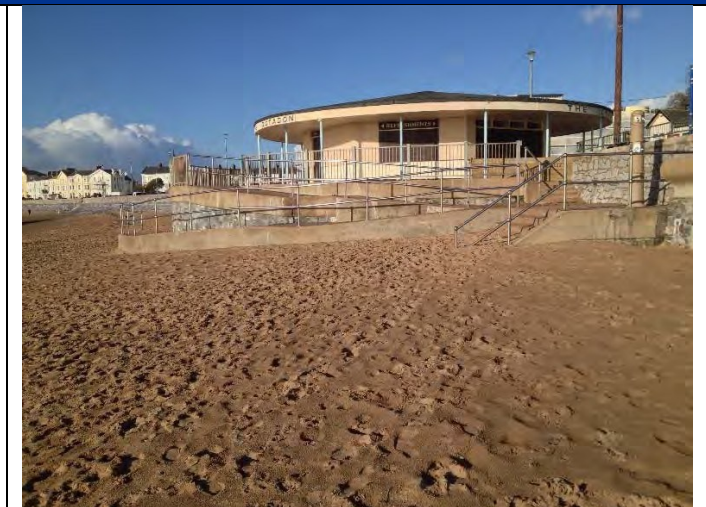
AIMS Asset Name	170455 [NFCDD ref. 113FAS3351002C04]		
Location description	From Octagon Café east to access ramp		
Asset Description	Vertical masonry seawall and concrete recurve at crest, fronting public gardens and seafront road.	Construction Date	Reconstructed 2006?
Asset Length	171m		
Inspection Date	8 th December 2014		
Inspection Comments	No sign of structural movement or crest settlement, masonry and joints sound. No cracks apparent in concrete capping beam. Hand railing and promenade surfacing in good condition. Toe beam visible along short section at east end of wall. Beach levels ~2.2m below crest. Access steps and hand railing at mid-length in good condition. Wall extends around promontory of the Octagon Café at west end, ramps, steps and hand railing in good condition.		
Crest level:	+4.87m ODN [from NFCDD]		
Toe level:	+0.7m ODN [POOR QUALITY DATA - scaled from trial pit survey]		
Overall Condition:	2 GOOD

Residual Life:	Best estimate 75 years (slowest/ fastest estimate 50 – 120 years)		
Recommendations:	Monitor beach levels at east end.		
Urgency:	No repairs

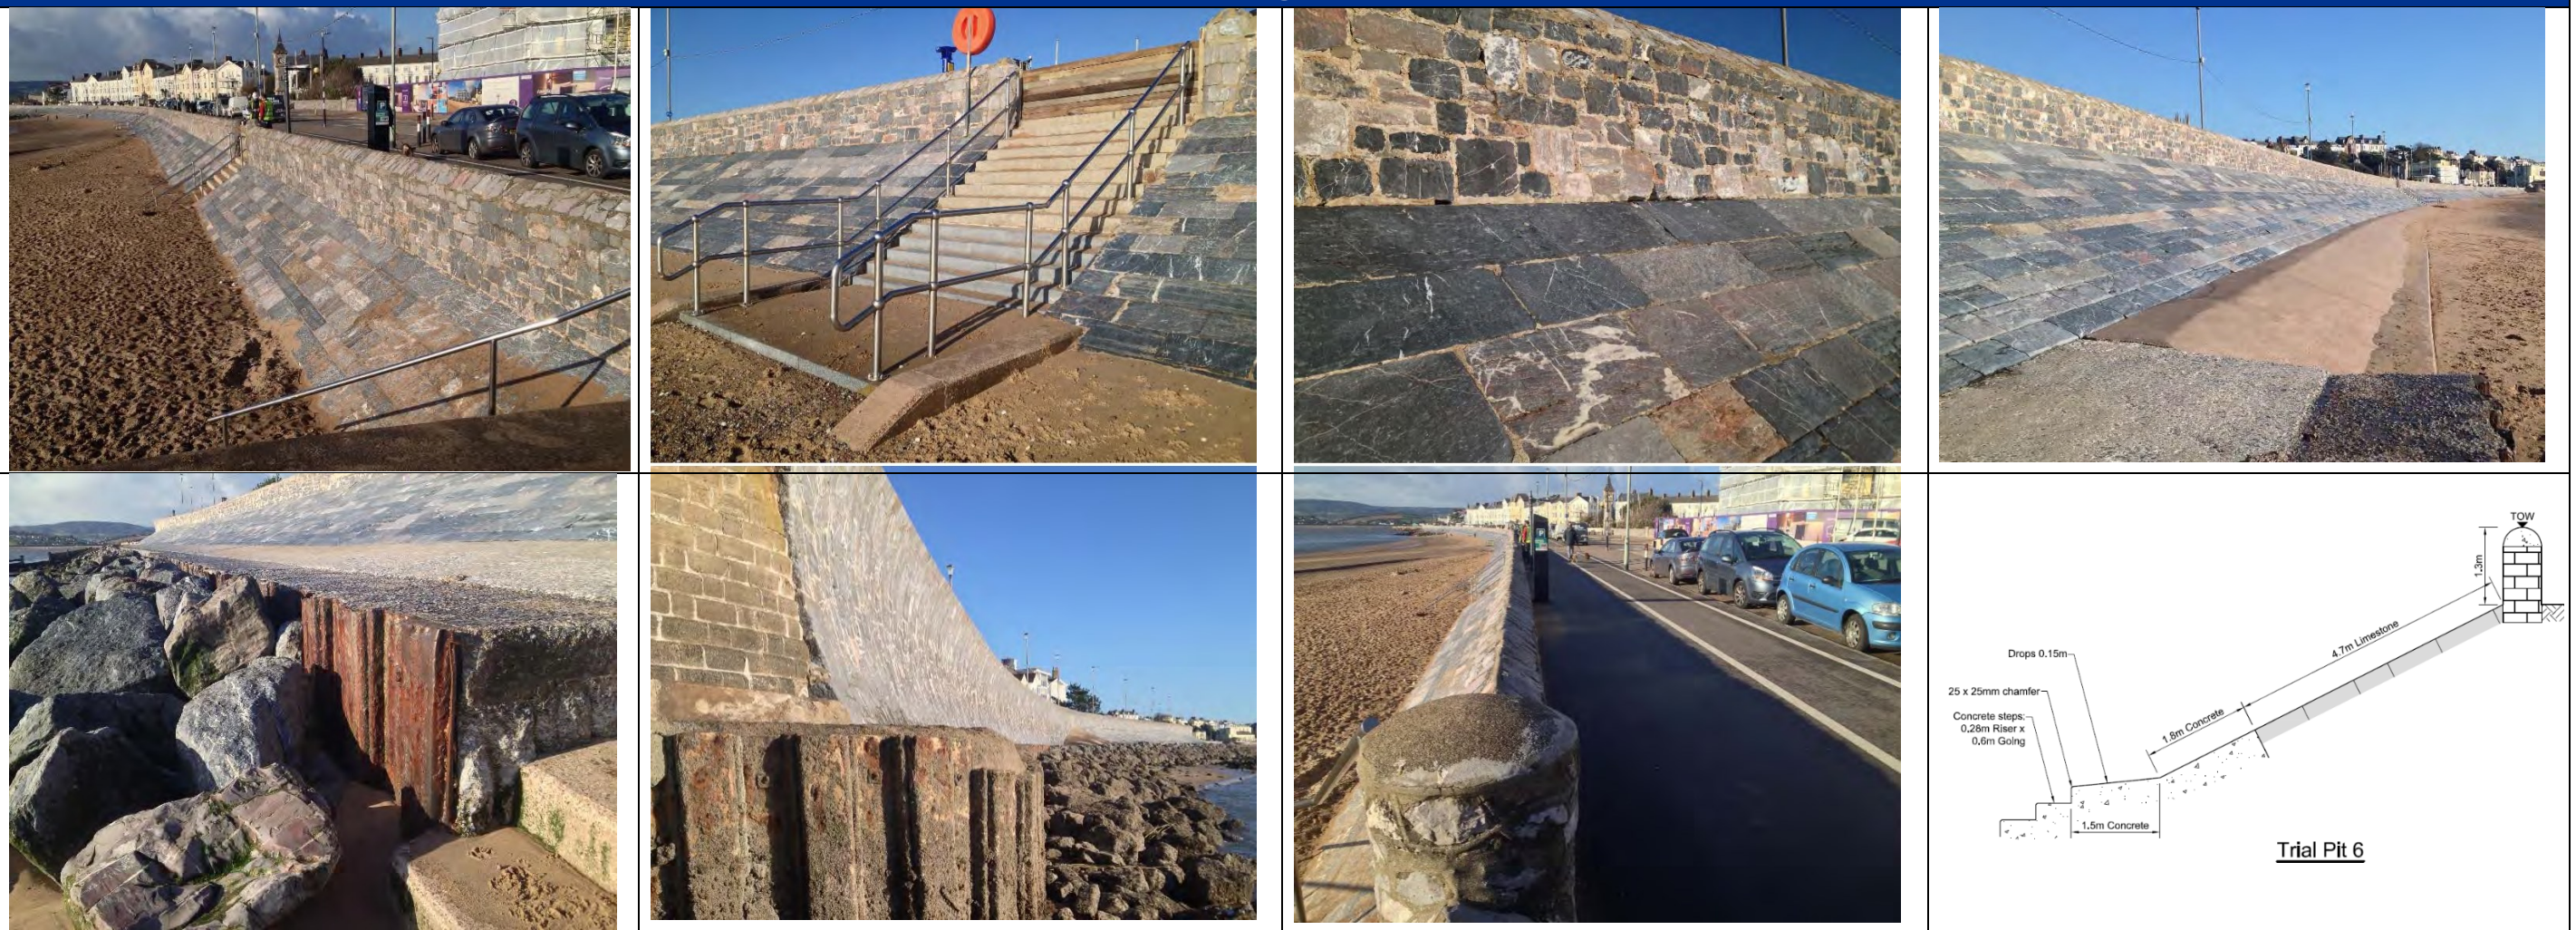
AIMS Asset Name	3808 [NFCDD ref. 113FAS3351002C05]		
Location description	Octagon Café to Slipway at west end of Esplanade.		
Asset Description	Sloping masonry seawall and vertical crest wall with rock armour, fronting promenade and seafront road.	Construction Date	1841/42, parapet added 1869, rock armour added 2004.
Asset Length	697m		
Inspection Date	8 th December 2014		
Inspection Comments	No signs of movement or settlement of crest. All masonry and joints are sound, some minor loss of mortar at base of crest wall. Abrasion of sloping masonry but no damage apparent. Toe of structure well buried at east end, low beach levels exposing top edge of toe beam at west end. Corrosion to sheet piles along toe at west end resulting in noticeable loss of section. Rock armour fronting piles angular and well packed with no movement apparent. Heavy abrasion to toe beam behind rock armour. Access steps and hand railing at east end and along wall in good condition. No damage to promenade surfacing but, some wind-blown sand on promenade. Approximate beach level below base of crest wall: 8 joints down at east end, 12 joints down at centre, top edge of toe beam at west end.

Crest level:	+4.87m ODN [from NFCDD]		
Toe level:	-0.1m ODN [scaled from trial pit survey – agrees well with AIMS]		
Overall Condition:	2 GOOD		
Residual Life:	Best estimate 75 years (slowest/ fastest estimate 50 – 120 years)		
Recommendations:	Repair gaps in masonry at base of crest wall. Monitor beach levels at west end.		
Urgency:	Routine

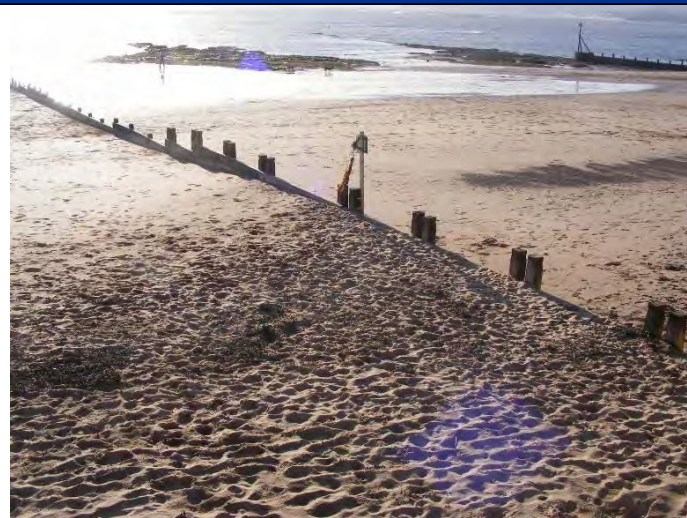
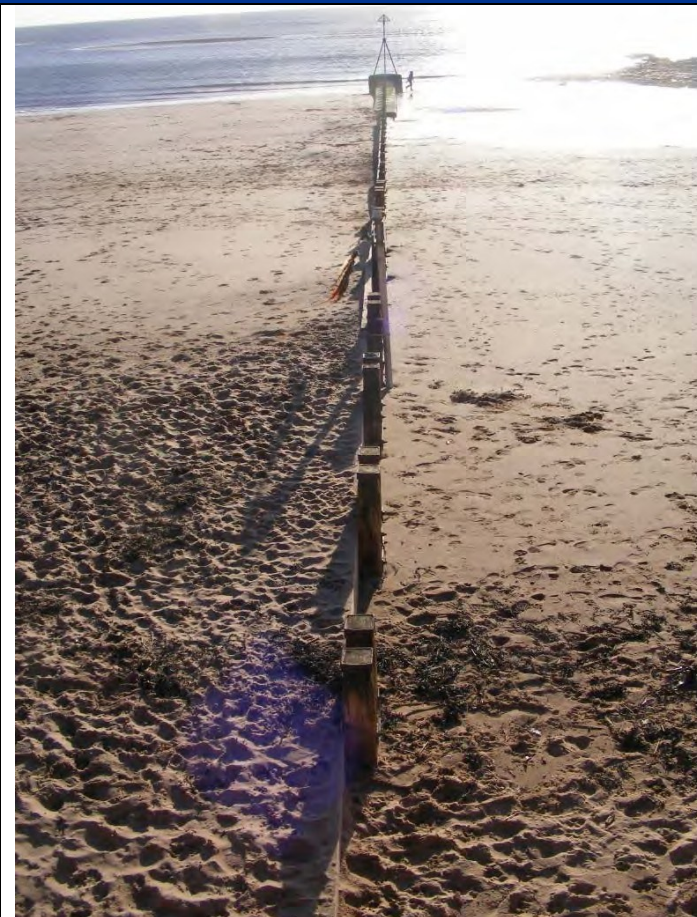
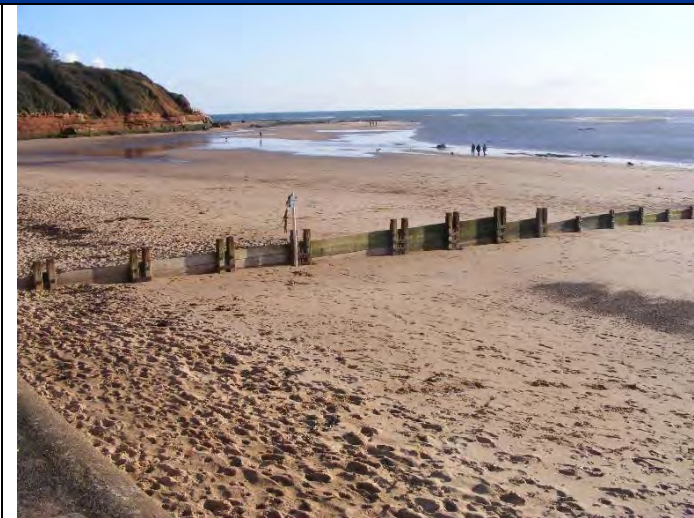
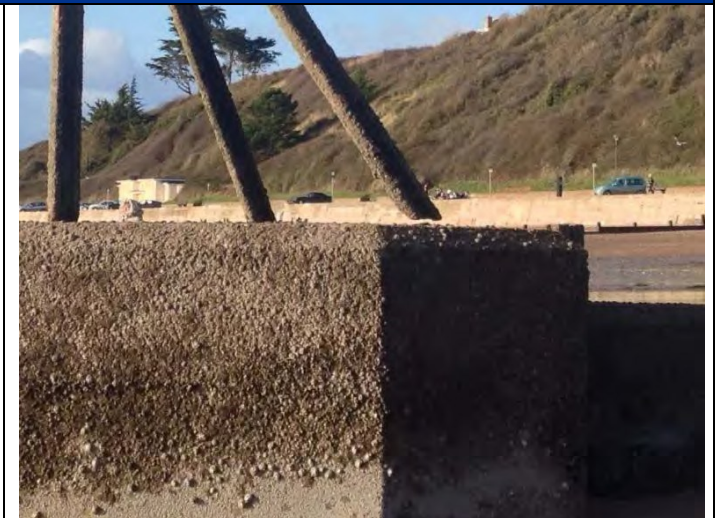
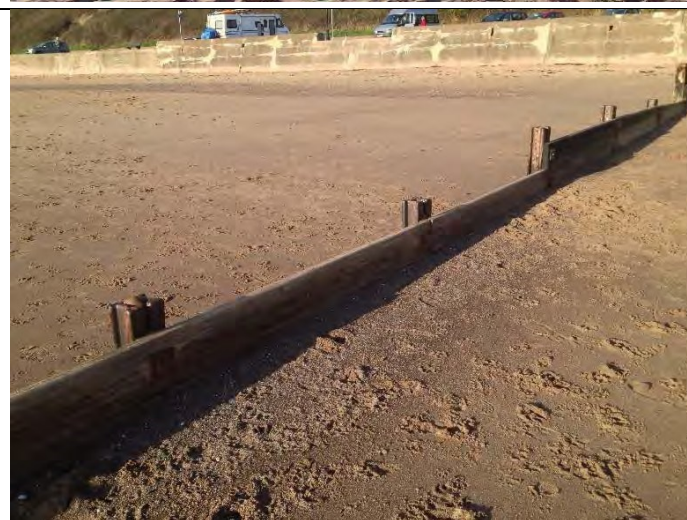
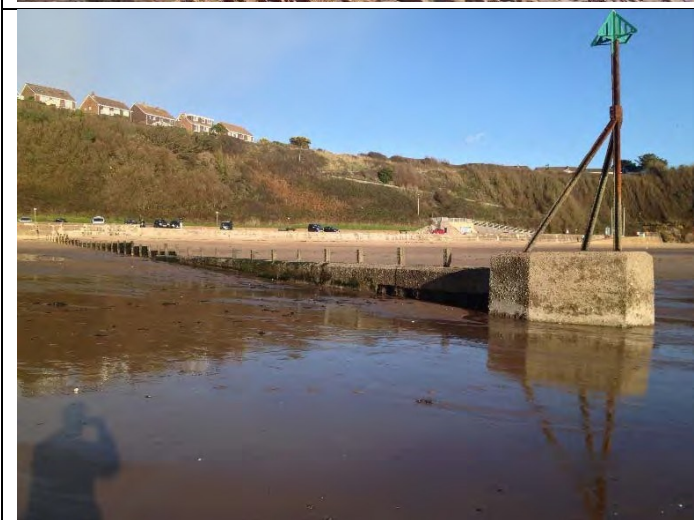
Asset Name		Groyne no. 1	
Location description		First groyne along Queens Drive at Orcombe Point	
Asset Description		Timber post and plank groyne with concrete and base and steel posts at seaward end. Steel navigation marker.	Construction Date 1970's
Asset Length		90m	
Inspection Date		8 th December 2014	
Inspection Comments		Structure appears sound, groyne straight and all piles vertical with no evidence of rotation or undermining. Some abrasion to timber planks but little or no gaps between planks evident. Planks missing along seaward concrete section of groyne. All fixing sound, some corrosion evident. Some abrasion to concrete base. Steel bracing to navigation marker damaged and detached from base. Beach material level with top plank in upper beach. Strand line ~5-10m from seawall.	
Beach level differential	Upper	+0.6m (east side)	
	Mid	+0.3m (east side)	
	Lower	-	
Overall Condition:		2 GOOD	
Residual Life:		10 - 15 years

Recommendations:		Consider raising groyne height in upper beach. Repair bracing to navigation marker.	
Urgency:		Routine.

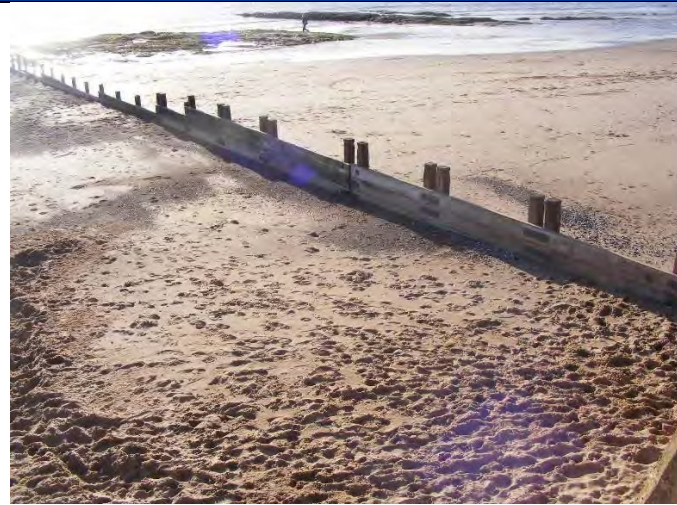
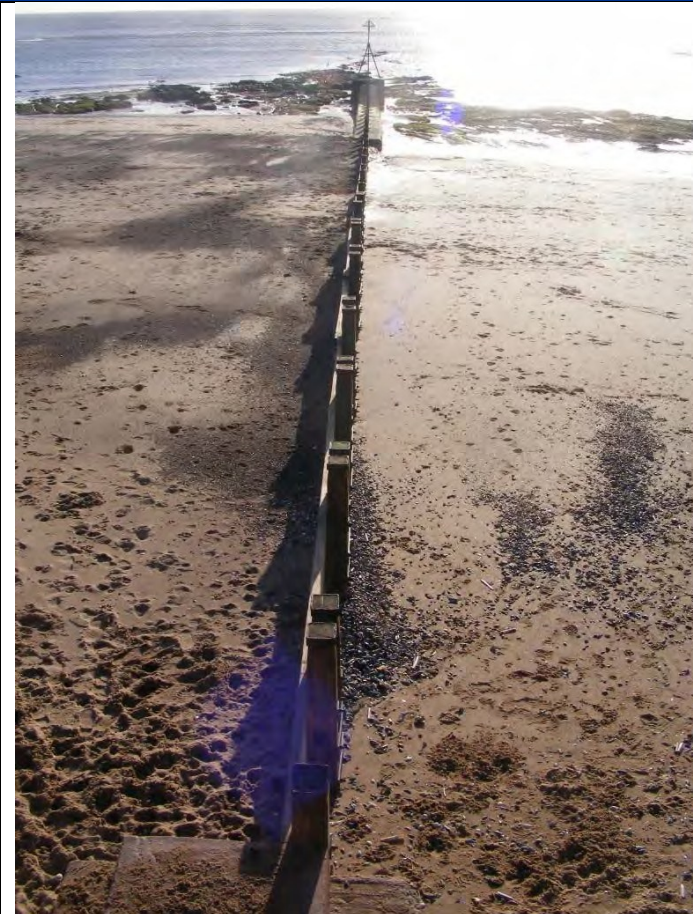
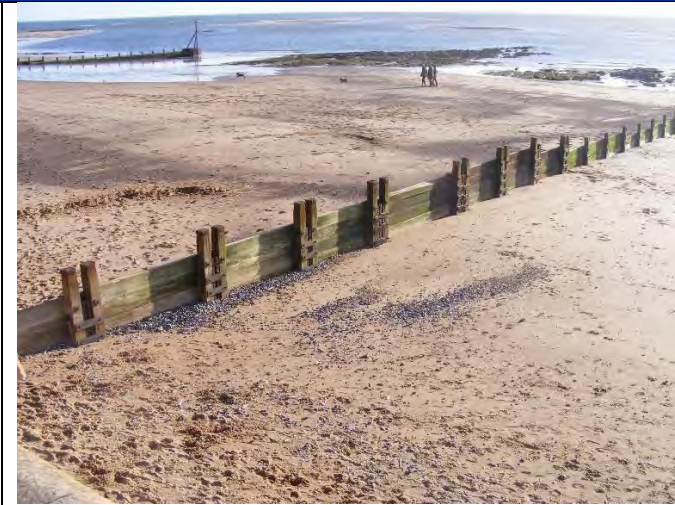
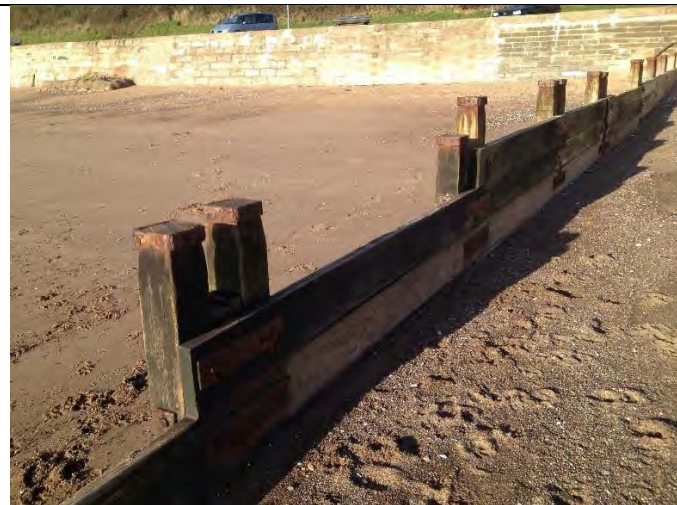
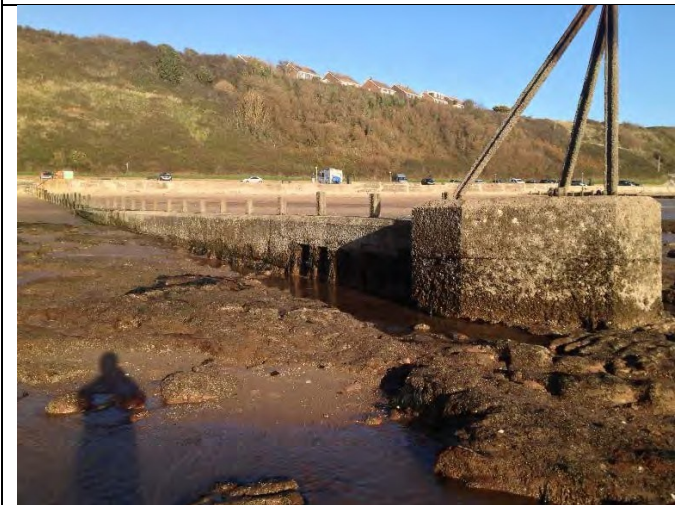
Asset Name		Groyne no. 2	
Location description		Second groyne along Queens Drive from Orcombe Point and The Maer	
Asset Description		Timber post and plank groyne with concrete and base and steel posts at seaward end. Steel navigation marker.	Construction Date 1970's
Asset Length		~90m	
Inspection Date		8 th December 2014	
Inspection Comments		Structure appears sound, groyne straight and all piles vertical with no evidence of rotation or undermining. Some abrasion to timber planks, minor gaps between planks in upper beach. Planks appear to be missing along mid to lower beach concrete section of groyne. All fixing sound, some corrosion evident. Some abrasion to concrete base. Low beach levels along mid and lower beach. Strand line 5m from seawall.	
Beach level differential	Upper	+0.3m (east side)	
	Mid	+0.4m (east side)	
	Lower	-	
Overall Condition:		2 GOOD	
Residual Life:		10 - 15 years	
Recommendations:		Monitor beach levels.

Urgency:		No repairs.

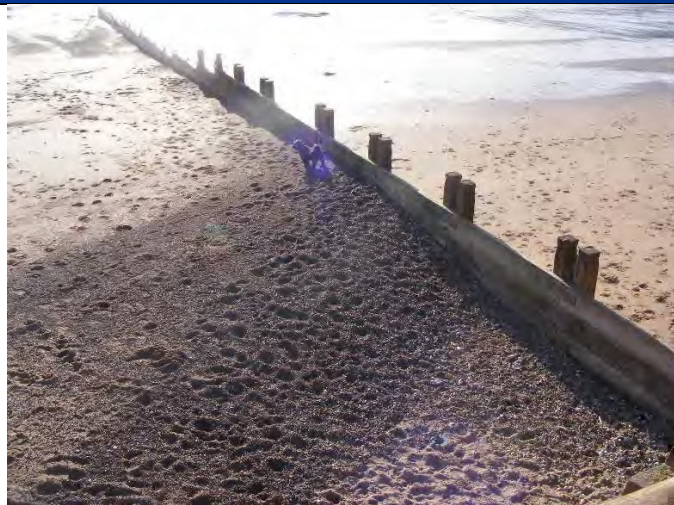
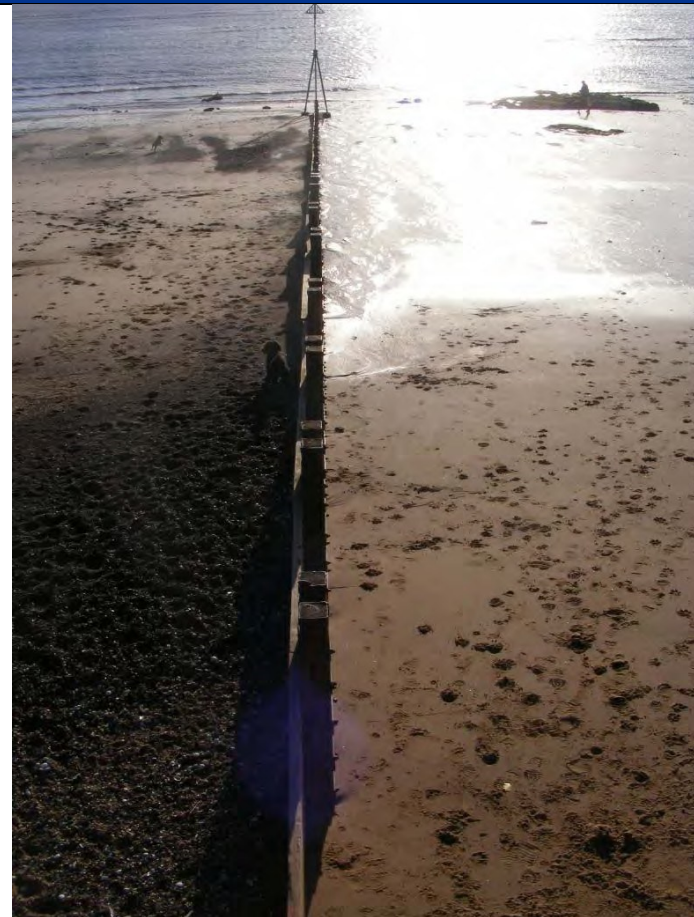
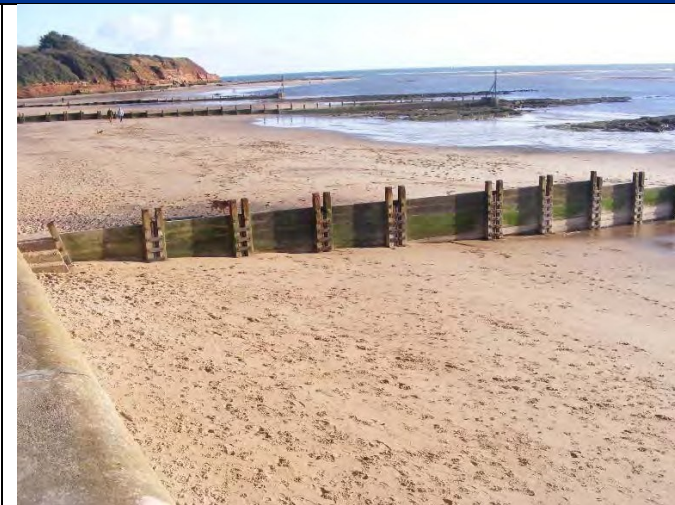
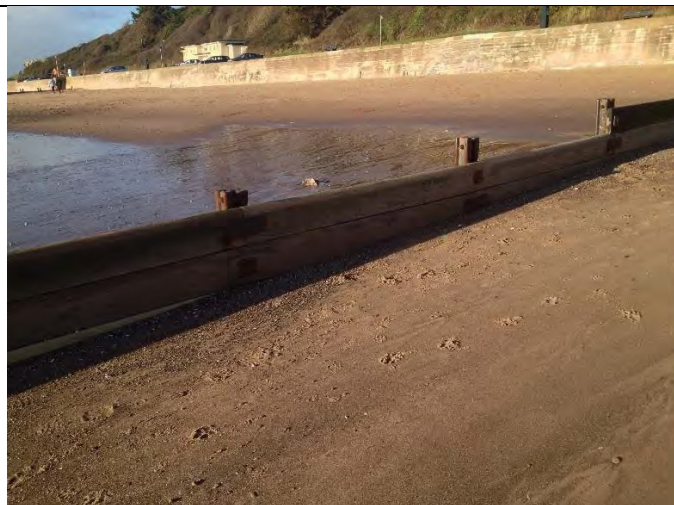
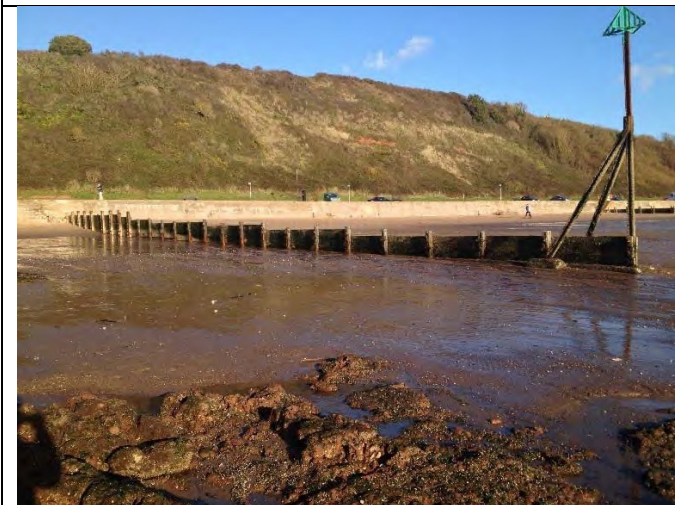
Asset Name		Groyne no. 3	
Location description		Third groyne along Queens Drive from Orcombe Point and The Maer	
Asset Description		Timber post and plank groyne with concrete and base and steel posts at seaward end. Steel navigation marker.	Construction Date
			1970's
Asset Length		~60m	
Inspection Date		8 th December 2014	
Inspection Comments		Structure appears sound, groyne straight and all piles vertical with no evidence of rotation or undermining. Some abrasion to timber planks, minor gaps between planks in upper beach. All fixing sound, some corrosion evident. Some abrasion to concrete base. Low beach levels along upper, mid and lower beach. Groyne much shorter than groynes to east (1-3) and west (5-6). Strand line at toe of seawall.	
Beach level differential	Upper	+1.0m (east side)	
	Mid	+0.7m (east side)	
	Lower	+0.4m (east side)	
Overall Condition:		2 GOOD	
Residual Life:		10 - 15 years	
Recommendations:		Monitor low beach levels, consider placing additional beach material.

Urgency:		No repairs.
