Appendix A – Exmouth Coastal Defence Condition Assessment Report

Prepared by: Matthew Stannard
 Date: 24-02-2015
 Version: 1

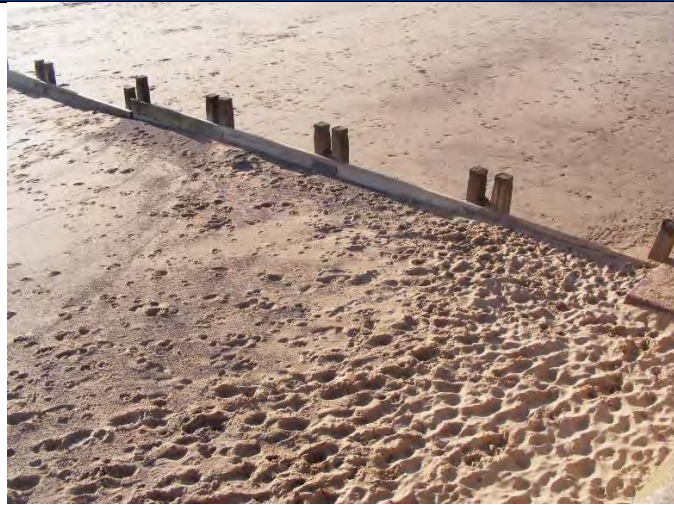
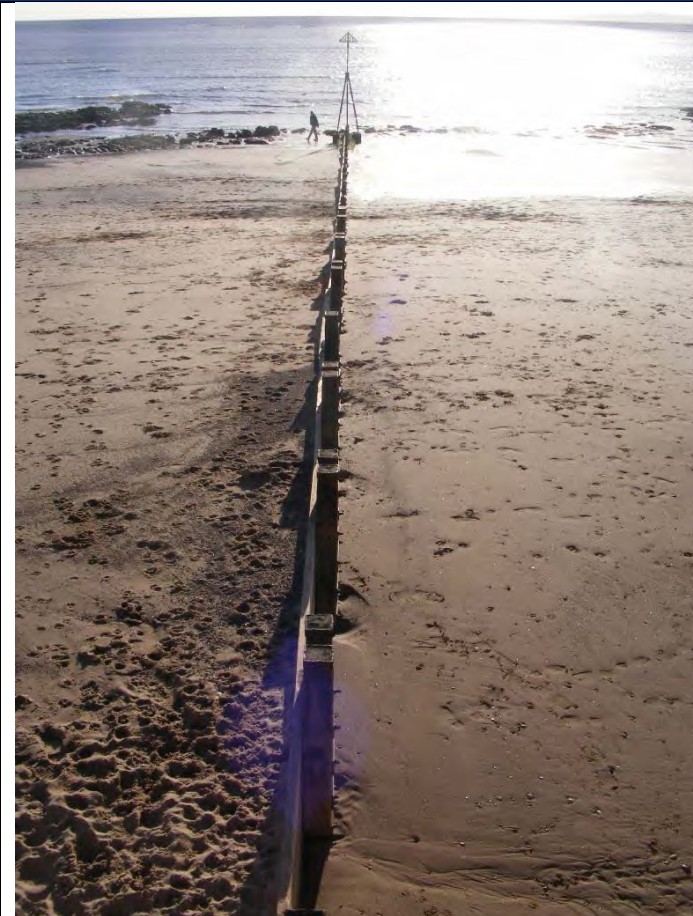
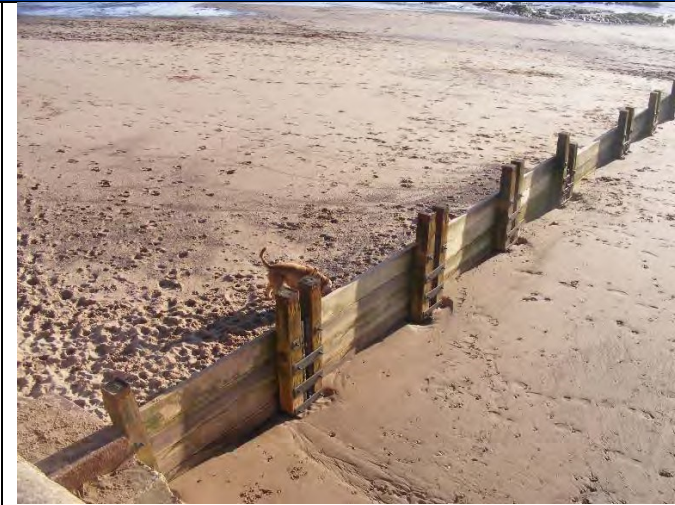
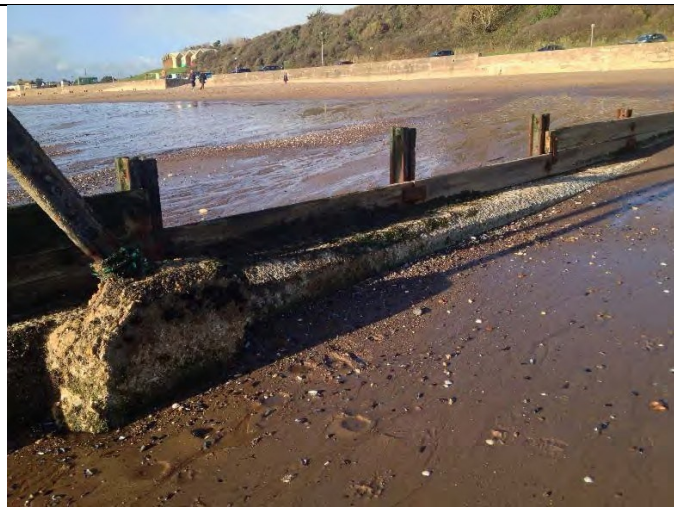
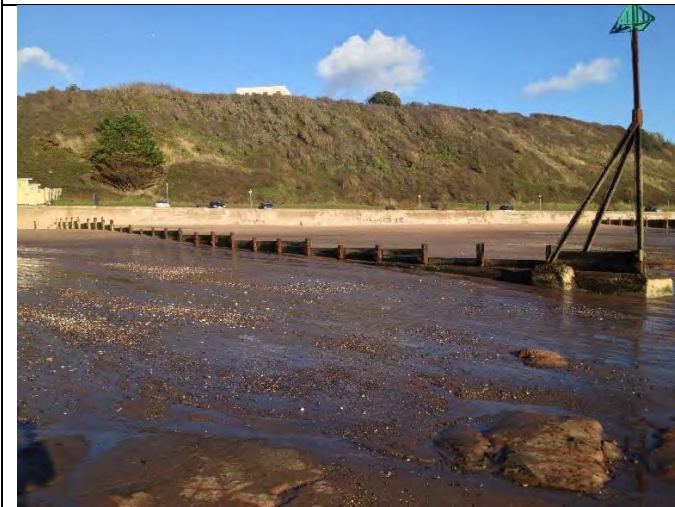
Asset Name		Groyne no. 4	
Location description		Fourth groyne along Queens Drive from Orcombe Point and The Maer	
Asset Description		Timber post and plank groyne with concrete and base and steel posts at seaward end. Steel navigation marker.	Construction Date 1970's
Asset Length		~60m	
Inspection Date		8 th December 2014	
Inspection Comments		Structure appears sound, groyne straight and all piles vertical with no evidence of rotation or undermining. Some abrasion to timber planks, some gaps between planks at mid-length. Two planks missing at seaward end of groyne. All fixing sound, some corrosion evident. Some abrasion to concrete base. Low beach levels along upper and lower beach. Groyne much shorter than groynes to east (1-2) and west (5-6). Beach material close to top of top plank in upper beach. Strand line at toe of seawall.	
Beach level differential	Upper	+0.7m (east side)	
	Mid	+0.7m (east side)

Lower	-	
Overall Condition:		2 GOOD	
Residual Life:		10 - 15 years	
Recommendations:		Consider raising height of groyne in upper beach to improve performance.	
Urgency:		No repairs.

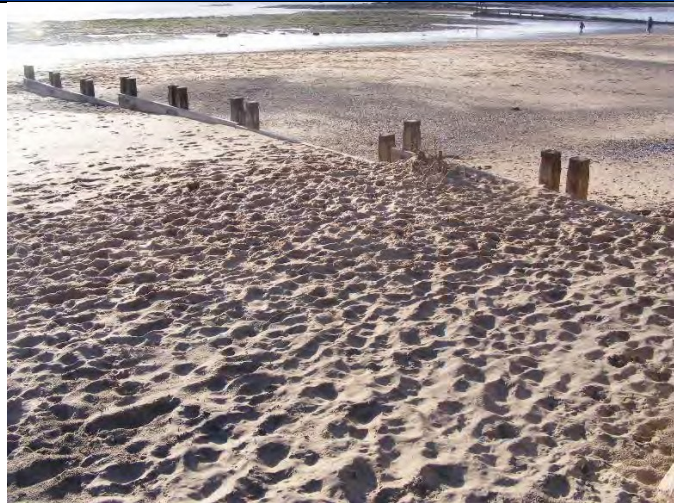
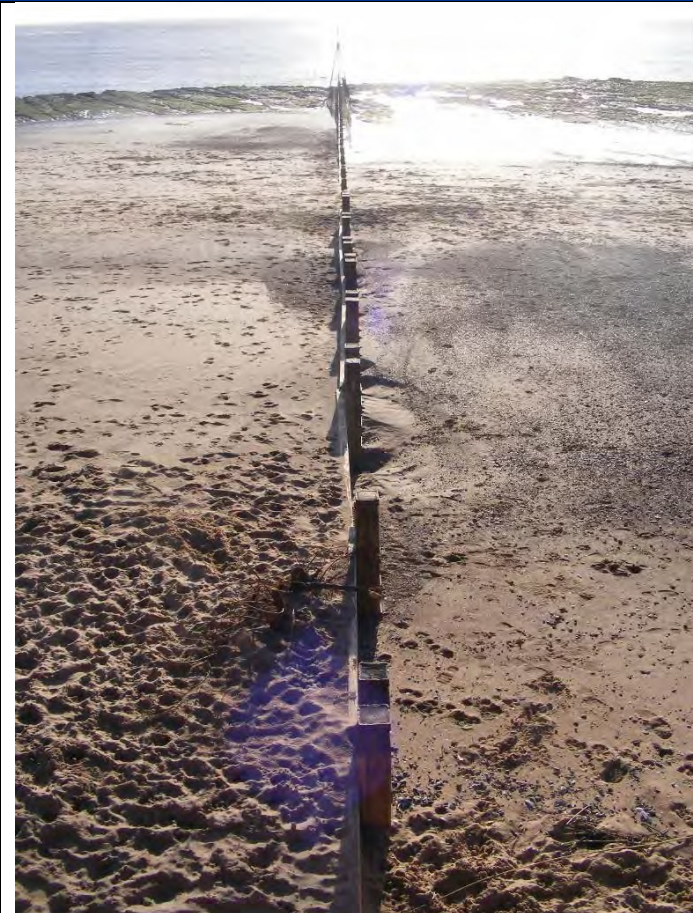
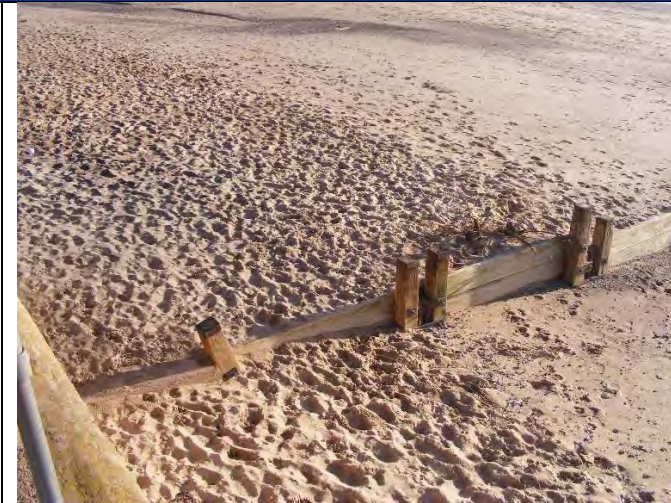
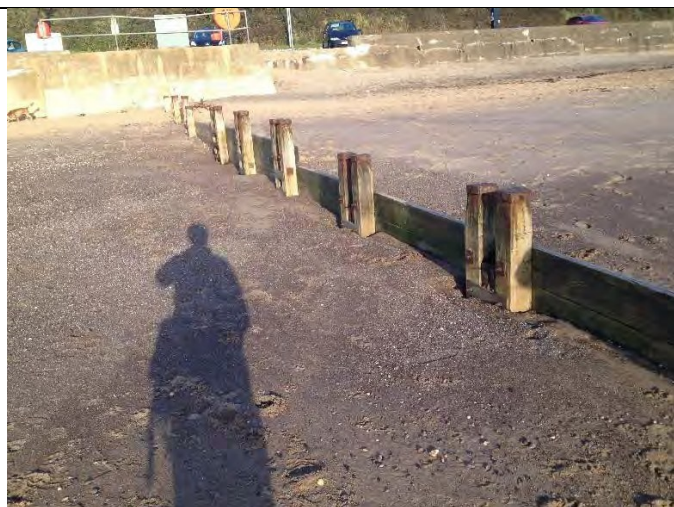
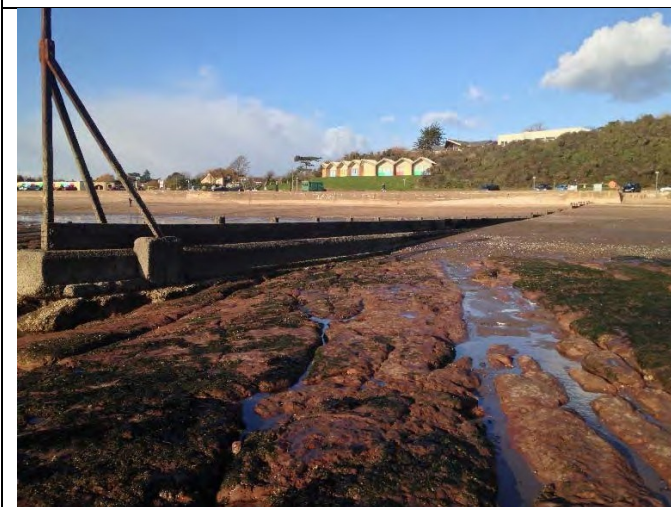
Asset Name		Groyne no. 5	
Location description		Fifth groyne along Queens Drive from Orcombe Point and The Maer	
Asset Description		Timber post and plank groyne with concrete and base and steel posts at seaward end. Steel navigation marker.	Construction Date
			1970's
Asset Length		~90m	
Inspection Date		8 th December 2014	
Inspection Comments		Structure appears sound, groyne straight and all piles vertical with no evidence of rotation or undermining. Some abrasion to timber planks, no gaps between planks evident. All fixing sound, some corrosion evident. Some abrasion to concrete base. Low beach levels along upper, mid and lower beach. Groyne much shorter than others to the east. Beach material close to top of top plank in upper and mid beach. Strandline 5m from seawall.	
Beach level differential	Upper	+0.3m (east side)	
	Mid	+0.7m (east side)	
	Lower	-	
Overall Condition:		2 GOOD	
Residual Life:		10 - 15 years

Recommendations:		Consider raising height of groyne in upper and mid beach to improve performance.	
Urgency:		No repairs.

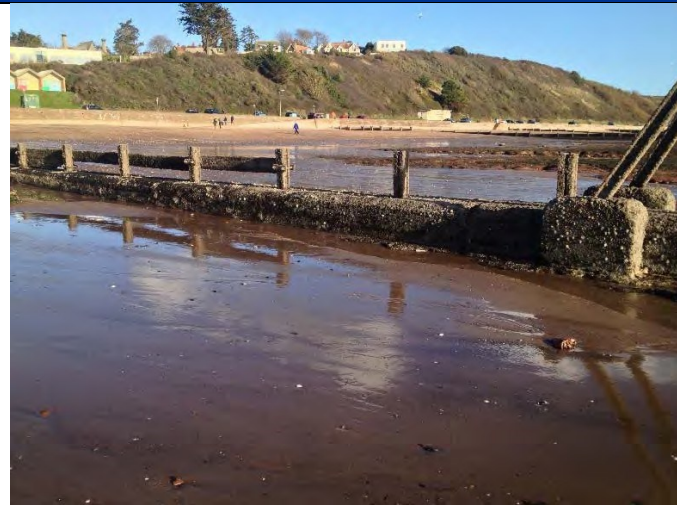
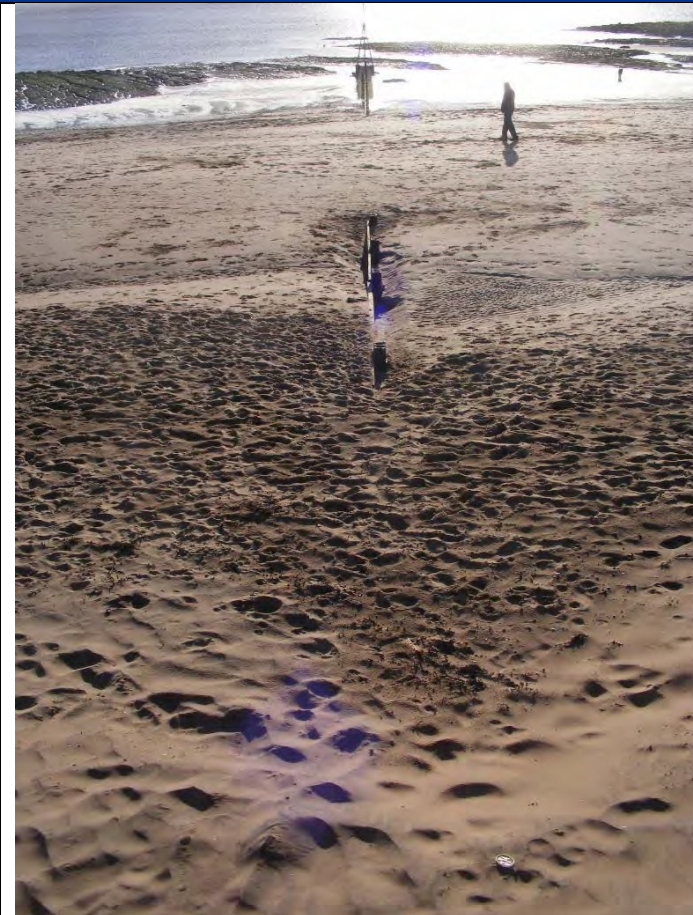
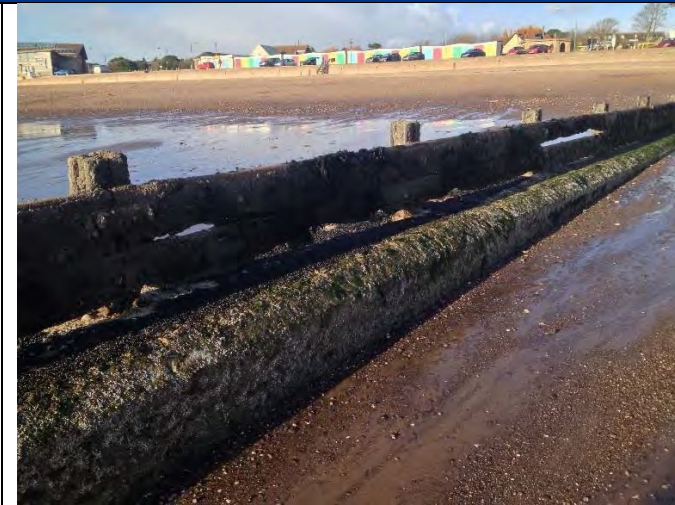
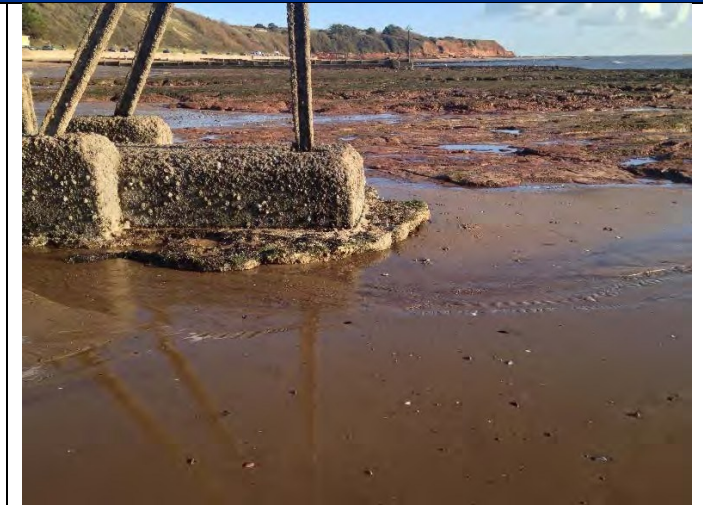
Asset Name		Groyne No.6	
Location description		Sixth groyne on Queens Drive from Orcombe Point and The Maer	
Asset Description		Timber post and plank groyne with concrete and base and steel posts at seaward end. Steel navigation marker.	Construction Date 1970's
Asset Length		~90m	
Inspection Date		8 th December 2014	
Inspection Comments		Structure buried in upper and mid beach so inspection not possible. Concrete Structure appears sound. Seaward end of groyne appeared straight and vertical with no evidence of rotation. Minor onset of undermining below concrete base at groyne head. Significant abrasions and gaps between planks at seaward end. Fixing appear sound, some corrosion evident. Strandline 20m from seawall.	
Beach level differential	Upper	Buried	
	Mid	Buried	
	Lower	-	
Overall Condition:		2 GOOD	
Residual Life:		10 - 15 years	
Recommendations:		Consider raising height of groyne in upper and mid beach. Replace planks in lower beach.

Urgency:		Routine.
