Defences Baseline

East Devon District
Council

August 2017

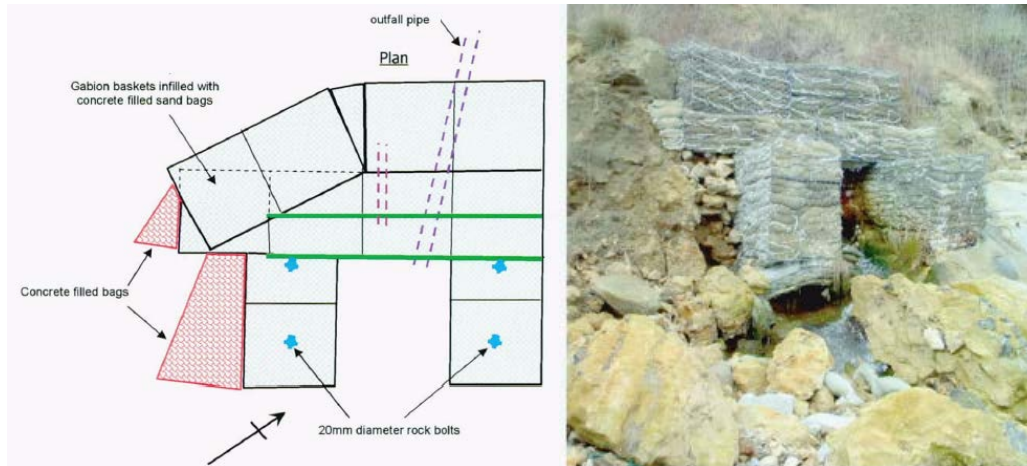
- The gabion baskets protected the culvert outlet/outfall during the winter storms in 2004, however a significant volume of landslip debris was washed away along with the loss of many loosely placed concrete-filled sand bags. This allowed some erosion at the western edge of the structure (David Roche GeoConsulting Limited, 2003).
- In 2005, further storms resulted in the loss of additional concrete-filled sand bags, and works were undertaken to strengthen the wing walls (David Roche GeoConsulting Ltd, 2005). The work included the introduction of additional gabion baskets filled with concrete-filled sand bags in front of the western wing wall as well as extending the wing wall further west (Figure 2-3).

Figure 2-2 Outfall protection works with destroyed areas in 2004/2005 shown in red and in the adjacent photo.

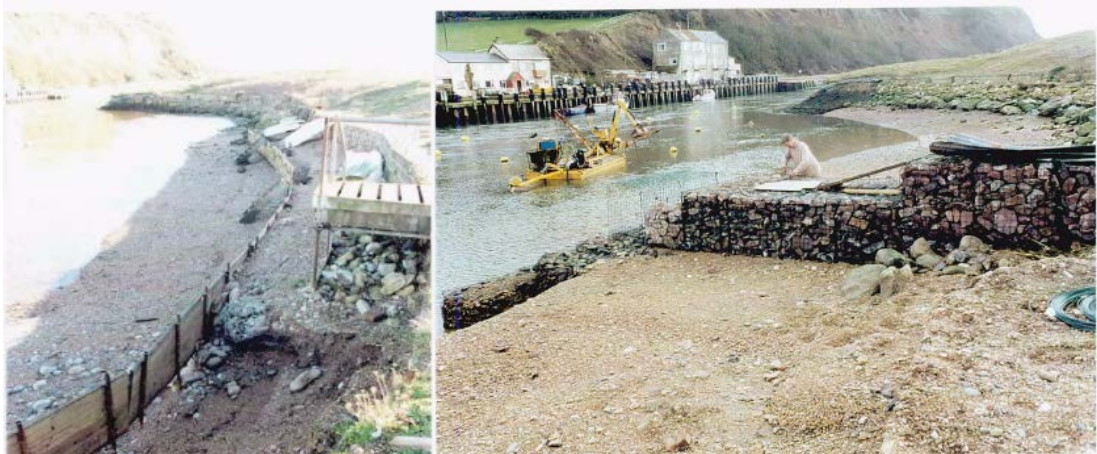
Figure 2-11 Photos of the protective fencing undermined and the construction of the gabion groyne
 Source: Axmouth Harbour Management (2003)

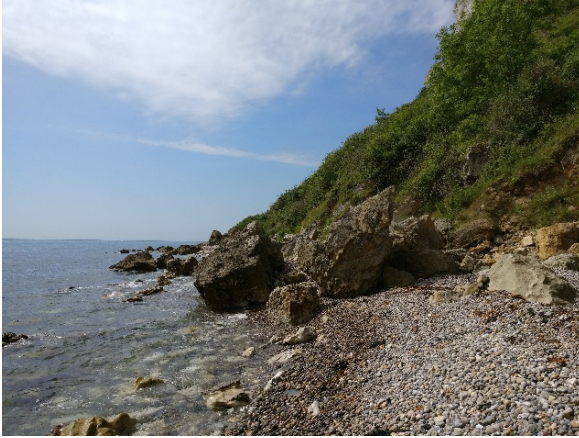
Well-vegetated area of spalled rock at cliff base

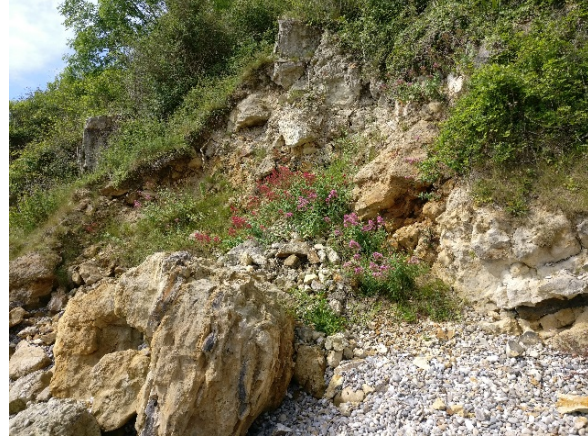
Signs of recent slips with large and small rock

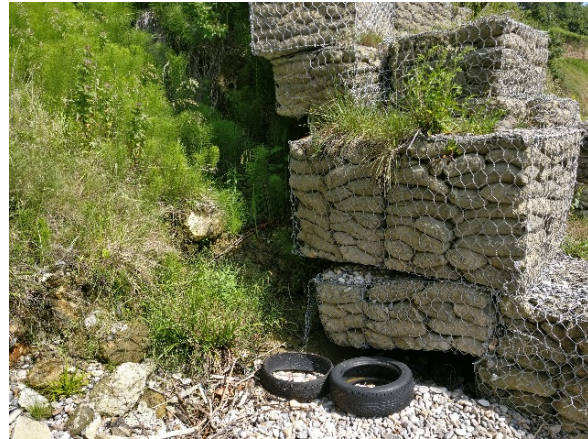
Undermining and outflanking have caused slumping

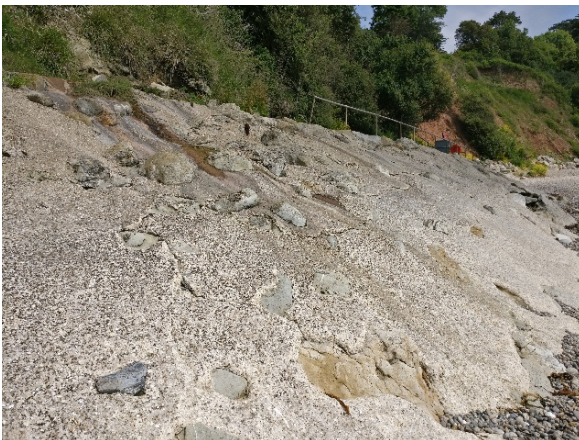
Steep, concrete revetment surface was cracked

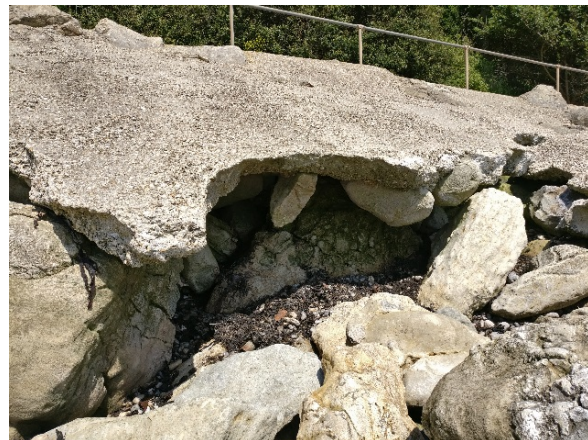
Failure at slope toe leading to loss of fill

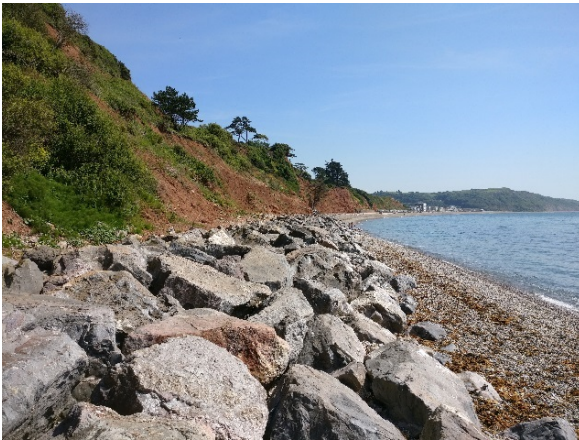
Generally consistent profile

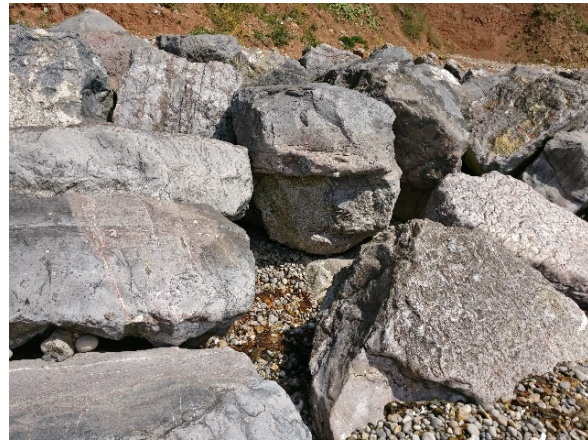
Large voids present within the structure

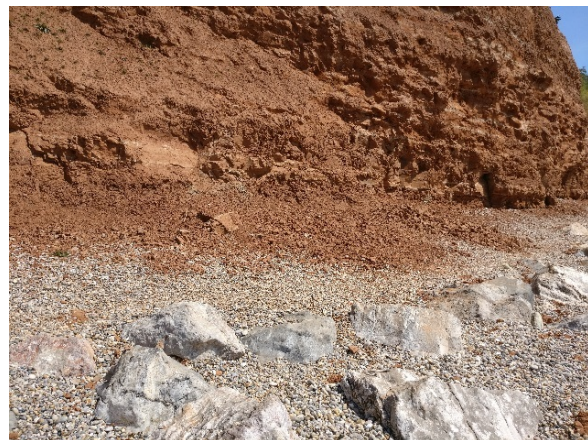
Signs of recent cliff failure behind buried rock revetment

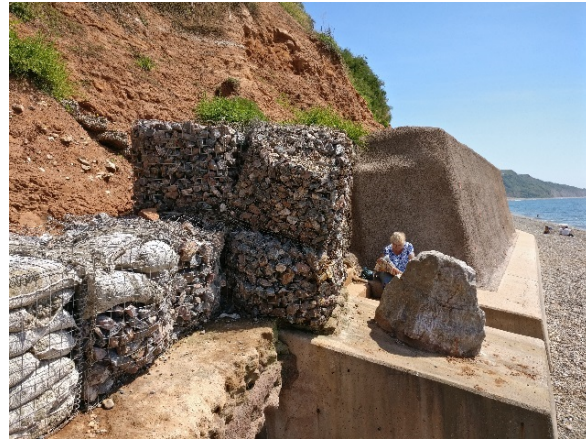
Deformation of gabion baskets and loss of fill material

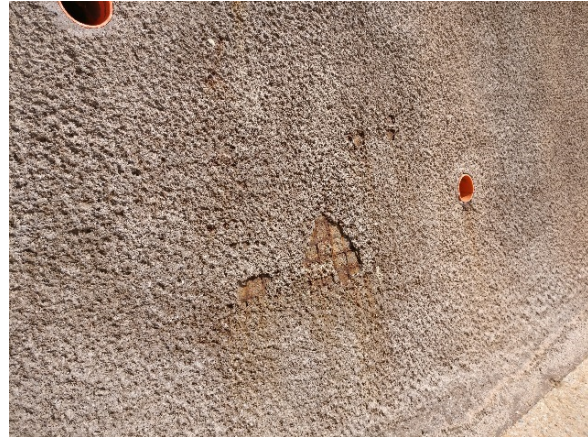
Spalling of surface concrete resulted in exposure of underlying steel

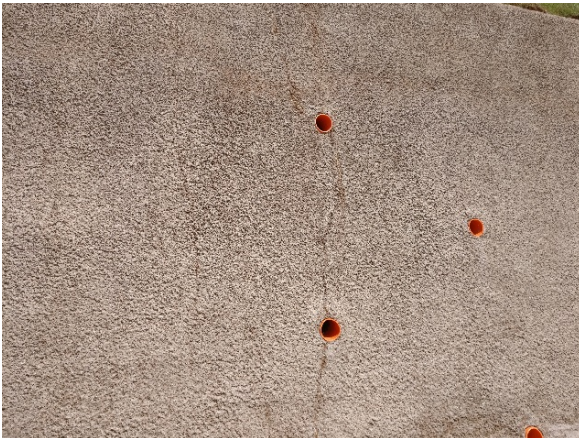
Vertical cracking aligned to drainage channels

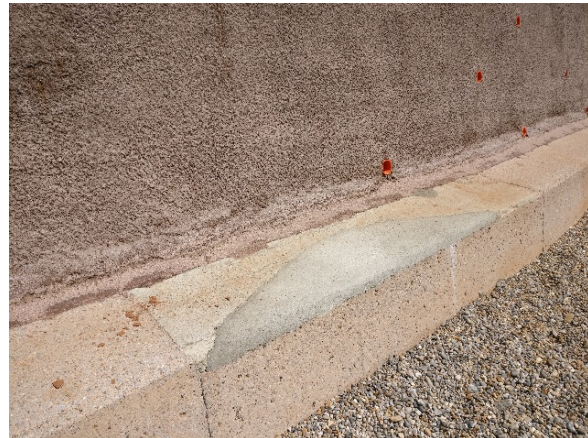
Patch repairs to concrete toe

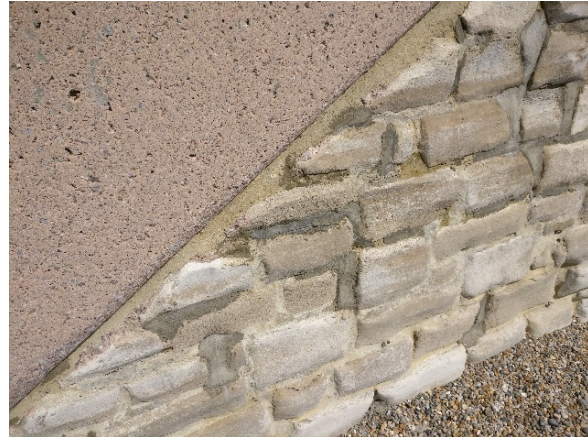
Patch repairs to grouting between stone blocks

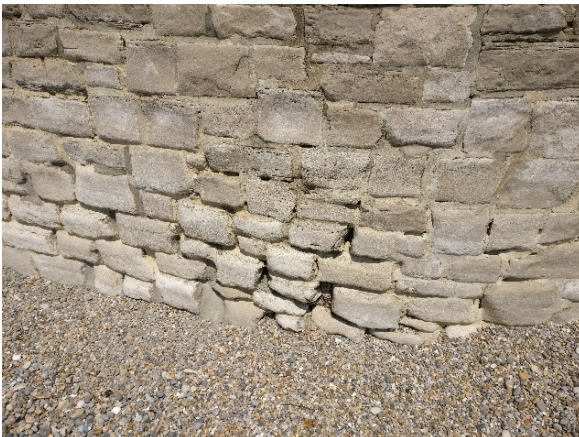
Localised loss of grouting between stone blocks

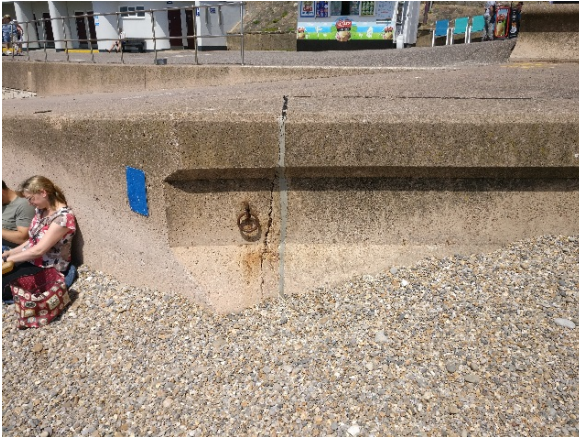
Vertical cracking of concrete seawall with wave return

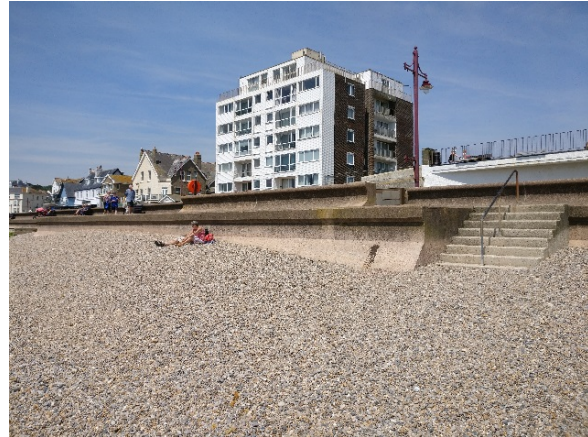
No signs of wall undermining, or slumping

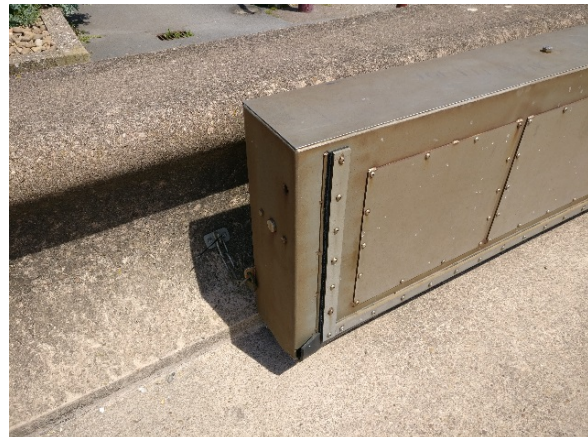
Multiple flood gates present, with damage to rubber seals

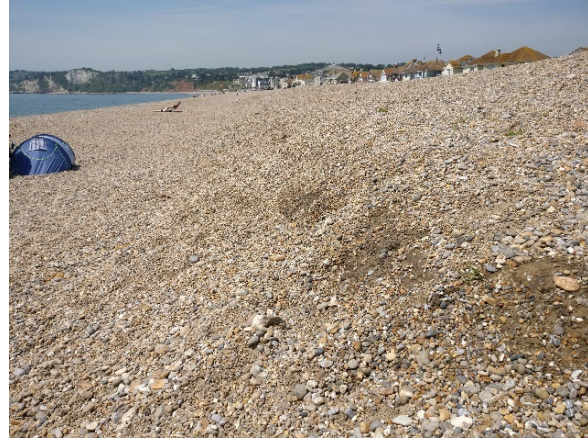
Beach steepens further east, exposing consolidated silt within the beach core (previous dredged material)

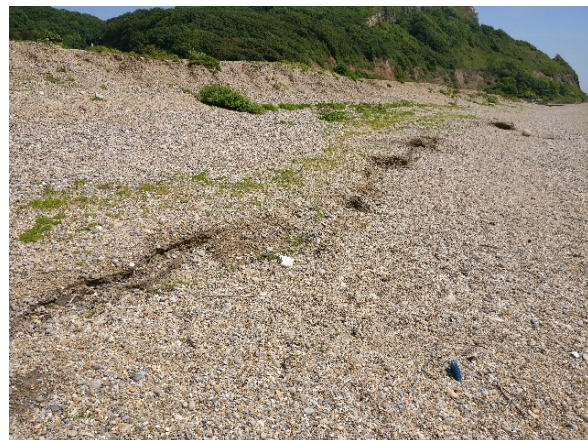
Cliffing was noted at the toe of the upper beach, exposing consolidated silt

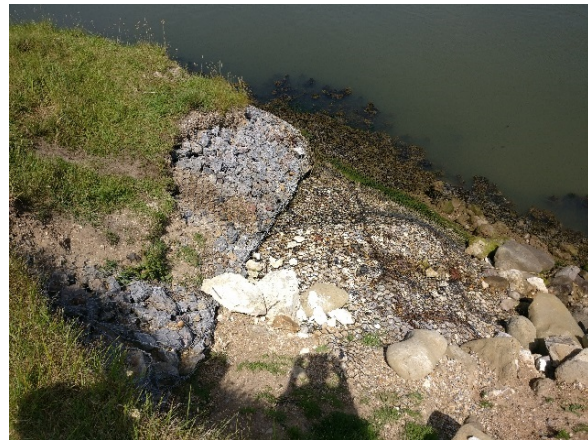
Damage to grass cover and underlying gabion mattresses

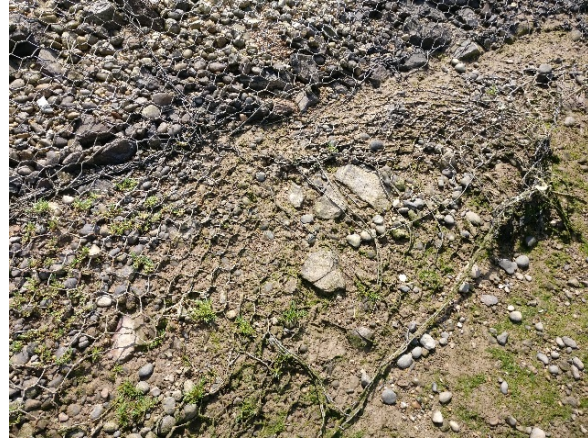
Some damage to steel has allowed loss of fill material

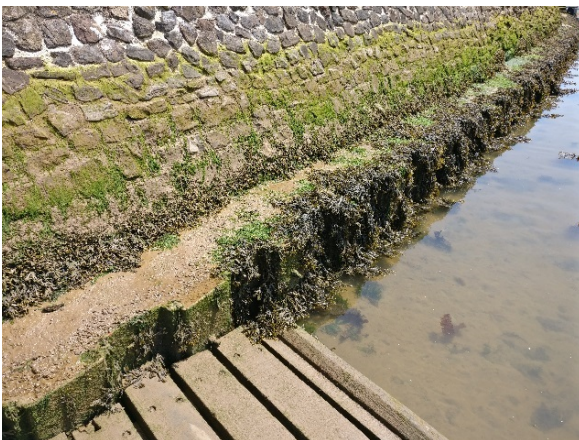
Surface corrosion of steel sheet pile toe

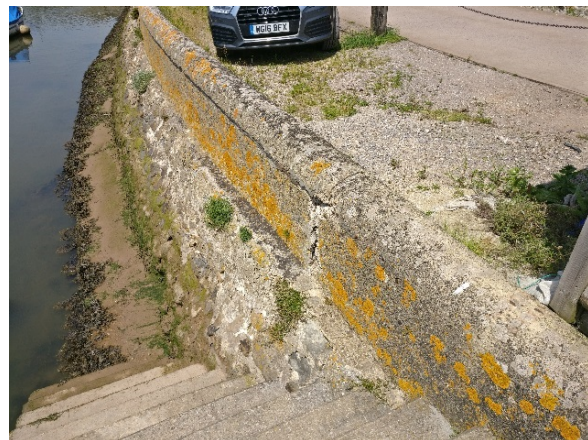
Some vertical cracking of the upper concrete wall

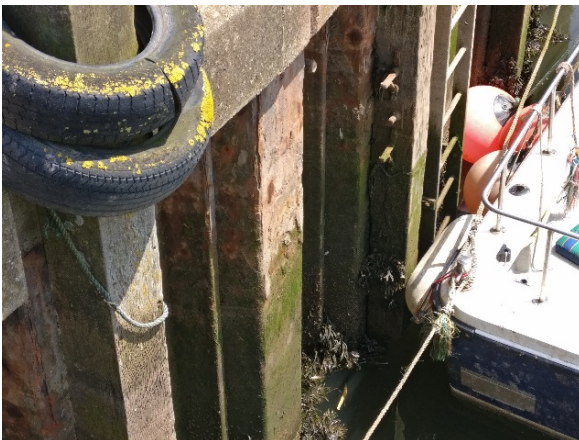
Surface corrosion of the main sheet pile wall

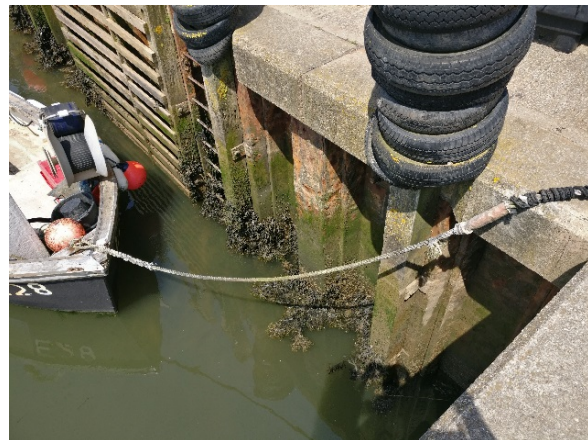
Surface corrosion in the upper section of the sheet pile

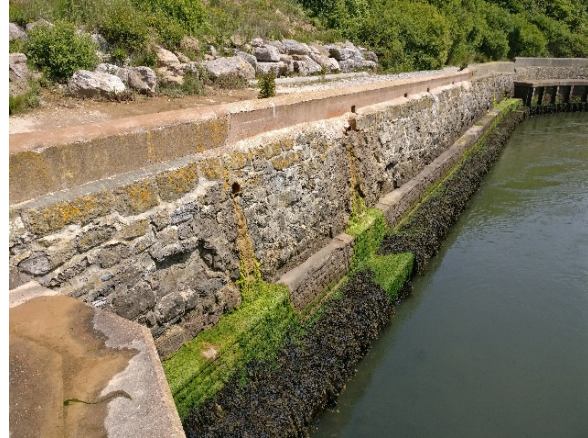
Patch repairs to the upper section of stone block wall

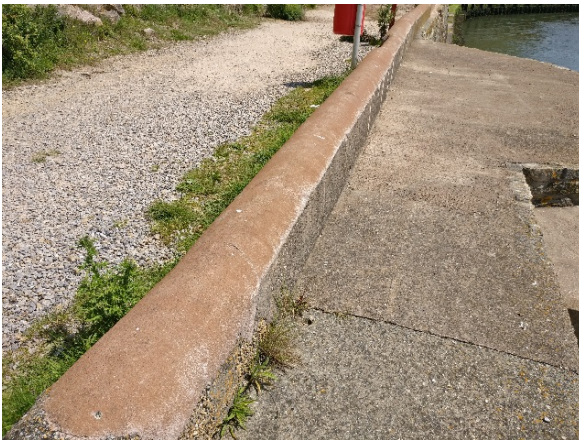
Patch repairs to the concrete flood wall
