Seaton BMP Cliff Assessment

PREPARED FOR: East Devon District Council

PREPARED BY: Paul Fish

DATE: October 12, 2017

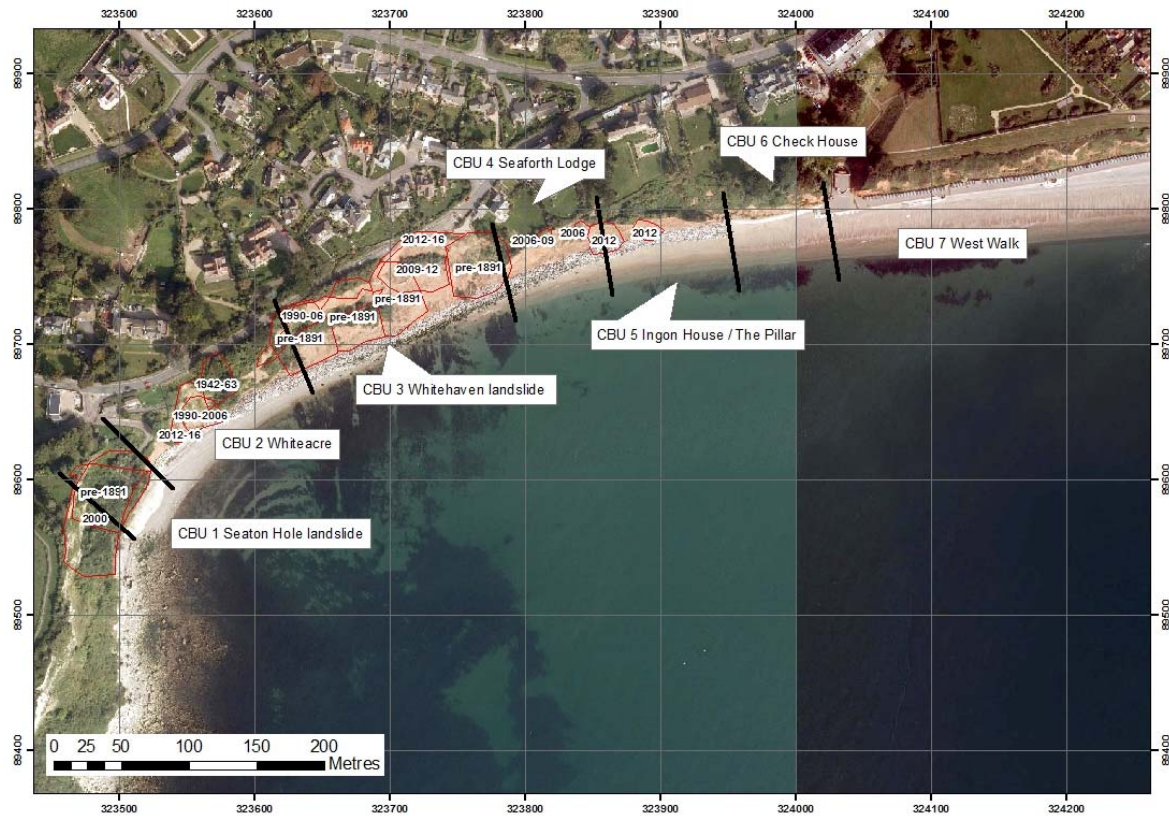
Figure 3. Cliff behaviour units and summary evidence for the date and location past cliff instability events.

In support of a new assessment of cliff behaviour, a GIS-based review of historical cliff recession has been undertaken using past editions of OS maps, aerial photography and LiDAR dating from the 19801 to 2016. Using GIS, the assessment allows changes in the cliff to be measured as accurately using historical mapping and serial imagery. The data available to this study are summarised in Table 1, which also documents evidence for cliff activity visible in each dataset. Locations and dates of these past landslides are shown on Figure 3.

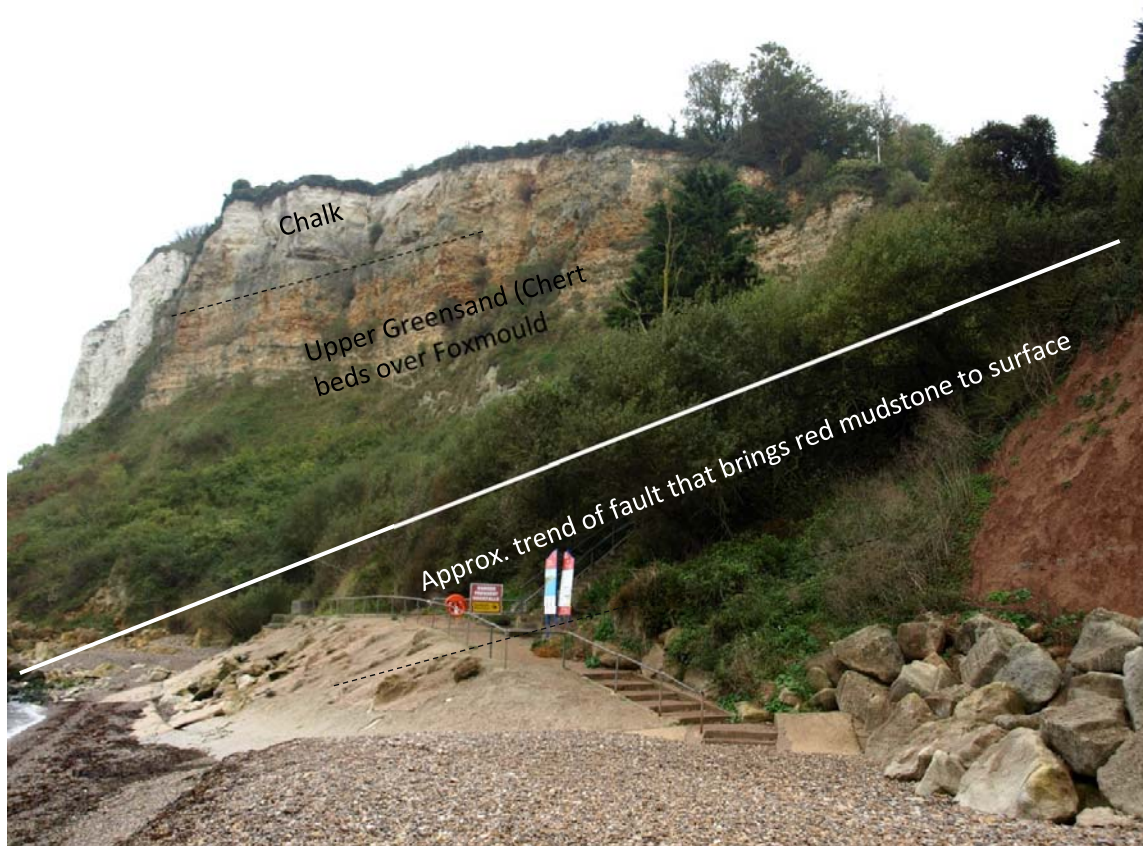
Figure 4a. CBU 1. Seaton Hole landslide. Well-vegetated debris from the 2000 landslide in Upper Greensand that follows alignment of a N-S trending fault. Cliff toe protected by concrete apron.

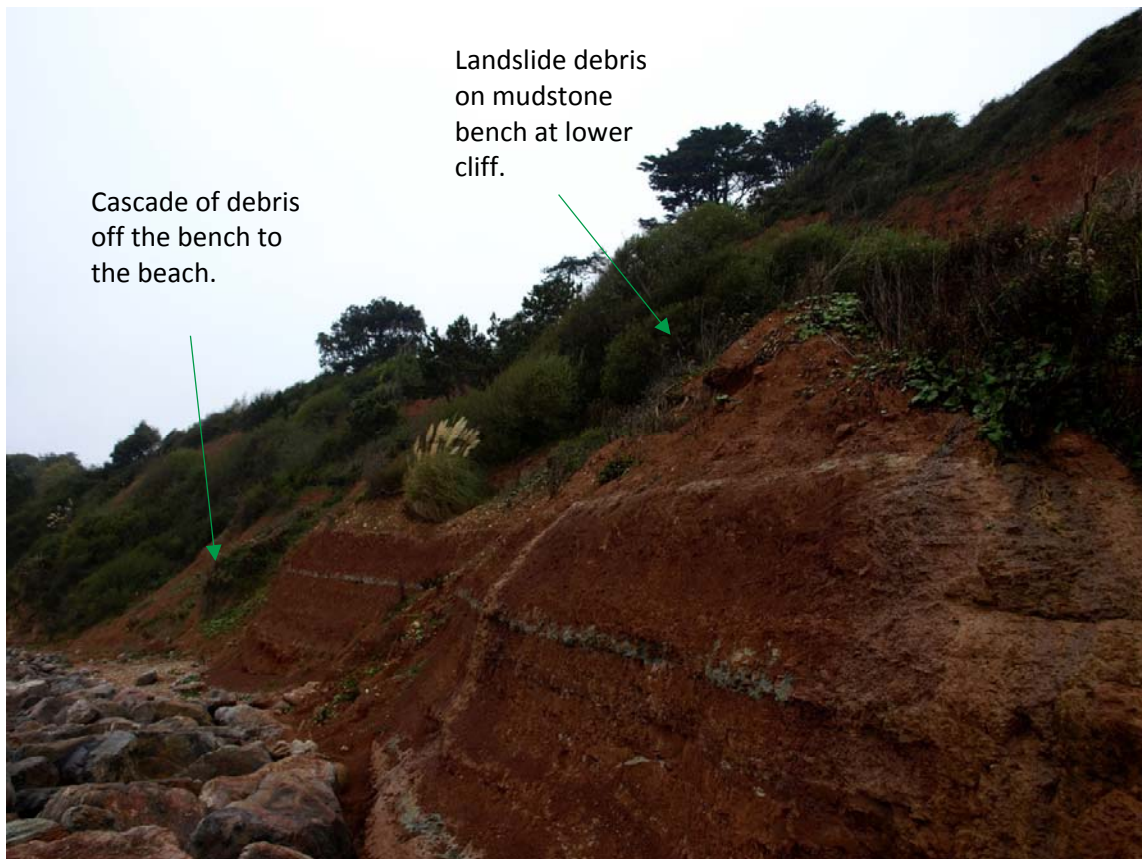
Figure 4b. CBU 2. Whiteacre. Mudstone cliff with rock armour at toe. Periodic failures in the upper cliff that is mantled with vegetated debris resting on an in situ mudstone lower cliff bench. Localised failures on the cliff produce fine grained sediment that may be delivered to the beach.

- At Whiteacre (CBU2) where no change in the cliff top position can be measured prior to 2006, but 10m retreat occurred in the subsequent eight years. Prior to 2006 this CBU is known to have been active, with the former beach access path being lost prior to the 1933 OS map, however this activity was limited to the cliff face and does not appear to have resulted in retreat of the cliff top.

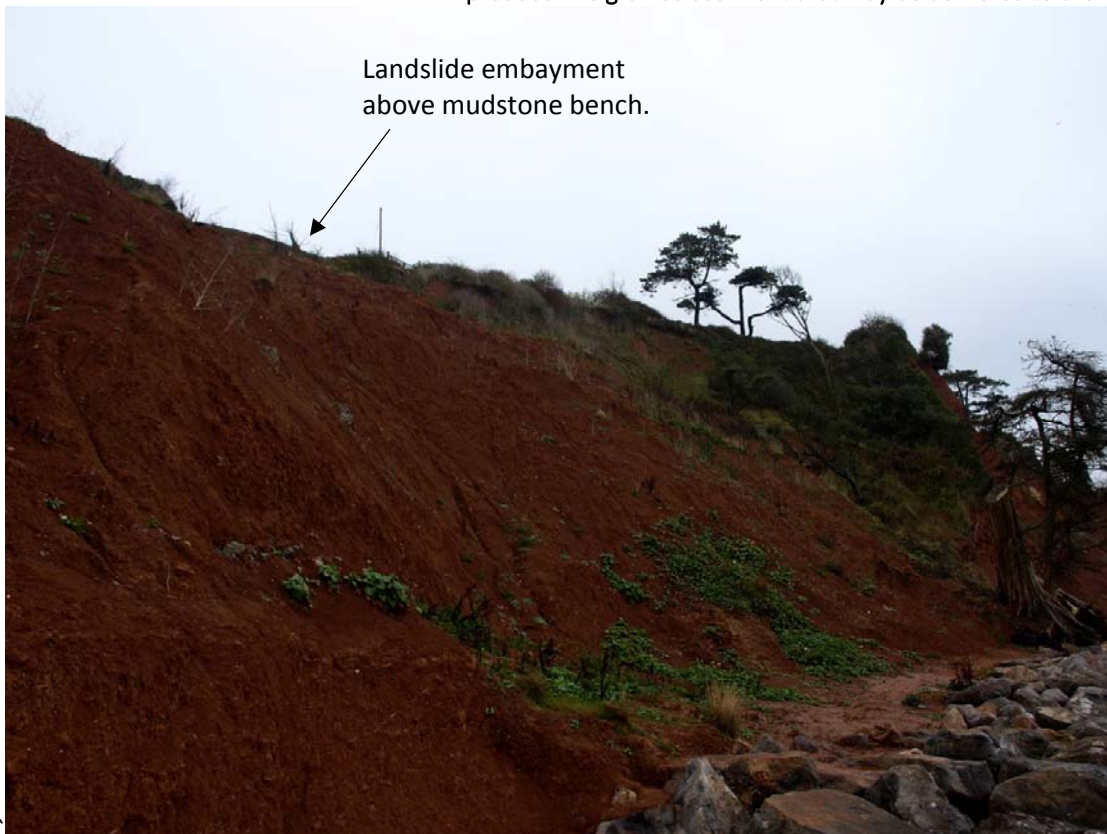
Figure 4c. CBU 3. White Haven landslide. Overview of failure in mudstone cliff showing failure of the upper cliff, debris cascade over the lower cliff and stream and wet ground at the toe. Localised failures on the cliff produce fine grained sediment that may be delivered to the beach.

- At the White Haven landslide (CBU 3), which has severed Old Beer Road, no change in cliff top position was recorded prior to the July 2012 landslide, but in the four years to 2016, a total of 19m of cliff top recession occurred (a maximum of 13m was lost between the 2006 and 2012 imagery, but this was probably all lost during the summer of 2012; a further 4m was lost between 2012 and 2014, and 2m more was lost between 2014 and 2016.

In contrast, the failure fronting 'White Haven' in CBU 3 that began in 2012 and led to the closure of Old Beer Road has resulted in significant cliff recession. The data indicates that up to around 19m was lost between the failure in summer 2012 and 2016.

The evidence indicates that the mechanism of cliff failure is mudsliding, with failure on a shallow basal shear surface in the upper part of the cliff. The shear surface is probably associated the depth of weathered mudstone. There is some evidence to suggest that the lateral extent of failure at White Haven is controlled by sub-vertical faults in the mudstone.

The summer 2012 failure at White Haven was associated with a sustained period of high rainfall and it is likely that elevated groundwater levels are the principal trigger of cliff failures. Toe erosion, leading to steepening of the cliff, is the principal preparatory factor for erosion. Despite toe protection measures being present in the cliffs for at least around 30 years, the cliffs remain steep and continue to adjust form by periodic shallow failures.

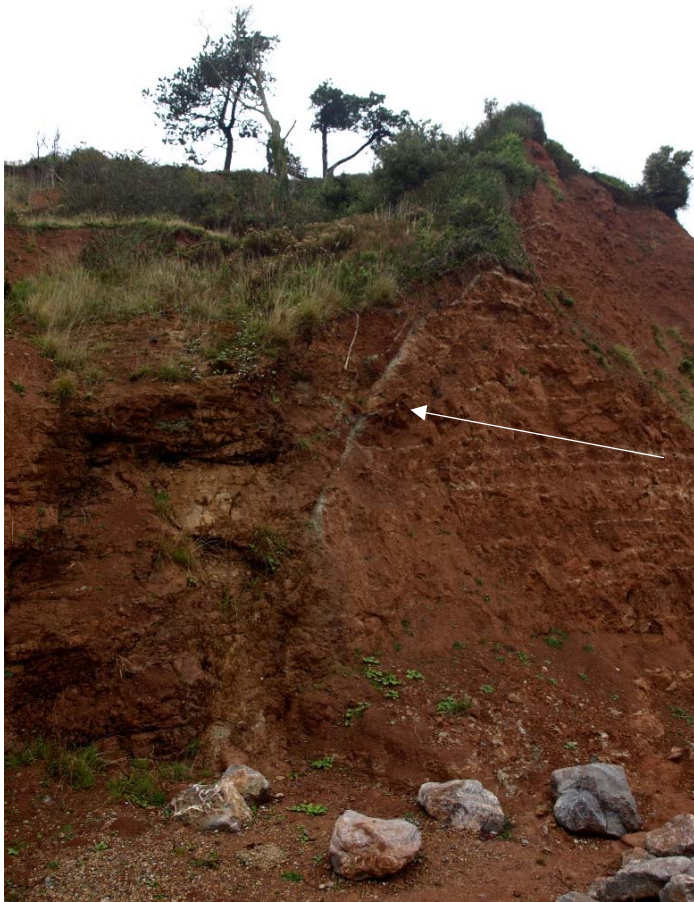
Figure 4d. CBU 3. White Haven landslide. Eastern lateral shear of the failure that appears to be structurally-controlled.

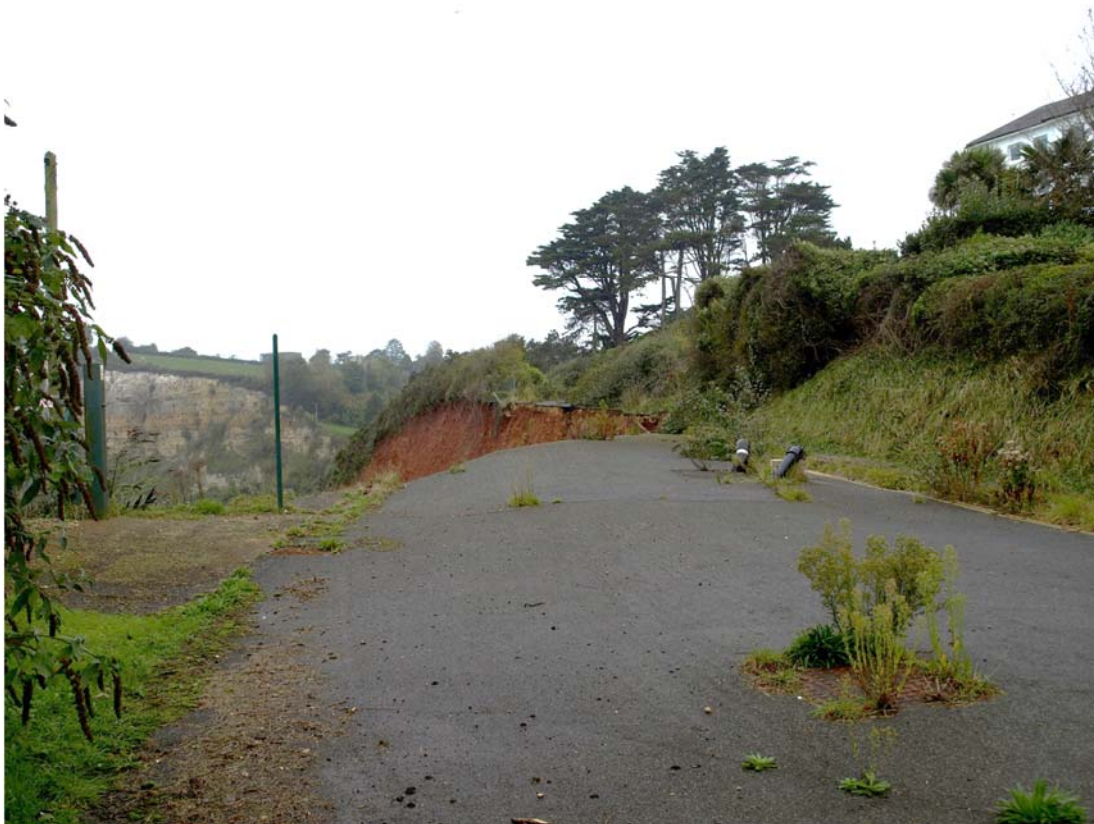
Figure 4e. CBU 3. White Haven landslide. View fom cliff top showing loss of c. 50m of Old Beer Road.

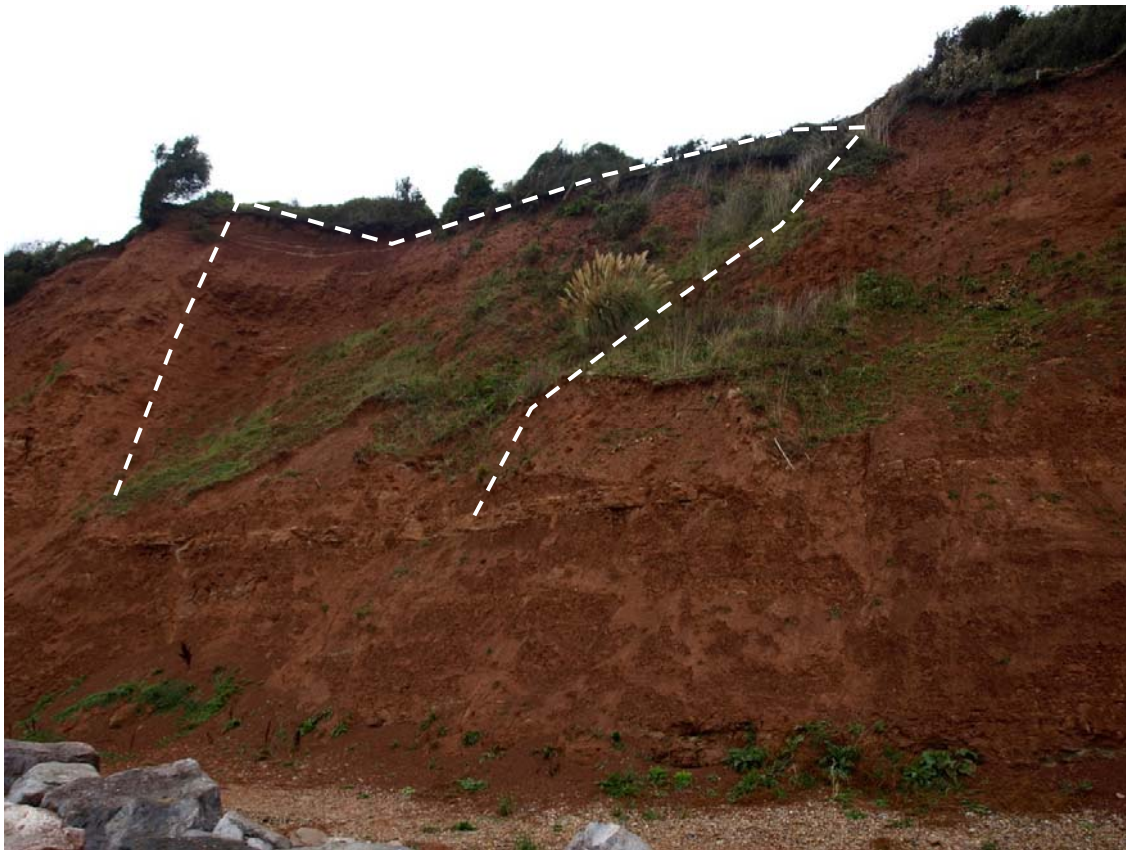
Figure 4f. CBU 4. Seaforth Lodge. Mudstone cliffs with toe revetment largely obscured by beach sediment and debris. Periodic, localised failures produce fine grained sediment that is delivered to the beach. Historical landslide embayment shown.

- Data from CBU 4 at Seaforth Lodge indicates 9m toe erosion was recorded between 1891 and 1990 at an average rate of c. 0.1m/yr and 7m erosion was recorded between 1990 OS map and 2014 aerial photo, giving an average rate of c. 0.3m/yr.

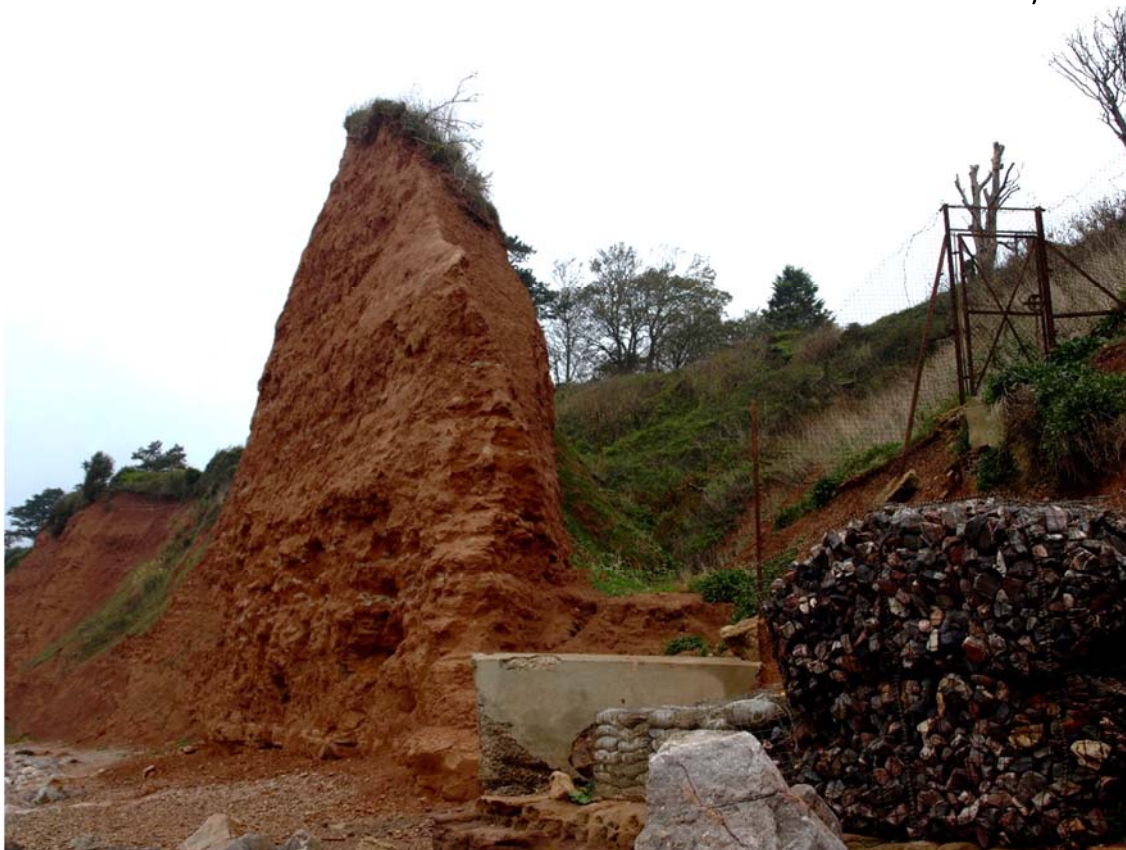
Figure 4g. CBU 5. Ingon House Chine, 'The Pillar'. Undefended narrow mudstone cliff formed by chine that runs sub-parallel to the coast. Periodic failures deliver fine sediment to the beach.

- Data from CBU 5 at Ingon House ('The Pillar') 4m toe erosion was recorded between the 1990 OS map and 2006 photo indicating an average rate of 0.3m/yr. 5m cliff top erosion was recorded between the 1990 OS map and 2014 photo indicating an average rate of 0.2m/yr.

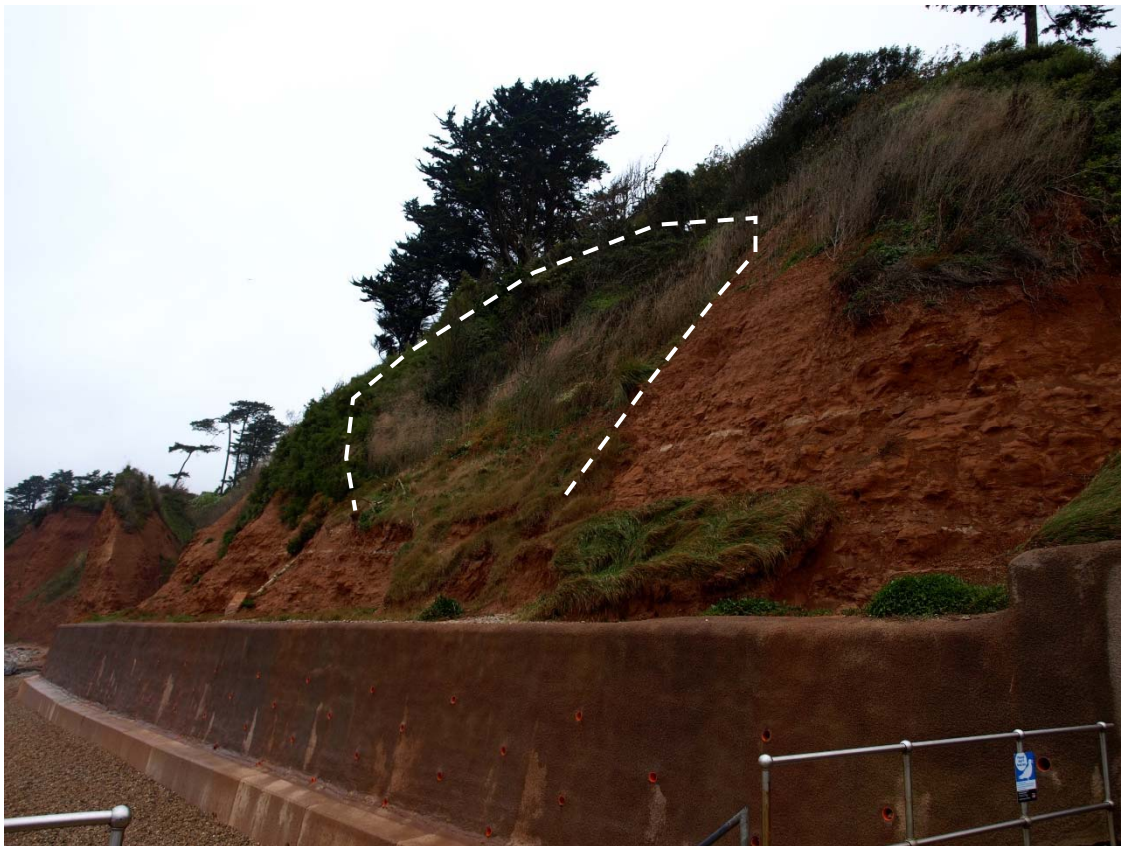
Figure 4h. CBU 6. Check House. Mudstone cliffs with two protection. Localised failures on the cliff produce fine grained sediment that may be delivered to the beach. Historical landslide embayment shown.

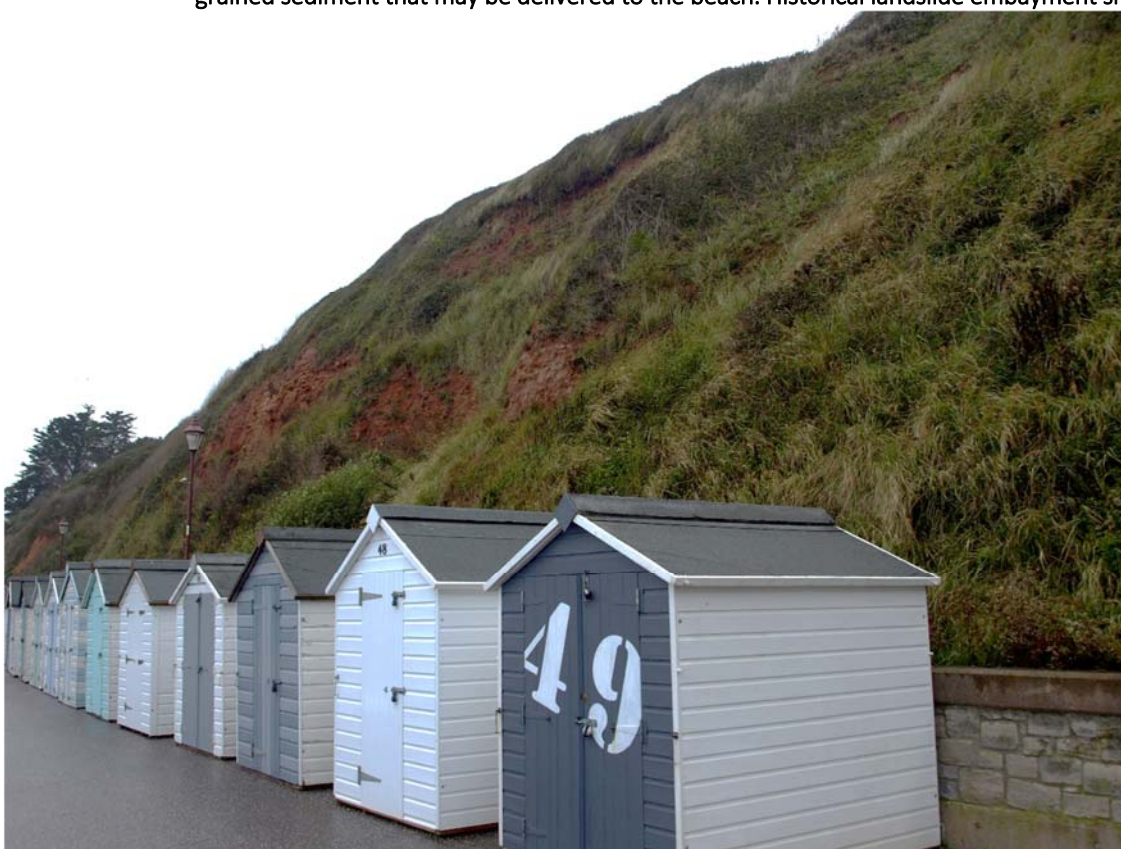
Figure 4i. CBU 7. West Walk. Mudstone cliffs with promenade toe protection since early 1900s. Localised failures on the cliff produce fine grained sediment that is not delivered to the beach.
