Defences Baseline

East Devon District
Council

August 2017

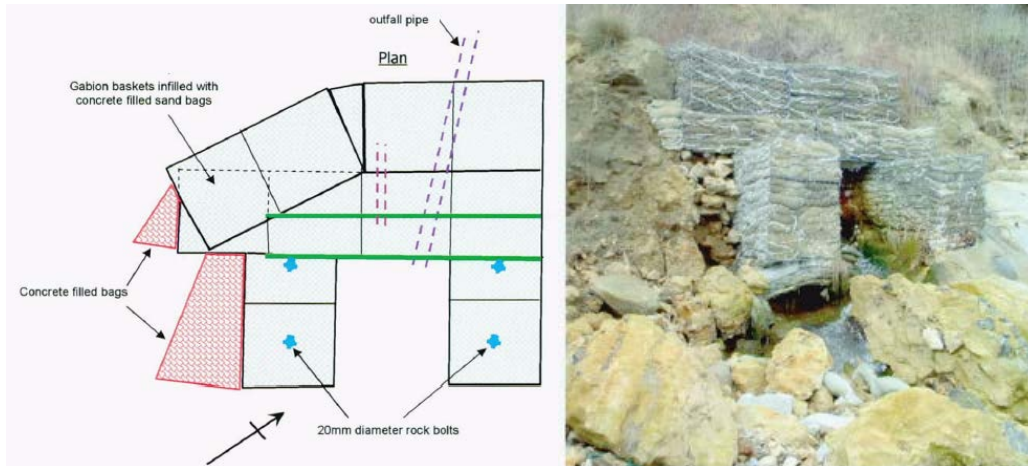
Figure 2-2 Outfall protection works with destroyed areas in 2004/2005 shown in red and in the adjacent photo.

- The gabion baskets protected the culvert outlet/outfall during the winter storms in 2004, however a significant volume of landslip debris was washed away along with the loss of many loosely placed concrete-filled sand bags. This allowed some erosion at the western edge of the structure (David Roche GeoConsulting Limited, 2003).
- In 2005, further storms resulted in the loss of additional concrete-filled sand bags, and works were undertaken to strengthen the wing walls (David Roche GeoConsulting Ltd, 2005). The work included the introduction of additional gabion baskets filled with concrete-filled sand bags in front of the western wing wall as well as extending the wing wall further west (Figure 2-3).

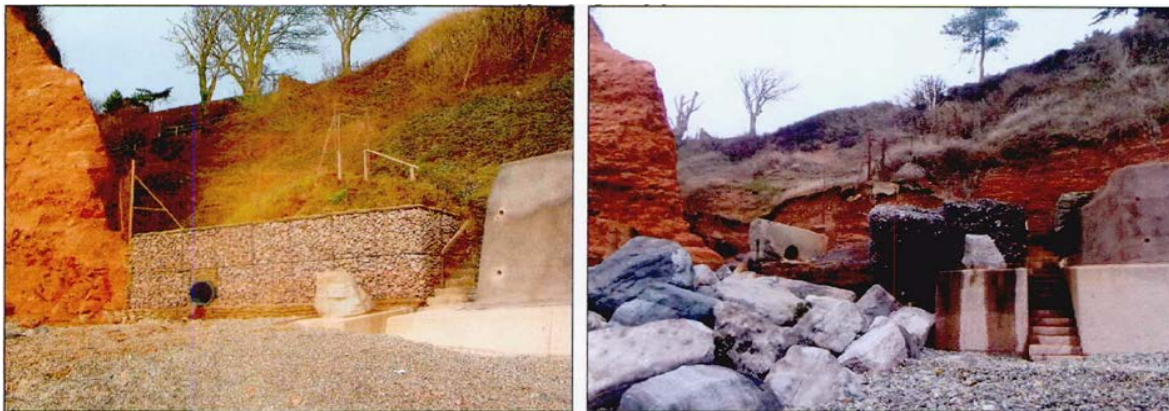
Figure 2-8 Construction photograph (2005) alongside the inspection photograph (2015)
Source: David Roche GeoConsulting (2015)

- In March 2015, an inspection of the Check House Wall and the western cliff area was completed. The inspection revealed that the stone filled gabions had suffered significant damage with more than half destroyed and the remaining gabions severely distorted and in danger of collapse (David Roche GeoConsulting Limited, 2015). Figure 2-8 shows the damage identified in 2015 compared with post-construction in 2005. Recommendations were made for remedial works with an indicative cost estimate between £20,000 and £30,000 (excluding VAT).

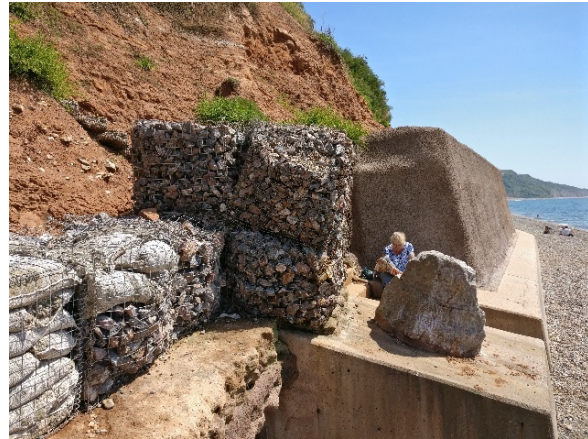
Deformation of gabion baskets and loss of fill material

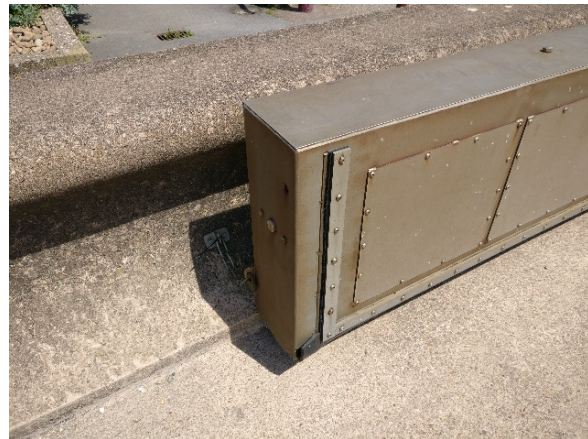
Multiple flood gates present, with damage to rubber seals

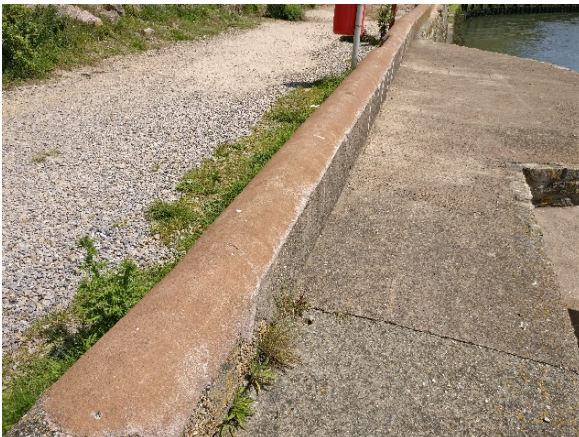
Patch repairs to the concrete flood wall
