SEAT ON BEACH MANAGEMENT PLAN

Coastal Processes Baseline

East Devon District
Council

February 2018

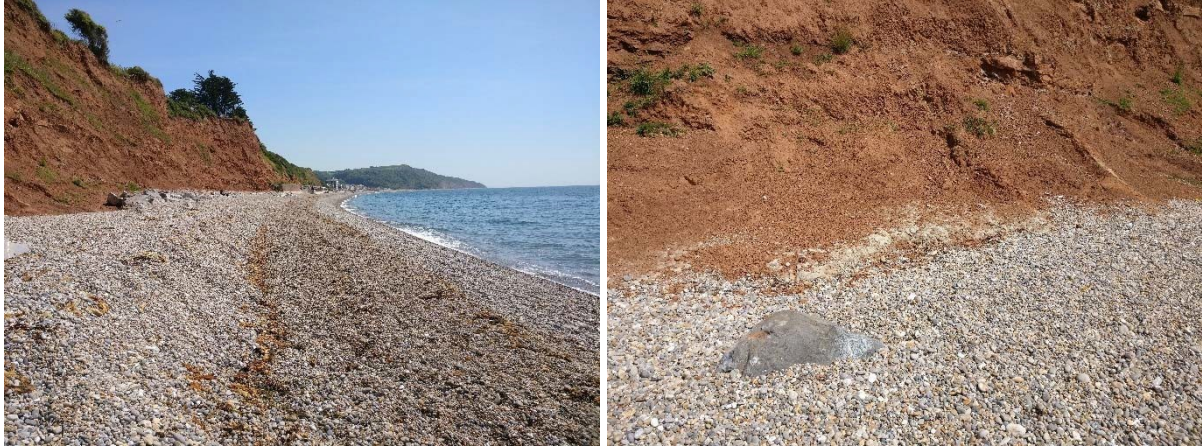
2. Erosion of the mudstone cliffs between Seaton Hole and Seaton provides a source of fine sediment to the beach below (Halcrow, 2011), as observed during the Defence Condition Assessment being undertaken for the BMP, and as shown in Figure 3.14. Past estimates of sediment supply suggest that the input is small (Posford Duvivier, 1994), but Posford Duvivier and British Geological Survey (1999) calculated a contemporary yield of approximately 6,000m³ per year (all fine sediment). A further 12,000m³ per year of fine material was calculated as being supplied from erosion of the shoreface. However, SCOPAC (2004) reported a high level of uncertainty regarding this supply.

Figure 3.14 Photographs showing release of fine material from eroding cliffs directly onto the beach
 Photographs taken during Defence Condition Assessment 14th June 2017, facing east

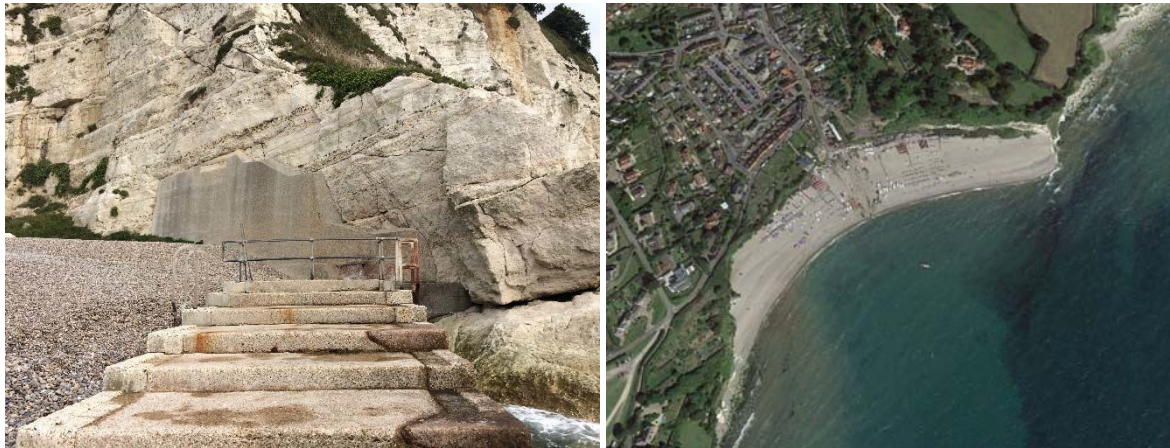
concrete groyne at King’s Hole at Beer during the early 1970s has reduced/inhibited longshore transport to the east and resulted in accretion of the beach there (SCOPAC, 2012). This is evident from a review of historical photographs held by the Seaton Museum, which showed a much narrower beach at Beer in 1877 compared to 2016 aerial imagery, which is shown in Figure 4.2; and LiDAR data, which has been collected as part of the South West Regional Coastal Monitoring Programme and shows accretion between March 2006 and March 2017 (refer to Figure 4.3). Unfortunately, beach profile data is not collected at Beer, so it has not been possible to quantify the changes observed and determine how they may link to the coastline at Seaton, Therefore, it is only observed from the aerial photography and LiDAR, that the material that has built-up in the lee of groyne could have otherwise been transported to Seaton.

Figure 4.2 Photograph showing infilling of King’s Eye Hole (left) and aerial photograph showing the concrete groyne at Beer (right)

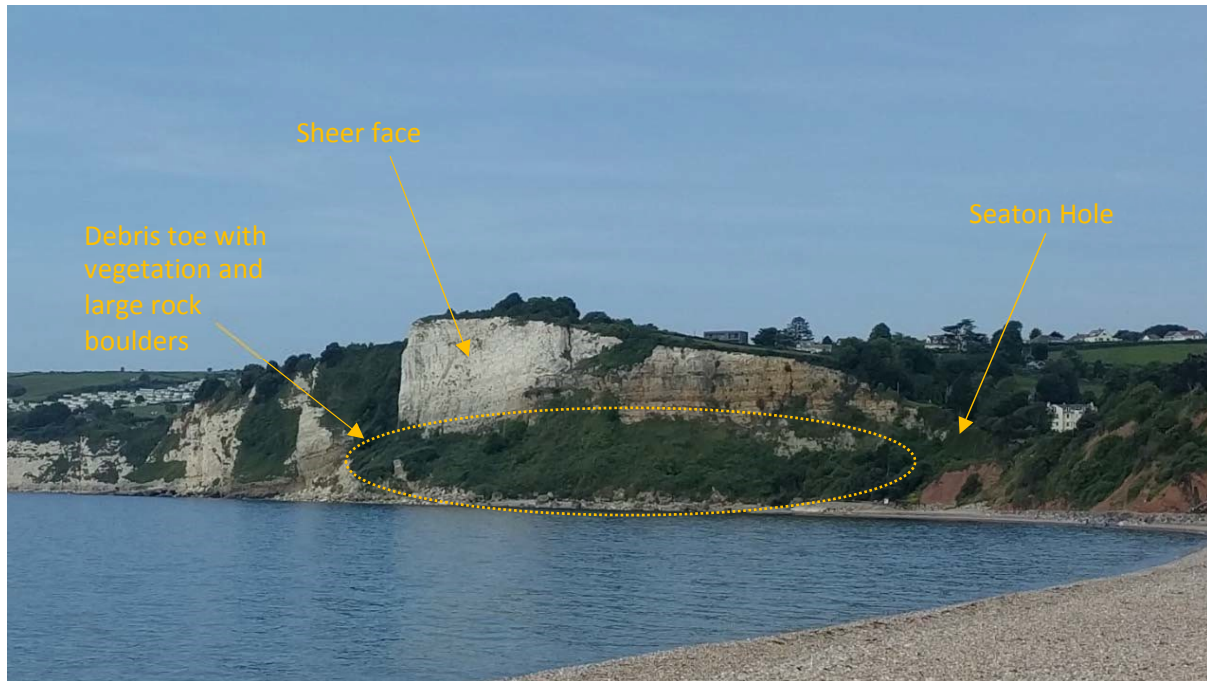
Figure 4.4 White Cliff geomorphology and defences
Photographs taken during Defence Condition Assessment 14th June 2017, facing west

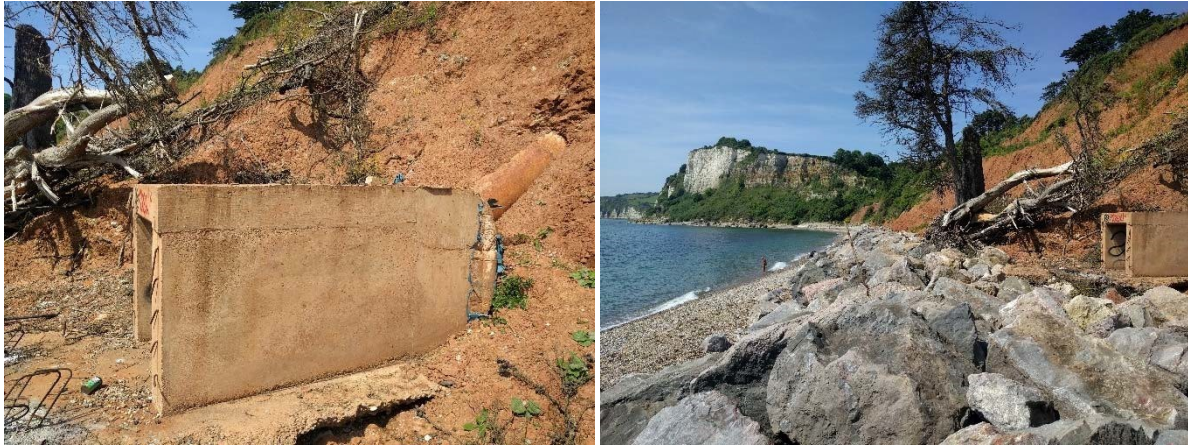
Today debris, as well as man-made structures are observed to be falling out from the cliffs as they erode, which is a health and safety issue. For example, see Figure 4.5, which shows the old emergency overflow from Seaton Hole sewerage pumping station at the cliff toe.

Figure 4.5 Photographs of the cliffs at Seaton Hole
Photograph taken during defence condition assessment 28th June 2017, looking south-west

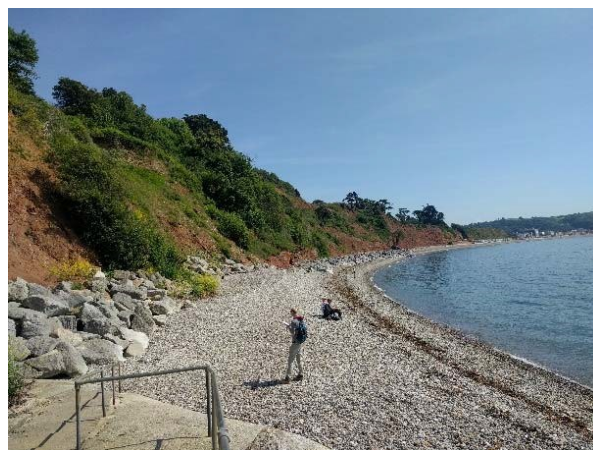
Figure 4.8 Photograph of beach between Seaton Hole and West Seaton
Photograph taken during defence condition assessment 28th June 2017, looking east

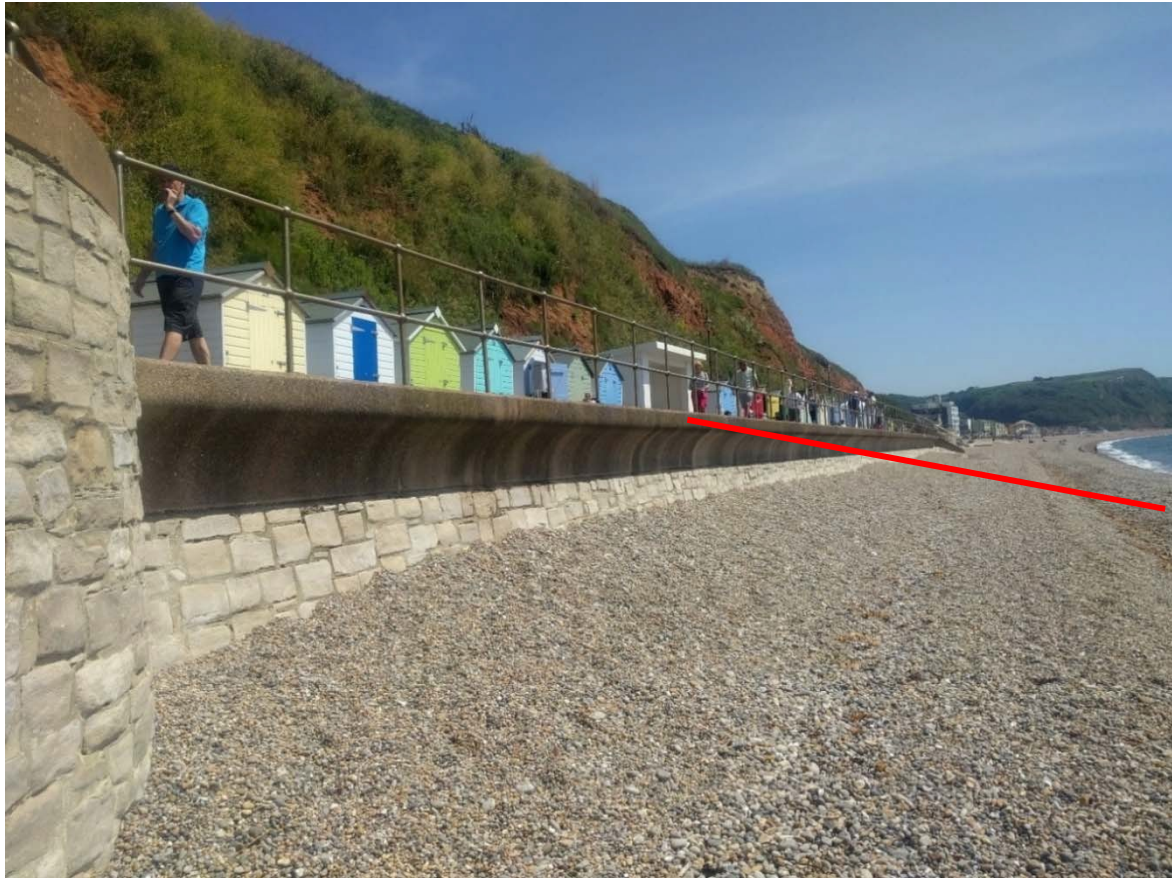
Figure 4.16 Photograph of beach at the location of eroding beach at profile 6a01185 (approximate position shown by red line)
Photograph taken during defence condition assessment 28th June 2017, looking east

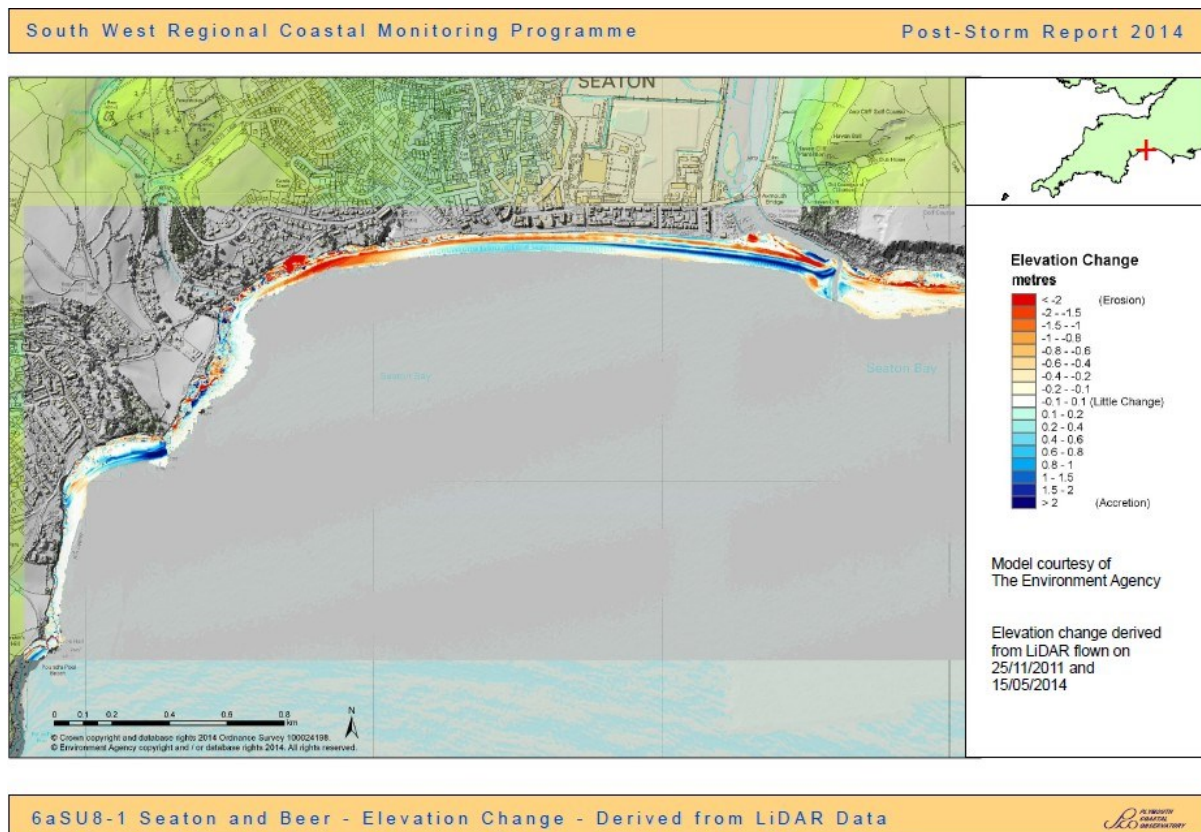
- A decrease in beach level along the top of Seaton Spit. It has also been reported that 40% of the eastern end of the spit was lost following the January/February 2014 storms (Author unknown 2, 2015); it is assumed that this is referring to material lost from the top of the spit as observed from the LiDAR difference plot, and from the post-storm beach profile data, discussed in the next Section.

Figure 4.18 LiDAR topographic difference model plot for Seaton, showing the change in elevation between November 2011 (pre-storm) and May 2014 (post storm) (PCO, 2014b)

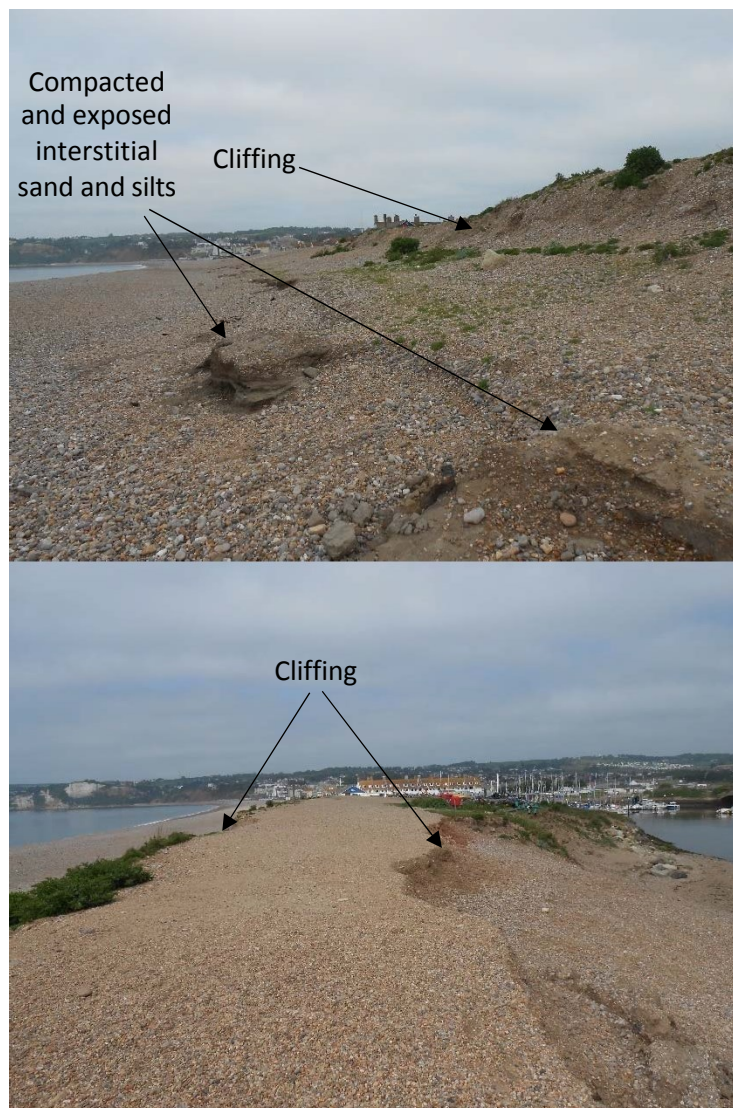
In turn, cliffing can also increase wave reflection on beaches and thereby further reduce beach levels in front due to scour action by waves.

Figure 4.24 Photographs of the Seaton Spit, showing cliffing and exposed compacted interstitial sand and silts
 Photographs taken during site visit 24th May 2017, top looking west, and bottom, looking north-west

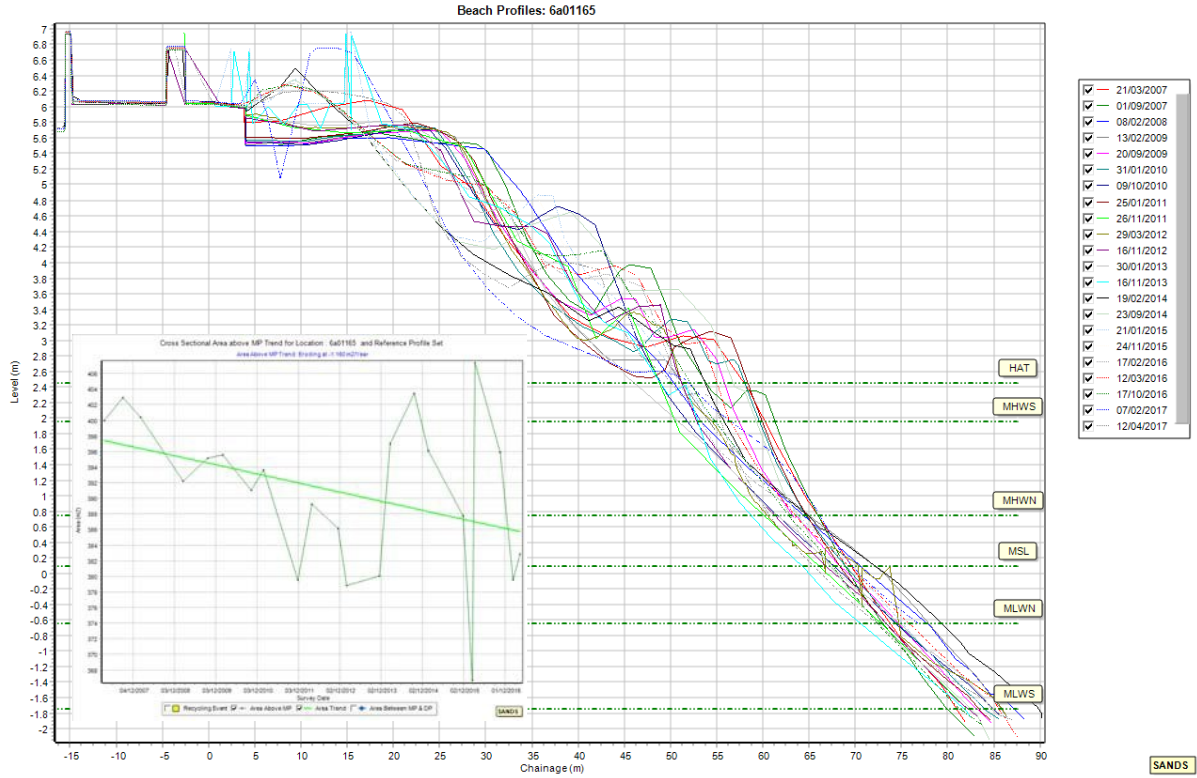
The review of beach monitoring data (refer to Section 4.3.2.3), shows that the section of beach (profile 6a011650) currently being used for the disposal of dredge material, and identified by the Environment Agency as a suitable site for the disposal of 2016/2017 material, is showing a trend for erosion; it is also dynamic and has suffered from erosion during storms (refer to Figure 4.25). Therefore, consideration and identification of alternative sites for disposal should be considered as a high priority.

Figure 4.25 Beach monitoring data for profile 6a01165, inset with plot of beach cross-sectional area change (m²)
