## Musbury Interim Conservation Area Review

# MUSBURY

Prepared for East Devon District Council by John Fisher BA, MA, MRTPI  
with contributions from Town and Parish Councils and Amenity Societies in East Devon

Published by East Devon District Council 1999  
© Copyright East Devon District Council

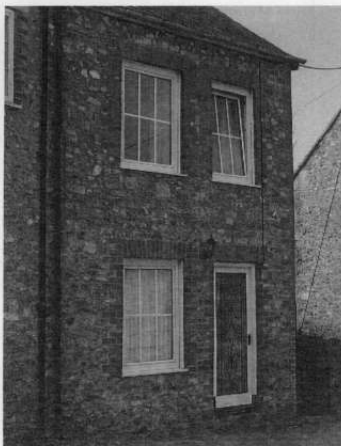
*Inappropriate PVCu windows fitted into a key building.*

- The most evident incremental change of the last few years is the use of replacement PVCu windows in many of the key buildings in the village. Examples are the Old Bakery Cottage, several houses in Rosemary Lane, Hillside Villas, Cartree Cottage and Mountfield Lodge.

- While there is no statutory control over replacement windows in many unlisted buildings the pressure to replace traditional timber windows with PVCu alternatives remains. The removal of traditional windows is the single most apparent change to the conservation area in recent years. There is greater awareness of the environmental impact of PVCu production and waste and while it is hoped that timber replacement windows are seen as the more sustainable option the marketing drives of the major PVCu window companies continue. In the light of this it is anticipated that a proposal to serve an Article 4 Direction to control replacement windows would form part of a future public consultation exercise.

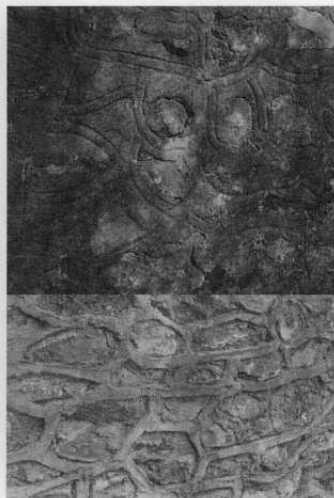
*Two examples of re-pointing where cement has been used and obscured the individual stones.*

- Many of the remaining stone boundary walls are being poorly maintained, some with inappropriate pointing almost obscuring the stones in the wall, for example in Combyne Road and in the church footpath. Some new garden walls in Axminster Road have been built with artificial stone which contrasts poorly with the real stone. However two good new stone boundary walls have been built, one at Monmouth House and one at the entrance to the conservation area at the junction of Marlborough Close and The Street.

- Old stone walls being demolished to provide parking places. Many of the remaining stone boundary walls being poorly maintained, some with inappropriate pointing almost obscuring the stones in the wall.

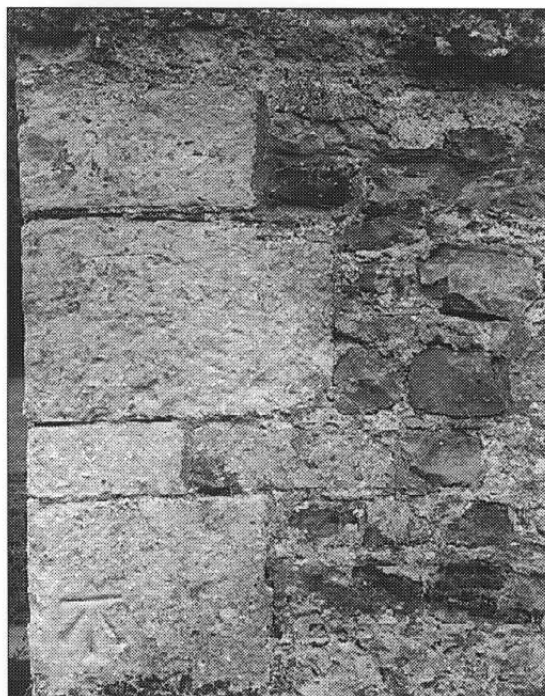
*Wall detail of the Parish Church tower showing dressed Beer stone and coursed chert*

6.1 Musbury, like many East Devon villages, has a wide range of building materials mainly consisting of cob on stone footings, local chert stone and brick. Beer stone is used in dressings and the Parish Church displays an attractive combination of roughly coursed chert and moulded ashlar Beer stone.

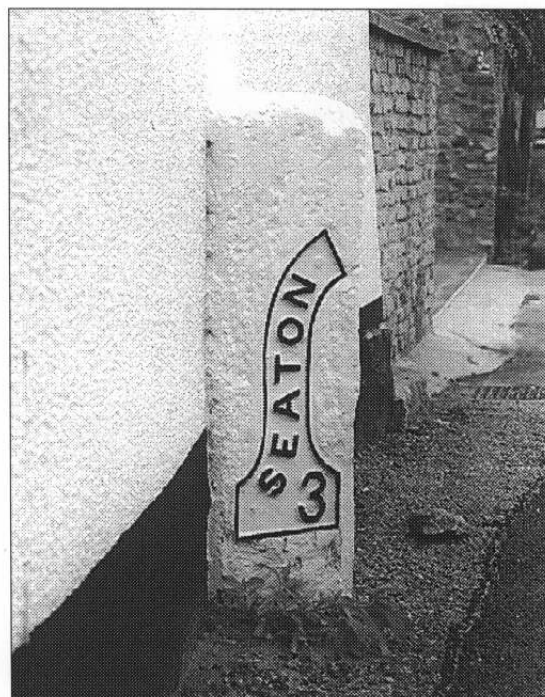
*Axminster Road; milestone with cast iron detail*

- Mountfield is an important listed building that is deteriorating and is still at risk with its future undetermined. The visually important trees in the grounds of Mountfield are maturing without being cared for and there has been no obvious replanting. The historic milestone outside Mountfield Lodge has been cracked, possibly by vehicle impact, however the cracking may be only superficial.

7.1 An old milestone, attractively marked, abuts a cottage in Axminster Road. This is probably the most significant remaining feature of this kind within the conservation area, and a reminder of the former historic importance of this road through the village.

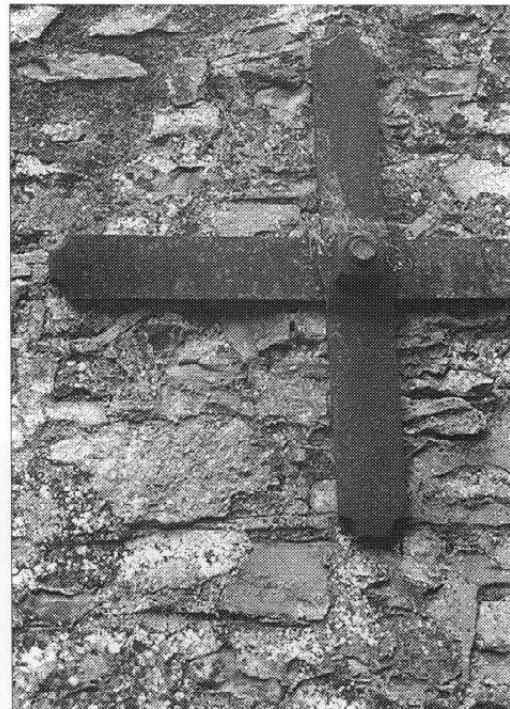
*Close-up detail of garden walls in Doatshayne Lane showing typical problems of decayed mortar and frost damaged brickwork (left) and the need to use wall ties to prevent further movement of structurally unsound sections. Here successive applications of cement mortar/render have almost obscured the stonework*

6.2 Roof materials are mainly of slate or thatch, but with several instances of bitumenised corrugated iron, normally an indication of an earlier thatched roof. Boundary walls are mainly of chert or brick, and as will be noted in the illustrated examples, are sometimes found in need of strengthening or repair and repointing.

- prominent overhead power lines, especially in Axminster Road, The Street and Doatshayne Lane
- the somewhat poor condition of some sections of stonework and brickwork in boundary walls, gate piers etc.
- the gradual erosion of original detail, especially of traditional carpentry to doors and windows, inappropriate pointing, and a few examples of restoration which include hard cement coated render and other later embellishments that are unsympathetic and tend to detract from the original character of the building.
