## Stockland Interim Conservation Area Review

# STOCKLAND

Prepared for East Devon District Council by John Fisher BA, MA, MRTPI  
with contributions from Town and Parish Councils and Amenity Societies in East Devon

Published by East Devon District Council 1999  
© Copyright East Devon District Council

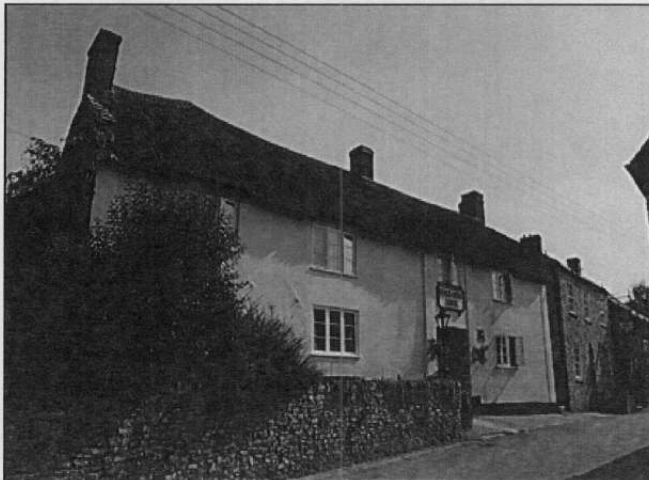
*The King's Arms in the village centre has recently been re-thatched.*

- There have been a few re-thatches in the village and the majority of these have used water reed as opposed to more traditional combed wheat reed. However, due to the recent wet summers the quality of wheat reed grown for thatching has been very poor with low predicted longevity. Therefore until the quality of the supply of wheat reed increases property owners have been given consent for the change in material. Local thatchers have continued to adopt the Devon tradition of using simple wrap-over ridge details as opposed to decorative ridges found more commonly in the east of England.

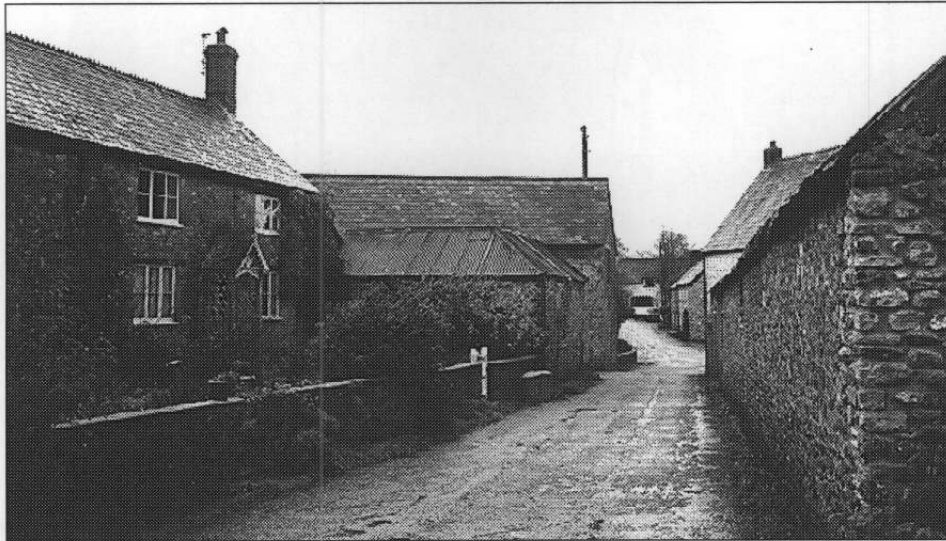
*Park Farm outbuildings(right) are to be converted to residential use. Chert stone walls and slate or corrugated iron roofs predominate.*

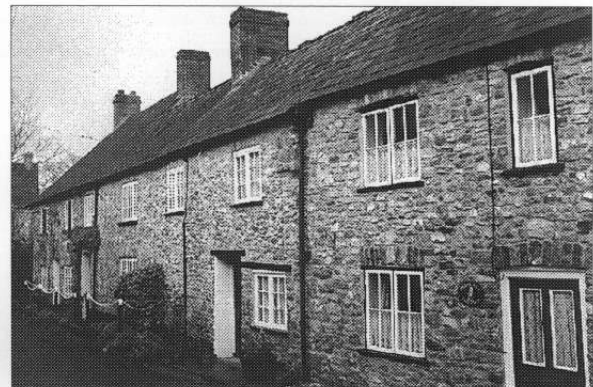
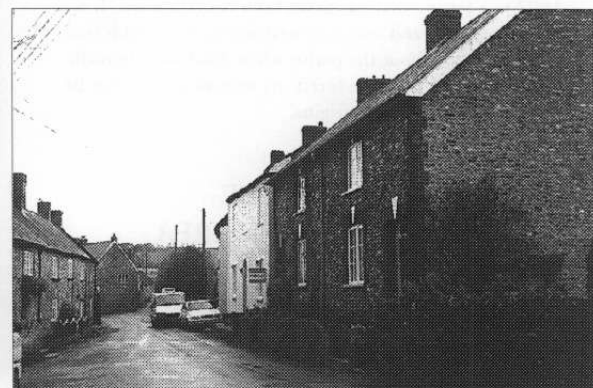
*The main village street (Honiton Road) contains 18th and 19th century terraces with chert and slate predominating but with brick dressings and stacks. Casement windows (2,4 or 6 light) are almost universal.*

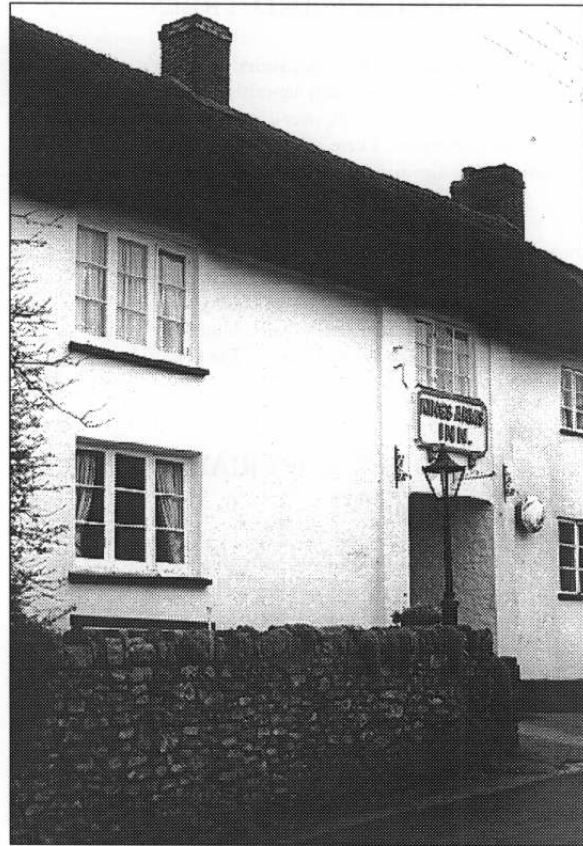
*Kings Arms Inn dates from the 16th century with original interior features including plank and muntin screen; open fireplace etc.*

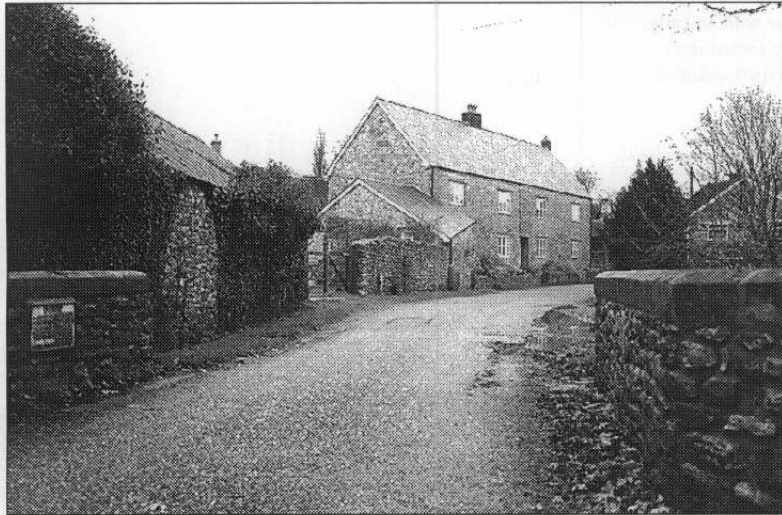
*Western approach to village with Park Farm in the background (left) and sign on bridge parapet (below left).*

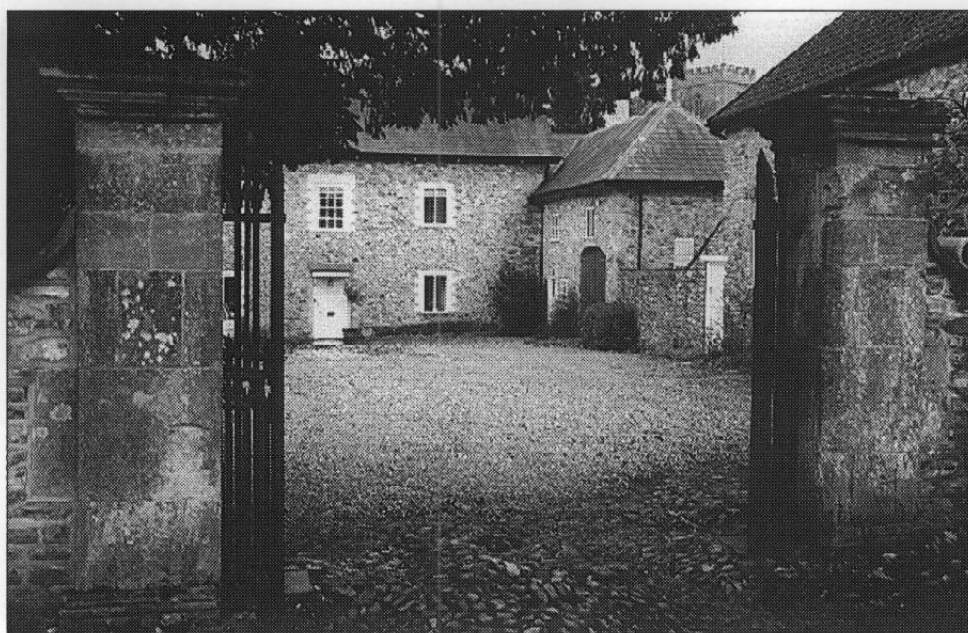
*The fine entrance to the Old Vicarage with chert stone cobbles, ashlared hamstone gate piers and heavy iron gates. (above and left)*

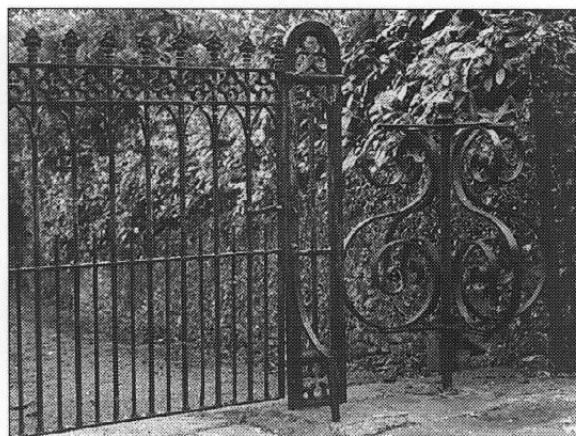
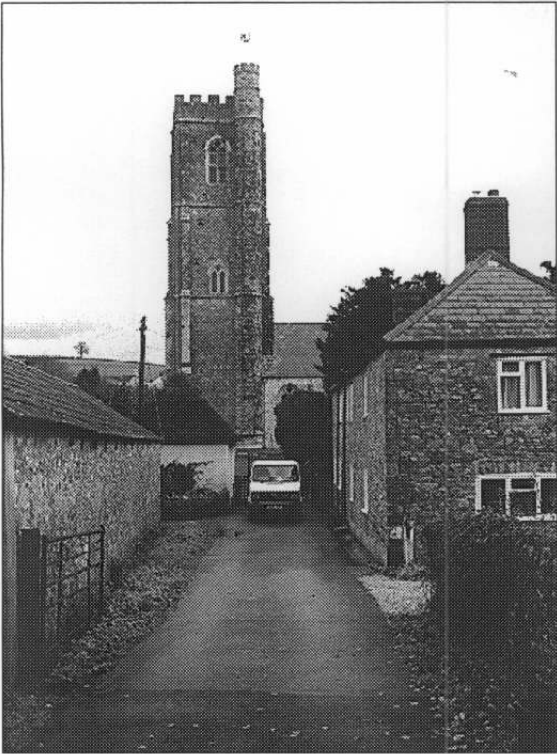
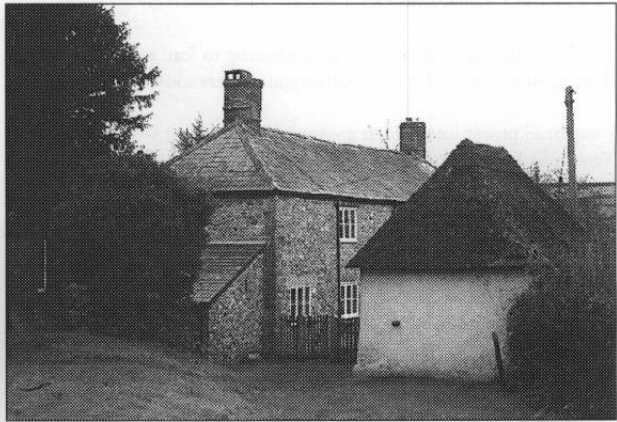
*One of the most striking features of the village is the footpath only access between the village centre and Parish Church (above and below) through a wrought iron turnstile. This path extends south of the church to an attractive outlier of cottages (above right), farm and former church ale house (far right, foreground). The splendid setting of the church, massive for a small village, can best be appreciated just before crossing the stream (below right).*

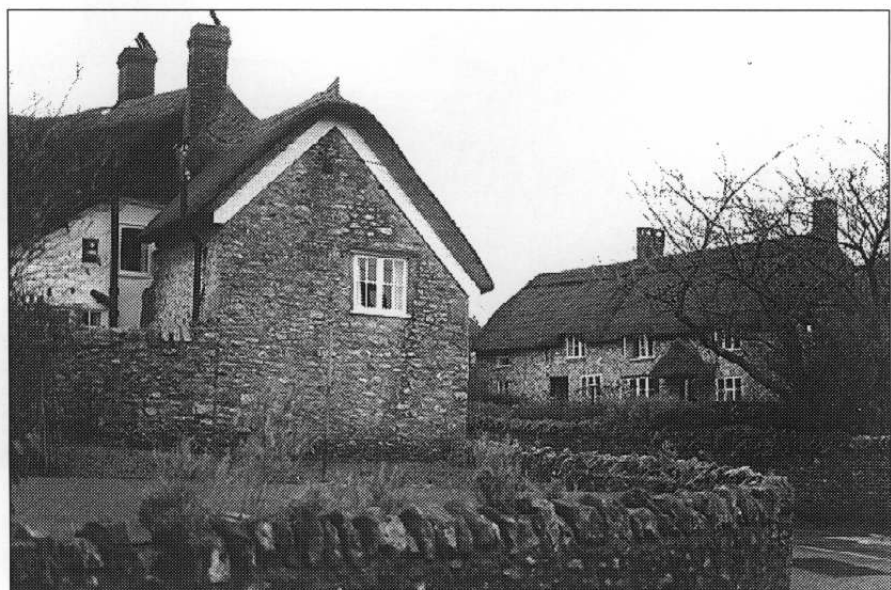
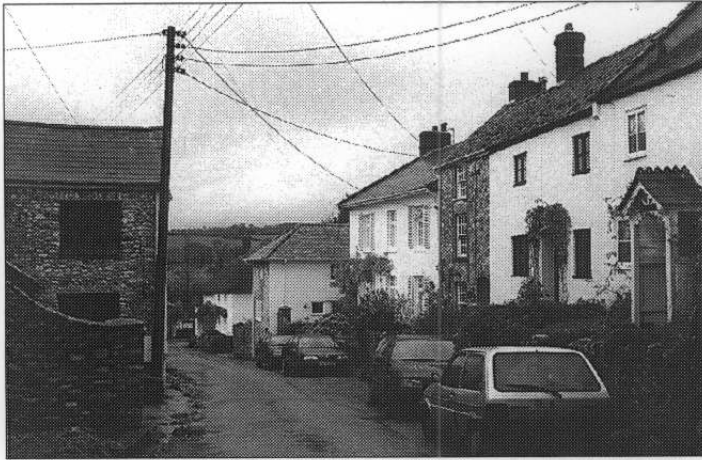
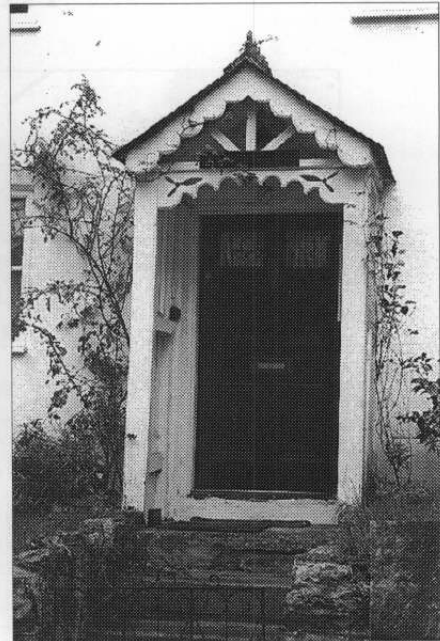
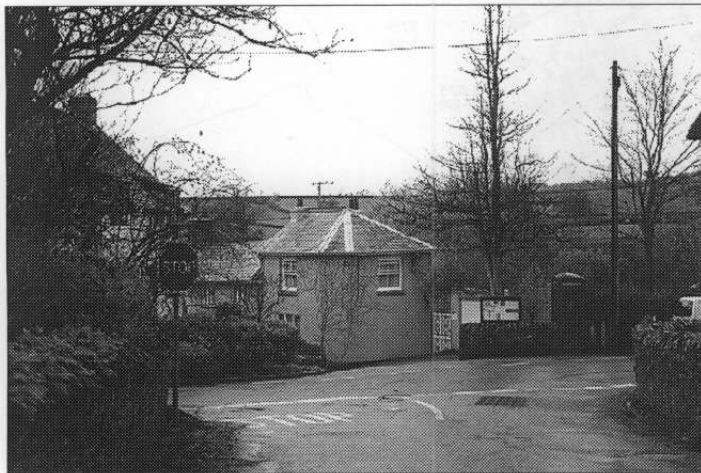
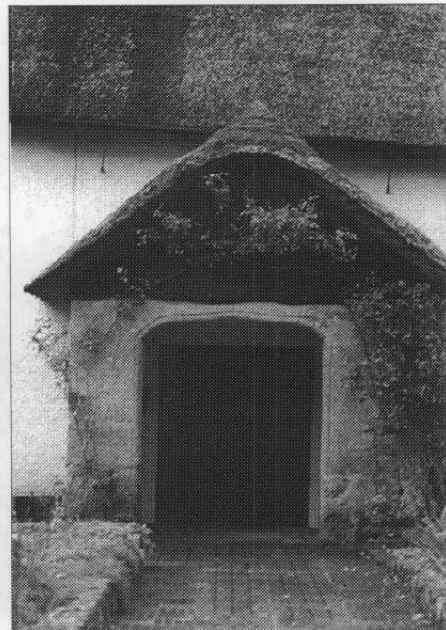
*Views in and approaching Yarcombe Road, towards King's Thatch (below left); view south (above); close to the junction with Honiton Road (below); 19th century porch (right); porch at Townsend Farm; probably 17th century and of dressed Beer stone (below right).*
