Whimble Interim Conservation Area Review

WHIMPLE

CONSERVATION AREA CHARACTER APPRAISAL

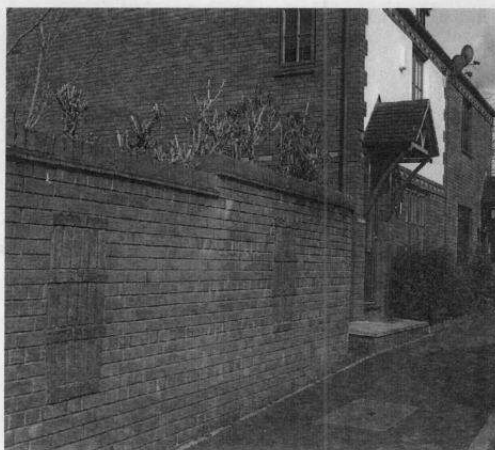
New residential development with strong suburban overtones, yet incorporating a barrel motif in the brick boundary wall.

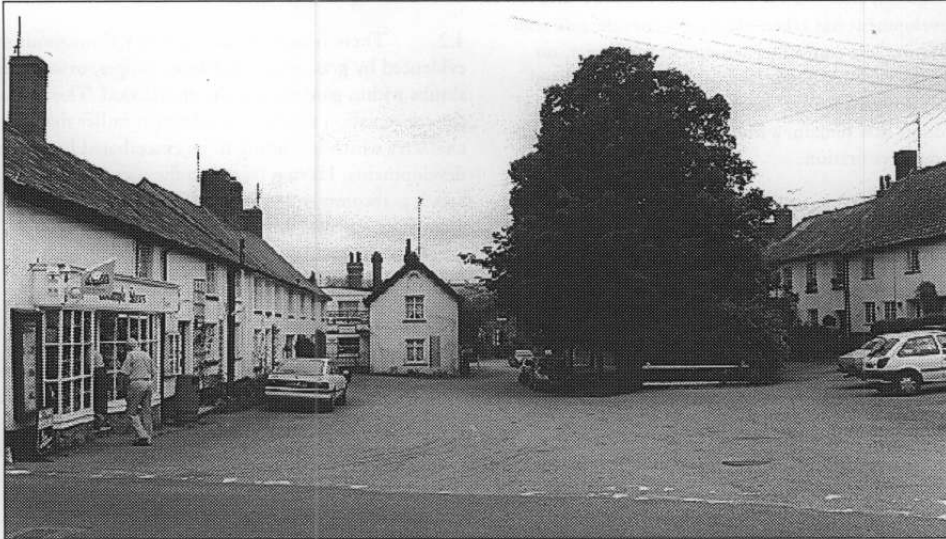
Views of The Square looking east (above) and west (below). The mature trees, grass verges and small stream enhance an already attractive space and the sense of enclosure.

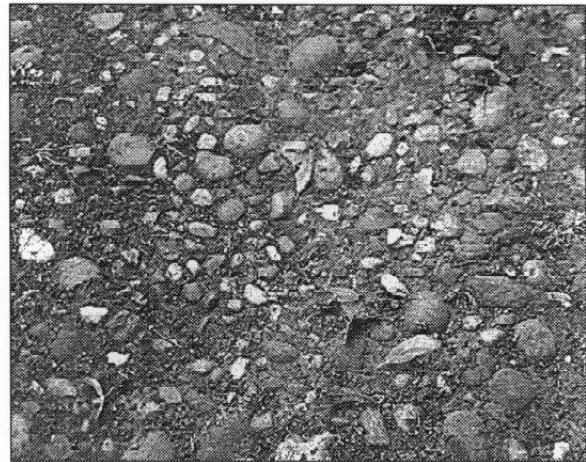
A considerable area of this ground surface exists along the north side of The Square. It has been carefully prepared to give adequate drainage without run-off, and remains firm in wet weather.

- The historic ground treatment, of pebbles laid in earth, on the north side of The Square is now deteriorating and is being patched at random with tarmac. The lower-lying areas are also becoming muddy and unusable. Unless this surface is properly maintained it will be lost.

5.1 Ground surfaces using natural materials are very localised. Of significance is the pathway fronting cottages on the north side of The Square which consists mainly of round pebbles with apparently compacted soil between. This produces a firm and effective surface, even in wet conditions.

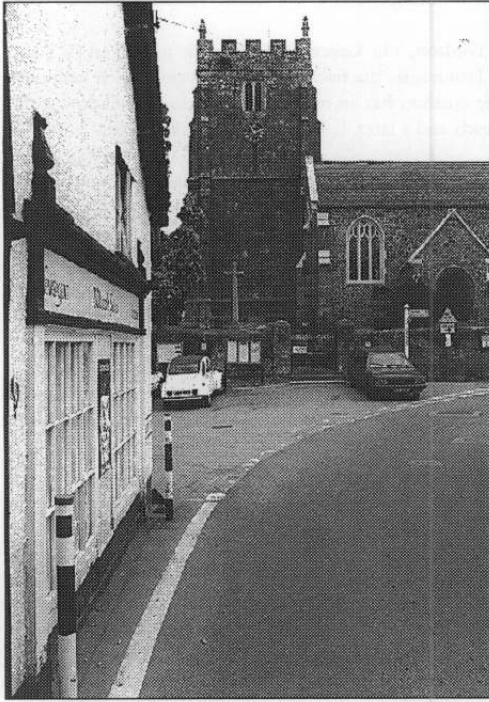
At the entrance to The Square the road follows a dog-leg course enabling a strong sense of enclosure, and effective in slowing down traffic. In (top left) an unusual shopfront where fascia brackets appear to have been inverted.

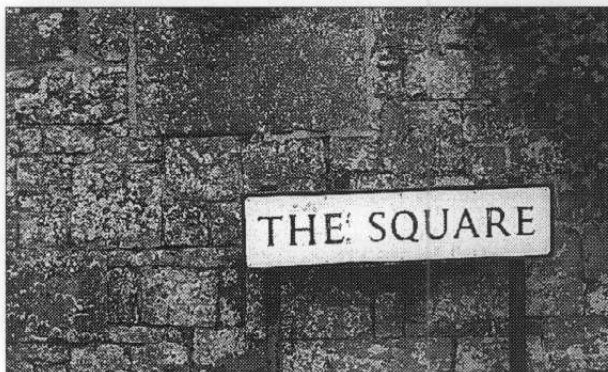
Retaining wall enclosing churchyard. Attractive squared-off, possibly sawn stone in a variety of dimensions, probably mid 19th century; a demonstration of once widespread skills of stonemasonry.

- The church is an extremely prominent central landmark in the village but its important presence is marred by the fact that its front boundary retaining wall in local sandstone is in poor condition with the coping crumbling away. Consent has now been granted to replace and repair the coping stones. The main elevation of the church is also spoilt by the proliferation of notices and signs of random sizes and styles that has now become a serious problem in this most sensitive part of the village.

6.4 The bulk of the church fabric and surrounding walls in red/purple sandstone, squared off and attractively coursed, probably dates from the virtual rebuild of 1844 and is a good example of the skill of the stonemasons who probably lived locally, although some would be journeymen, travelling from place to place. Such skill was commonplace in the 19th century but it normally applied only to major restoration projects. The base of the church boundary wall is corroding quite badly in places, partly due to the effect of road salt which is detrimental to many limestones and sandstones and which can cause rapid decay in some vulnerable locations.

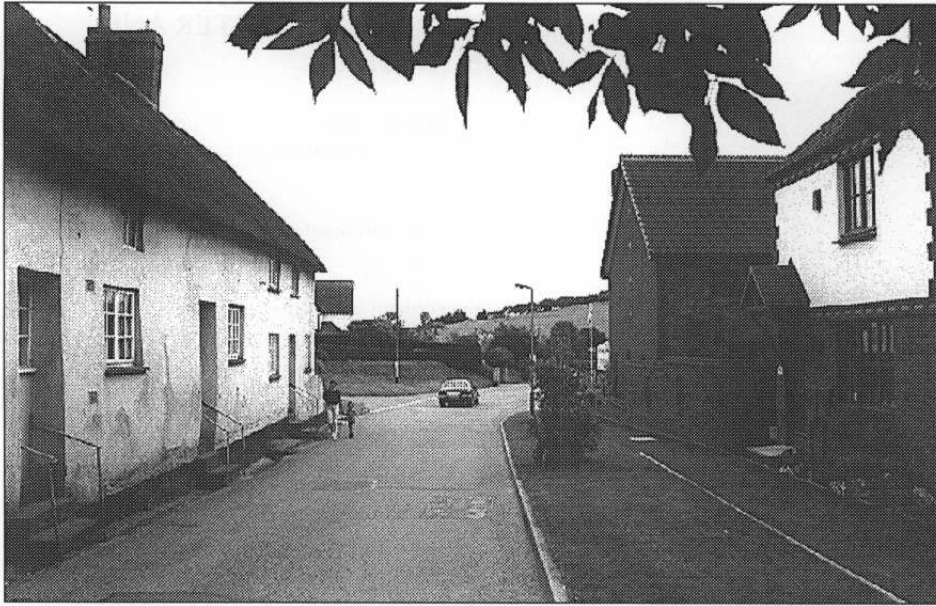
Examples of local vernacular architecture, where some buildings are listed, others not. New housing (left) does not appear to have taken account of the plain form and detailing of the cottages.

6.3 The photograph at the top of page 8 shows new housing in brick and tile with some decoration including ornamented ridge tiles. Whilst reflecting some traditional features of the village this bears little resemblance to the plain cob and thatch cottages immediately opposite.
