Colyton Interim Conservation Area Review

Purpose of the Review

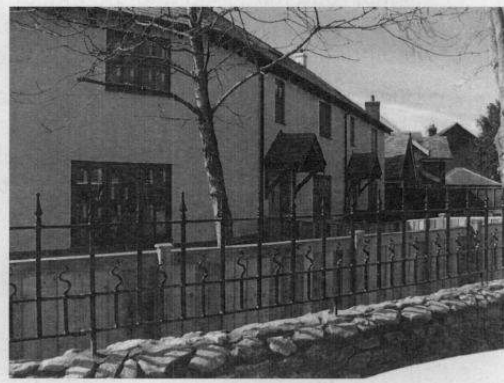
New housing near Umborne Bridge. Unfortunately there is a conflict between the iron railings and the suburban timber fences behind. This development is situated just outside the conservation area boundary.

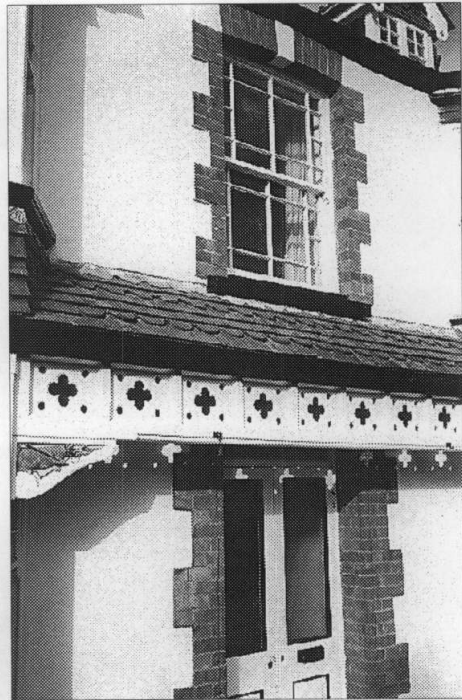
King Street, Chantry Orchard, fine carved detail

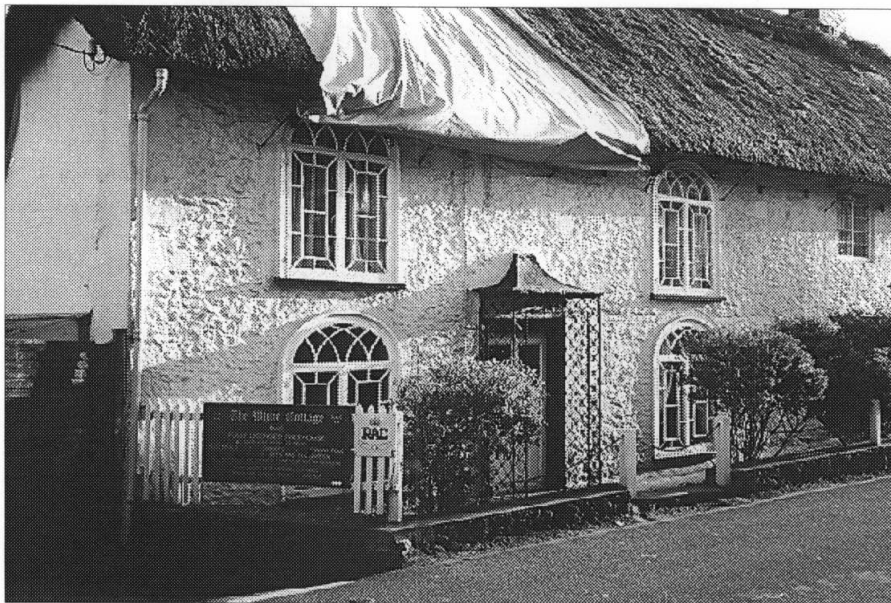
Dolphin Street, White Cottage, good ironwork and woodwork detail to cottage orne, but poorly sited signage and fencing, and decayed thatch

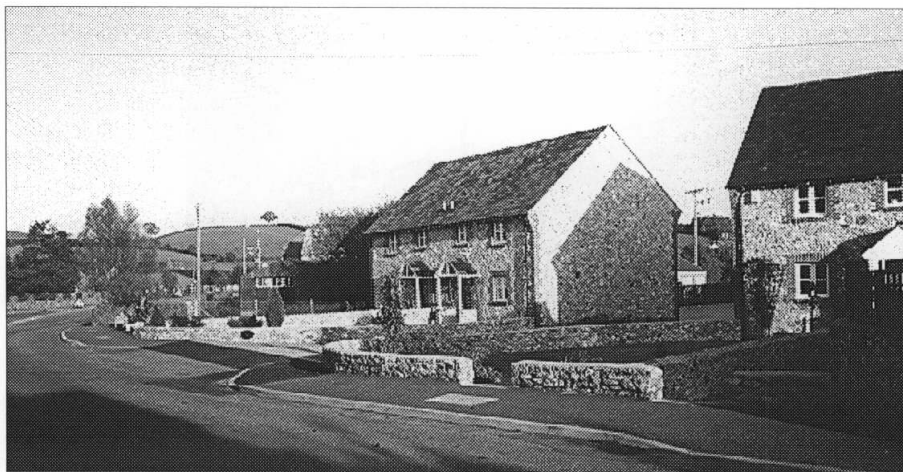
Dolphin Street, open-fronted redevelopment, but using traditional materials. Overhead wires tend to dominate out-of-town vista

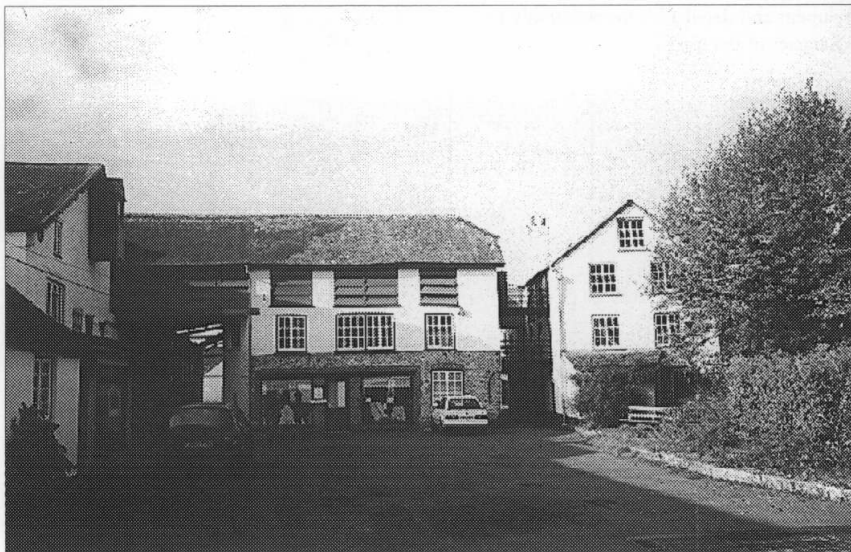
Hamlyn's Tannery, the front
