Defences Baseline

East Devon District
Council

August 2017

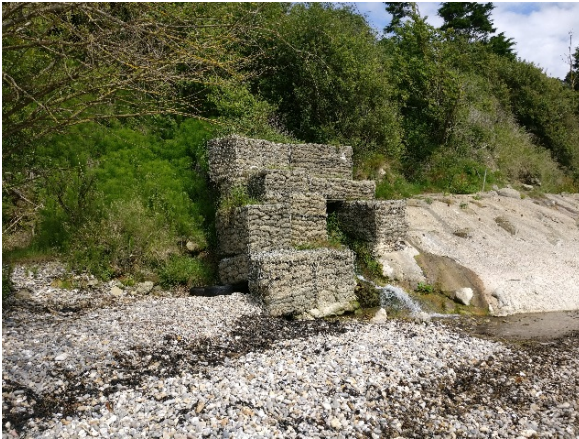
Gabion baskets protecting an outfall

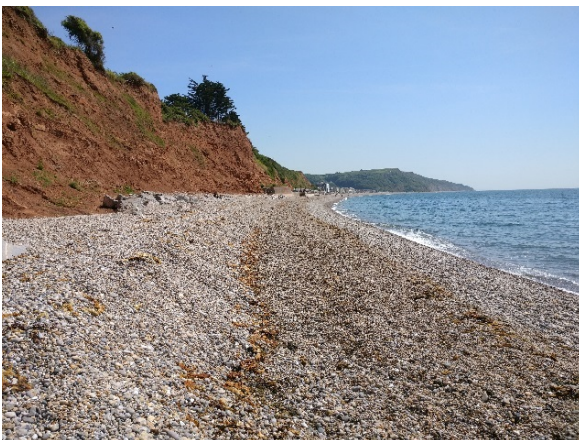
Rock revetment buried in some areas as beach levels increase in elevation

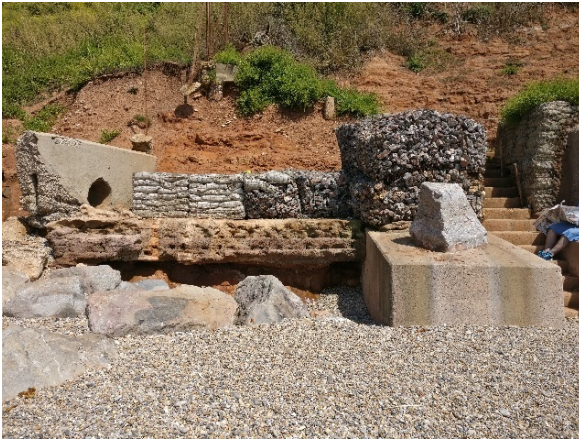
Asset Description: A complicated structure with multiple material types, creating a composite coastal erosion protection structure. The cliff toe was exposed behind the main beach area. This was overlain by multiple layers of concrete which have been eroded and undermined. Rock gabions and concrete-filled sand bag gabions provided protection to the upper section of cliff, although the access steps and former outfall behind the defence were out of use.

Rock at toe protection concrete slab and gabions

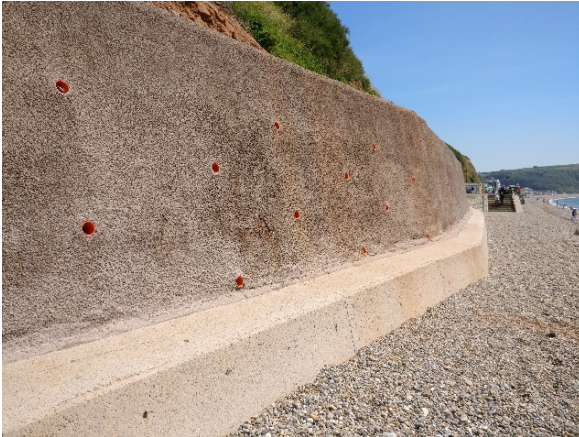
Sprayed concrete upper wall and reinforced concrete toe

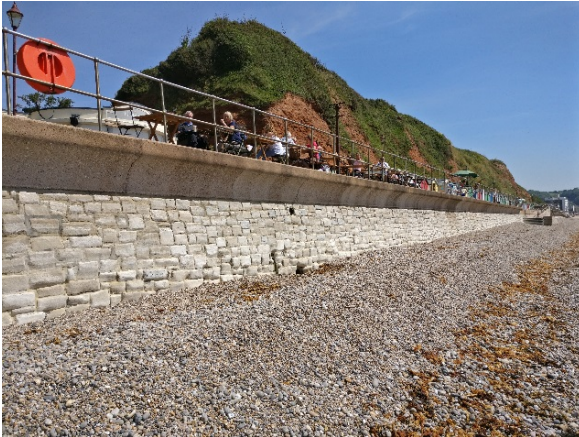
Stone block seawall topped with concrete recurve

Condition Description: The cliffs were well-protected and show no recent signs of erosion. The stone block seawall was in very good condition, with no indication of surface erosion or cracking. Mortar was in good condition, although multiple locations showed recent patch repairs where damage was previously recorded. There was no observed loss of stone blocks or fill material from within the wall, although some isolated locations displayed missing mortar which might lead to more significant structural damage if not addressed. Stainless steel handrails were in good condition and showed few signs of deformation or corrosion.

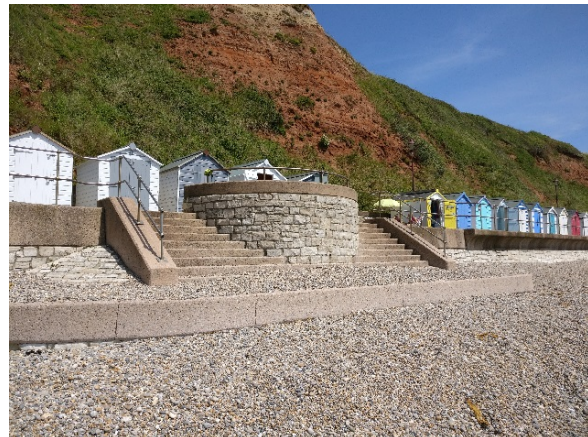
Typical stepped access in this frontage

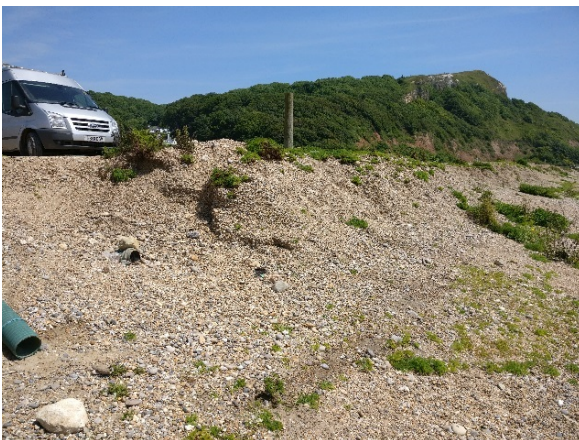
Steep upper beach in previous disposal area for dredging

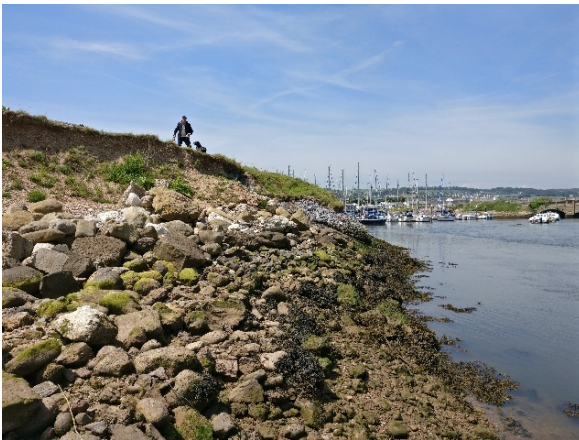
Larger cobbles protecting the back of the spit where cliffing and erosion has occurred

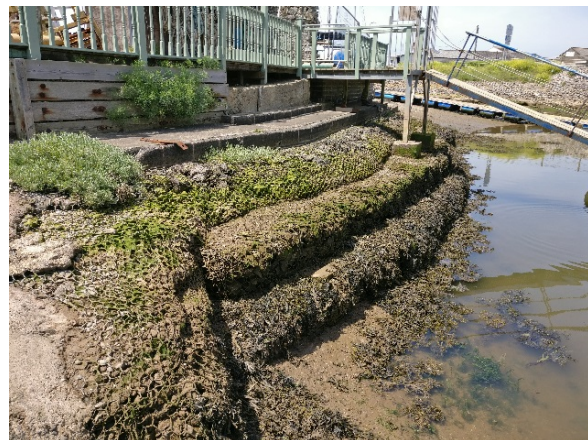
Gabion structures forming steeper defence profile

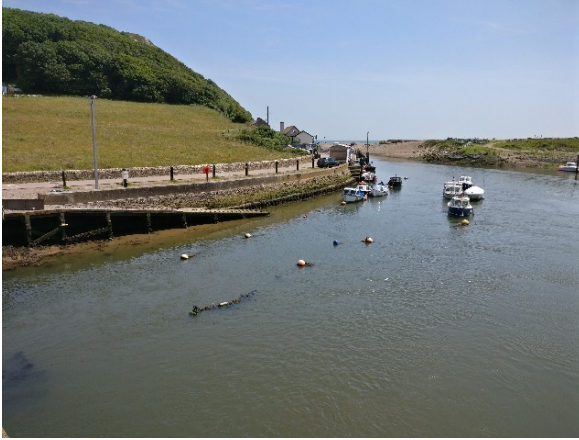
Composite flood defence with timber slipway

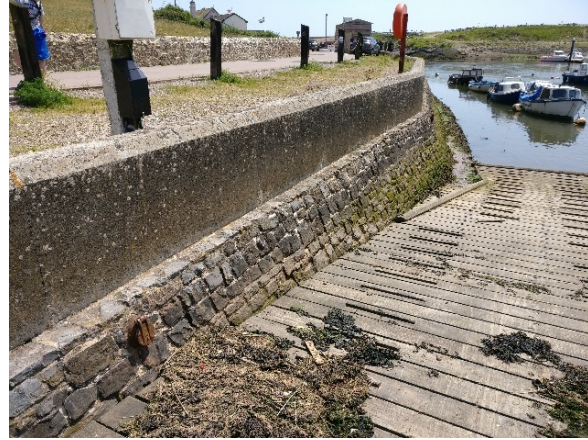
Composite structure with stone block lower wall and concrete upper wall

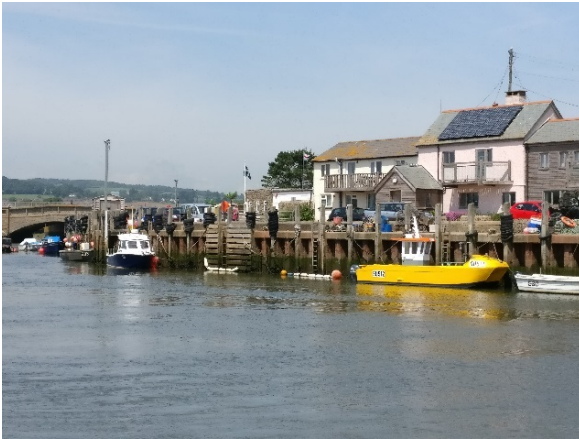
Steel sheet pile wall creates vertical defence

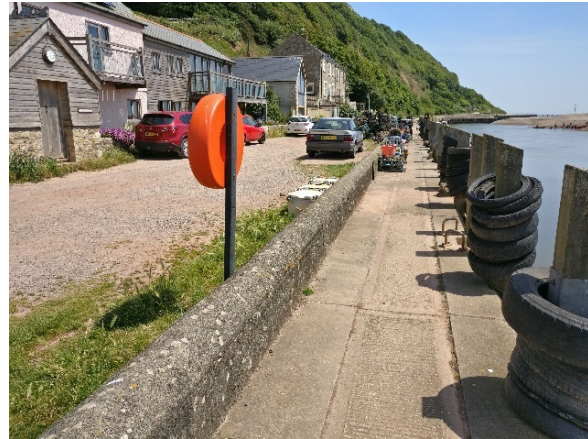
Concrete slab and short flood wall

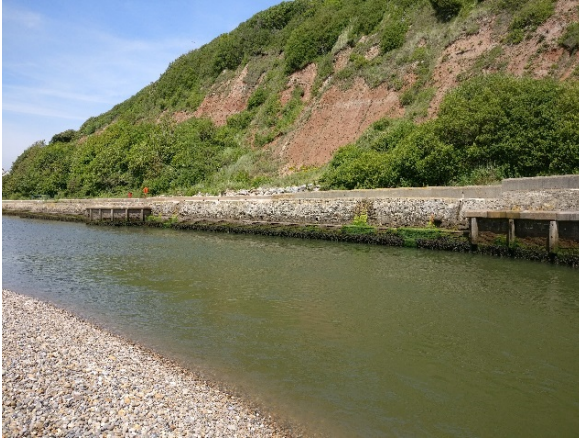
Stone block wall along the River Axe east bank

Condition Description: Recent surveys indicated that the steel sheet piles have suffered from ALWC, although this could not be observed during the site visit. The grouted stone wall was broadly in good condition, with no area of obvious damage or cracking in the surface of the structure. No overall slumping or heave, and no lateral bulging of the structure suggested that there were no undermining and issues with voids or drainage behind the structure. Several sections of the upper concrete flood wall have been repaired to ensure that the wall provides a consistent standard of flood protection, although there were signs of damage that had not been repaired.

Condition Grade: Grade 2 – GOOD
