SEAT ON BEACH MANAGEMENT PLAN

Coastal Processes Baseline

East Devon District
Council

February 2018

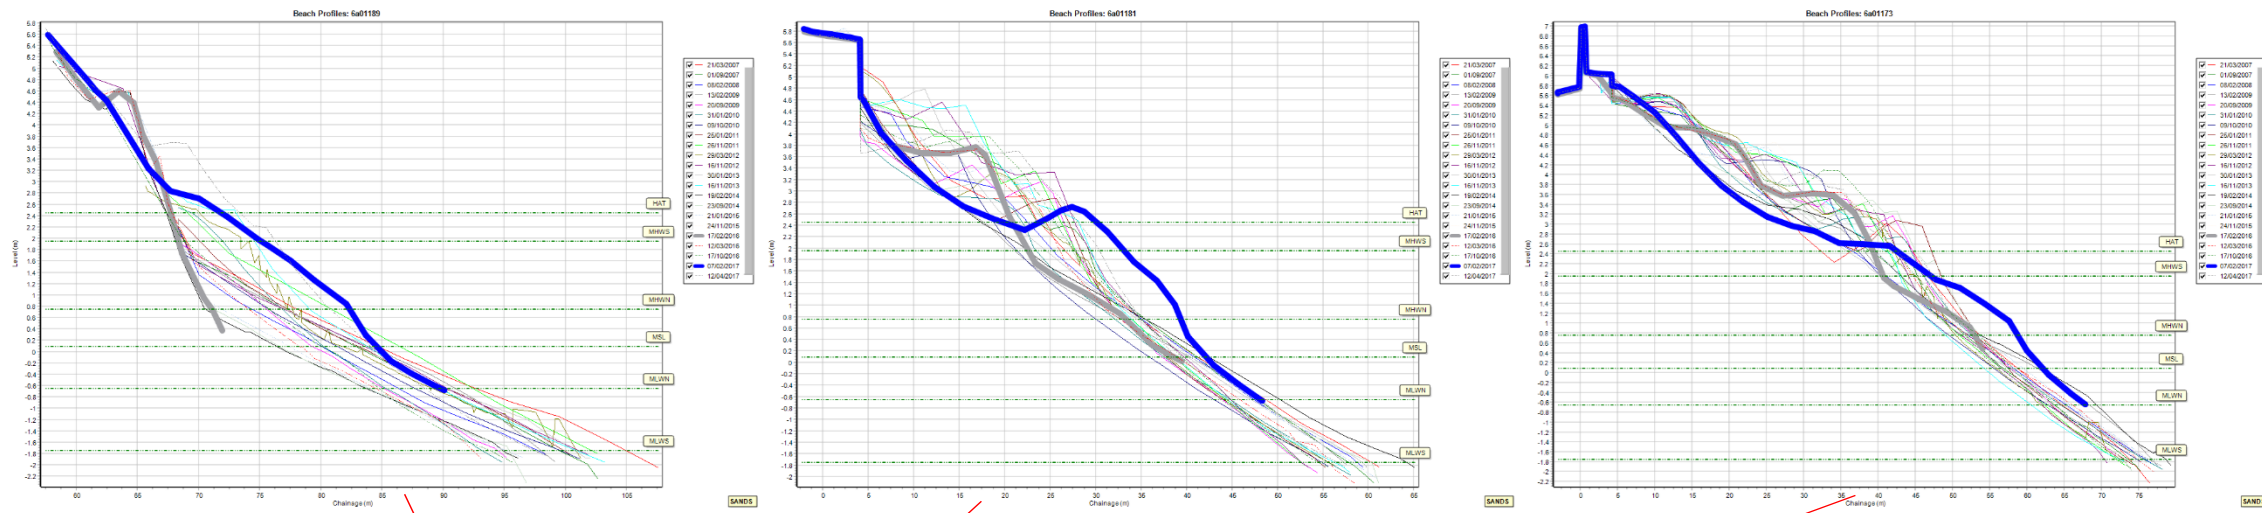
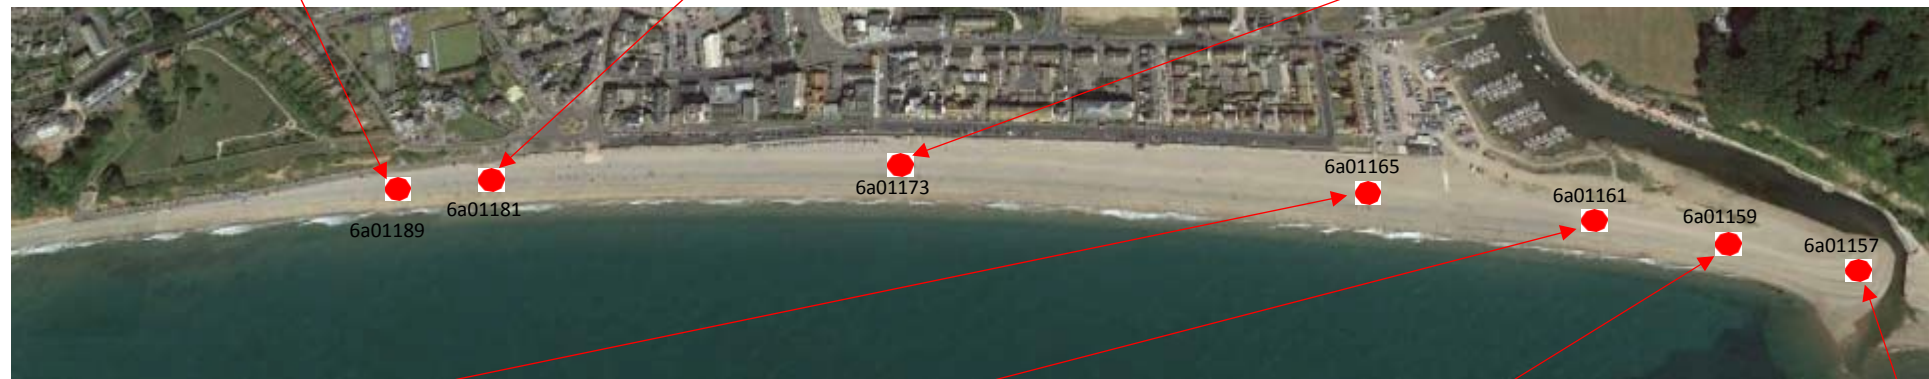
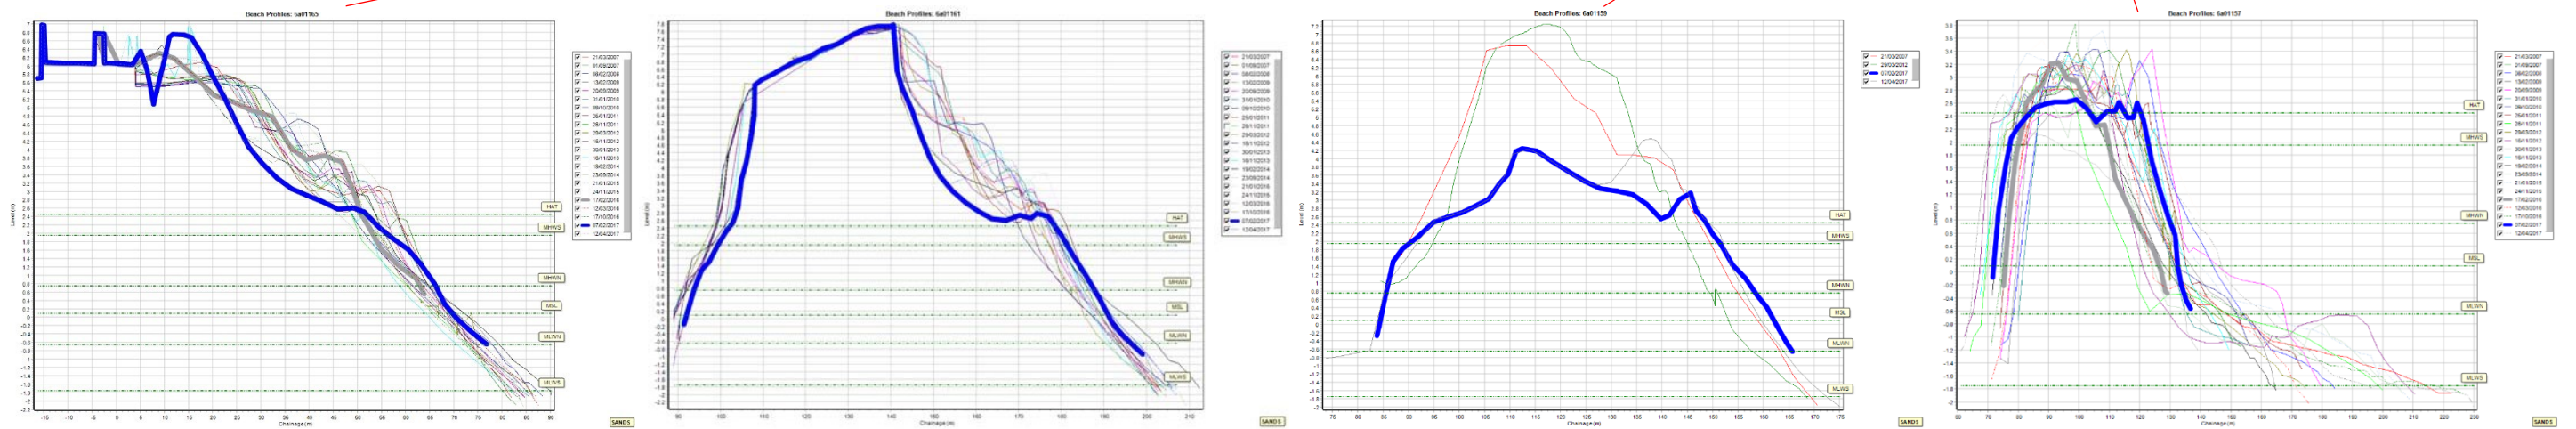
Figure 4.19 illustrates post-storm profiles at a number of locations, compared to the more normal year on year changes. Some key observations have been made from the data:

- At the western extent of the Seaton seawall, opposite the bottom of Castle Hill (profile 6a01181), during both storms the beach lowered in front of the seawall, forming a berm or ridge further down the profile. During the 2016 storm, the berm formed around 3.6mOD, whilst during the 2017 storm, the berm formed at a much lower level, around HAT (2.6mOD). Unlike other profiles, the beach at this location tends to develop a single berm during storms whereas elsewhere a series of ridges form across the beach; this may be related to the volume of material on the beach. It is also noted that over time, the beach height at the seawall is observed to vary by over 1m.

- At the eastern end of Seaton beach (profile 6a01165), the beach was generally unaffected by the 2016 storm (which could be due to the beach level at the time). The 2017 post-storm profile was actually surveyed at the same time that the trench had been opened for the disposal of the dredged material (removed during winter 2016) and is therefore the profile above HAT is not reflective of post-storm beach behaviour. However, it is observed from the profile that during this time there was also some draw-down of material below MHWS (1.95mOD). Similarly, to the two profiles to the west, formation of a berm below HAT during the 2017 storm.

- At the centre and distal end of the spit (profile 6a01159 and 6a01157), the 2017 storm resulted in lowering of the spit, but with deposition of material on both the landward and seaward face; which may have been caused by a combination of overtopping/overwashing and draw-down. The 2016 storm resulted in narrowing of the distal end of the spit, but a survey the following month shows widening of the spit, suggesting a rapid recovery.

Figure 4.19 Beach profiles for post-storm surveys, where a notable change outside of the general profile change is marked by a profile in bold (2016 storm in grey and 2017 in blue)
 *Note that the 2017 post-storm profile for profile 6a01165 was surveyed at the same time the trench was dug for the disposal of dredge material

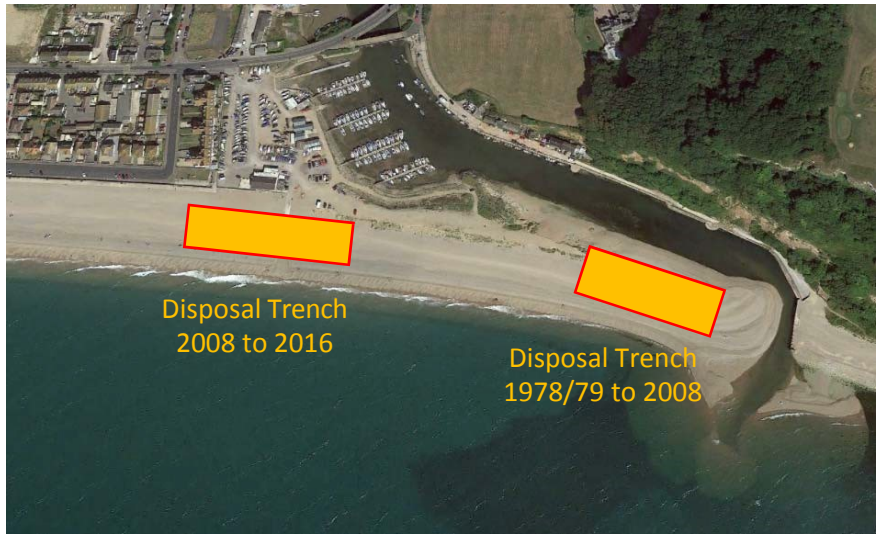
Dredging has been taking place since the 1970s, when silt was first removed by excavators and other methods thereafter. Since 2008, suction dredging has been used to remove the silt from the estuary. Dredged material is pumped into and disposed of within a series of trenches dug into the shingle spit; this includes an eastern trench located 130m west of the distal end of the spit, used between 1978/1979 and 2008, and more recently a trench in front of the Axe Yacht Club that has been used since 2008. The locations of the trenches are shown in Figure 4.21, with the open trench in the spit shown in Figure 4.22.

Figure 4.21 Map showing approximate locations of dredge disposal sites
Aerial image © 2015 Google Earth

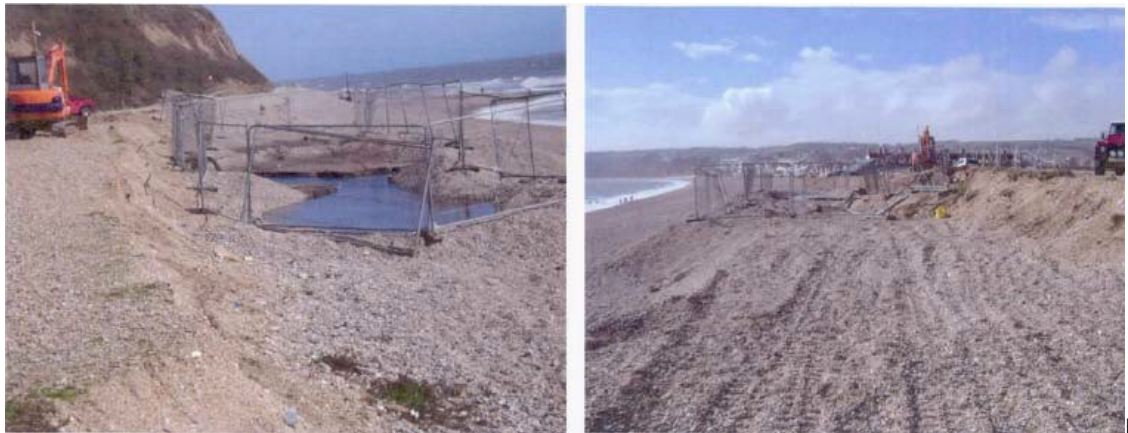
4.22 Trench for disposal of dredge material 2009/2010
Source: Author unknown 0, no date specified

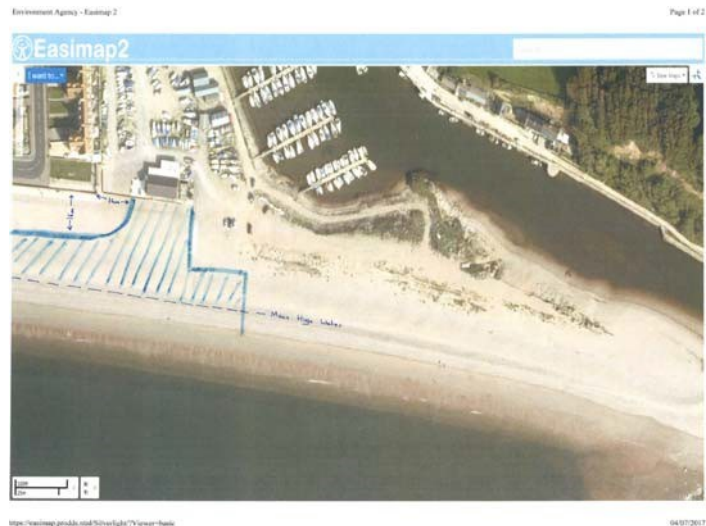
operation of the harbour (Environment Agency, *Pers. Comms.*, 2017). However, ahead of the outcomes of the Seaton BMP, the Environment Agency note that this exclusion is on the assumption that dredge material will be placed within the reception trench shown by the blue hatched area on the map in Figure 4.23 and above mean high water.

Figure 4.23 Permitted dredge disposal zone for 2016/2017 arisings
Source: Environment Agency, *Pers. Comms.*, 2017

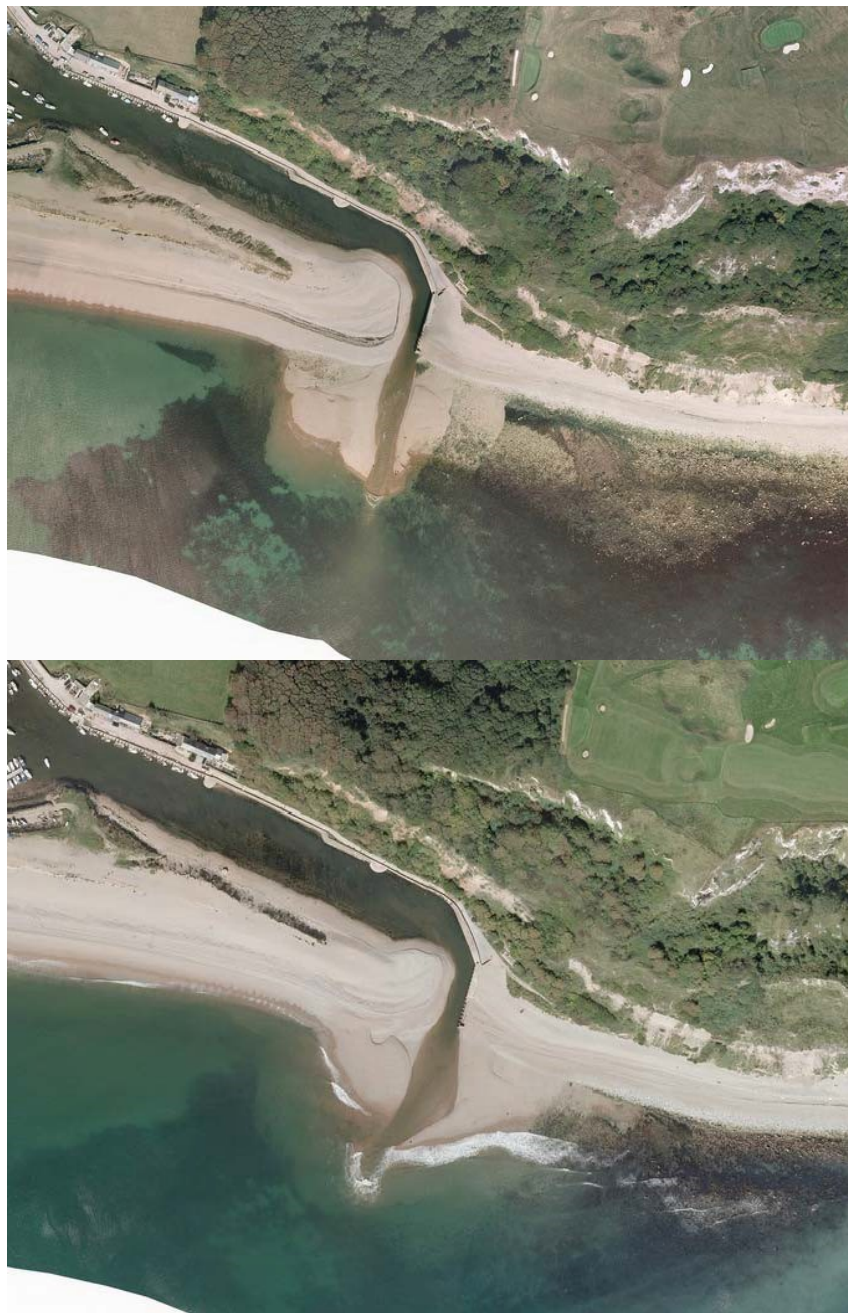
A rock platform is shown to protrude from the cliffs and foreshore on the eastern bank side of the estuary mouth. Aerial photographs from 2006 and 2009 (refer to Figure 4.26) clearly show the shingle beach, boulder beach rock platform and the build-up of the bar material and estuary delta. It is inferred from the photographs that the rock platform has the potential to affect movement of material around the mouth of the estuary. It is possible that material held within the delta may supply the beach at Seaton under certain incident wave conditions, i.e. when prevailing conditions drive east to west sediment transport.

Figure 4.26 Aerial photographs of the Axe Estuary mouth and Haven Cliff beach in 2006 (left) and 2009 (right)
Source: Channel Coast Observatory, 2006 and 2009
