Defences Baseline

East Devon District
Council

August 2017

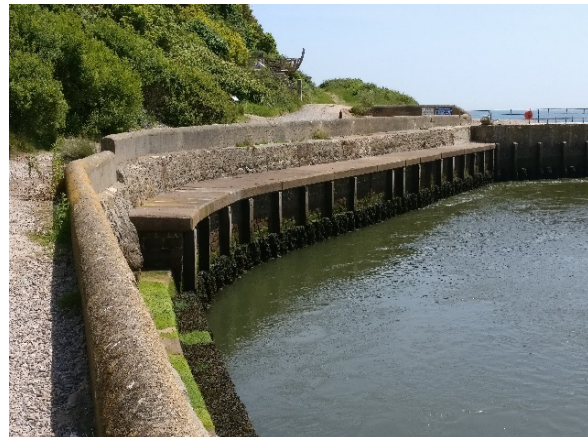
Concrete platform connected to the seawall close to the river mouth

Condition Description: Recent surveys indicated that the steel sheet piles have suffered from ALWC, although this could not be observed during the site visit. The grouted stone wall was broadly in good condition, with no area of obvious damage or cracking in the surface of the structure. No overall slumping or heave, and no lateral bulging of the structure suggested that there were no undermining and issues with voids or drainage behind the structure. Several sections of the upper concrete flood wall have been repaired to ensure that the wall provides a consistent standard of flood protection, although there were signs of damage that had not been repaired.

Condition Grade: Grade 2 – GOOD
