REPORT (FINAL)

Seaton Beach Management Plan

East Devon District
Council

February 2018

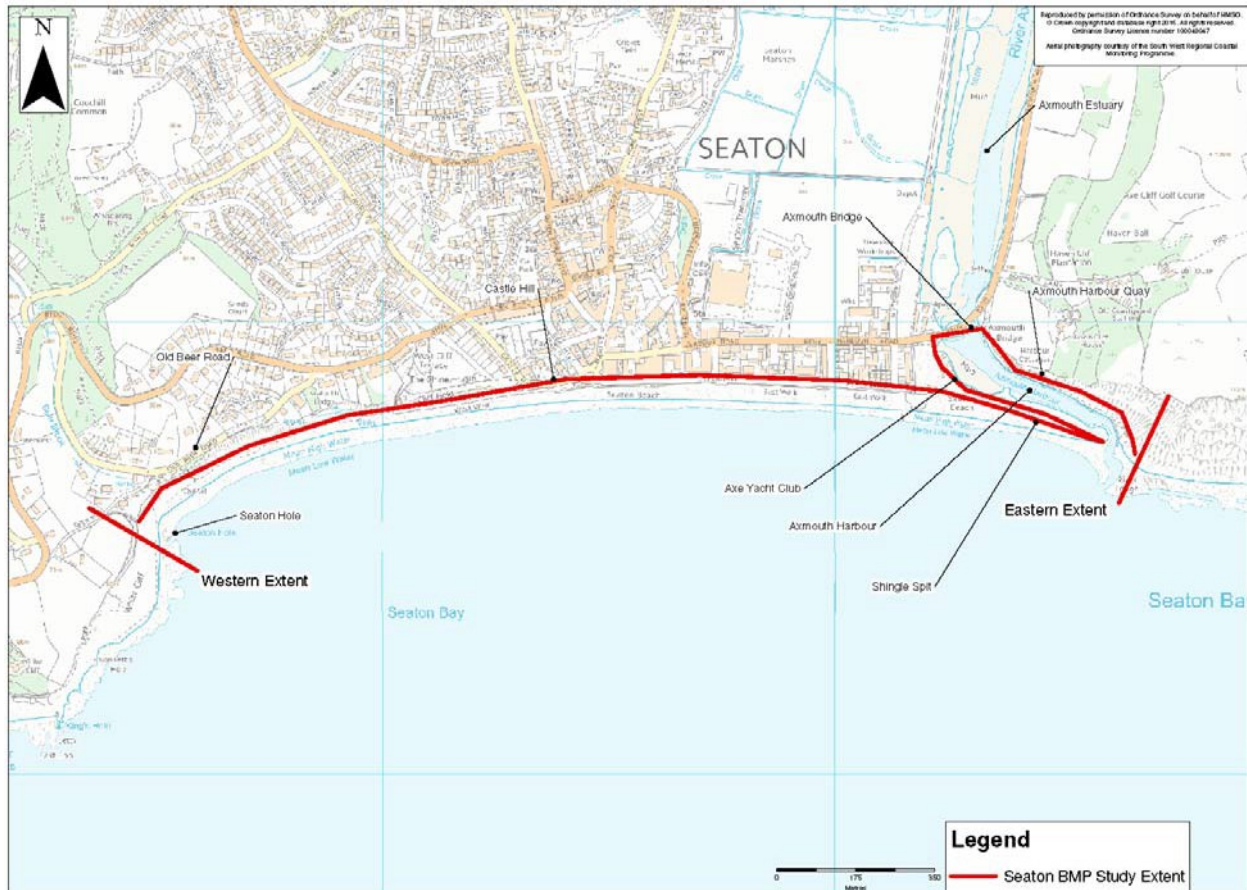
Figure 1-1 Seaton BMP area

This Beach Management Plan (BMP) has been prepared for East Devon District Council (EDDC), and their partner, the Environment Agency. The BMP area covers the coastline from Seaton Hole, in the west, to the Harbour Wall, on the east side of the River Axe, and the Axe River up to the Axe Bridge, as shown in Figure 1-1.

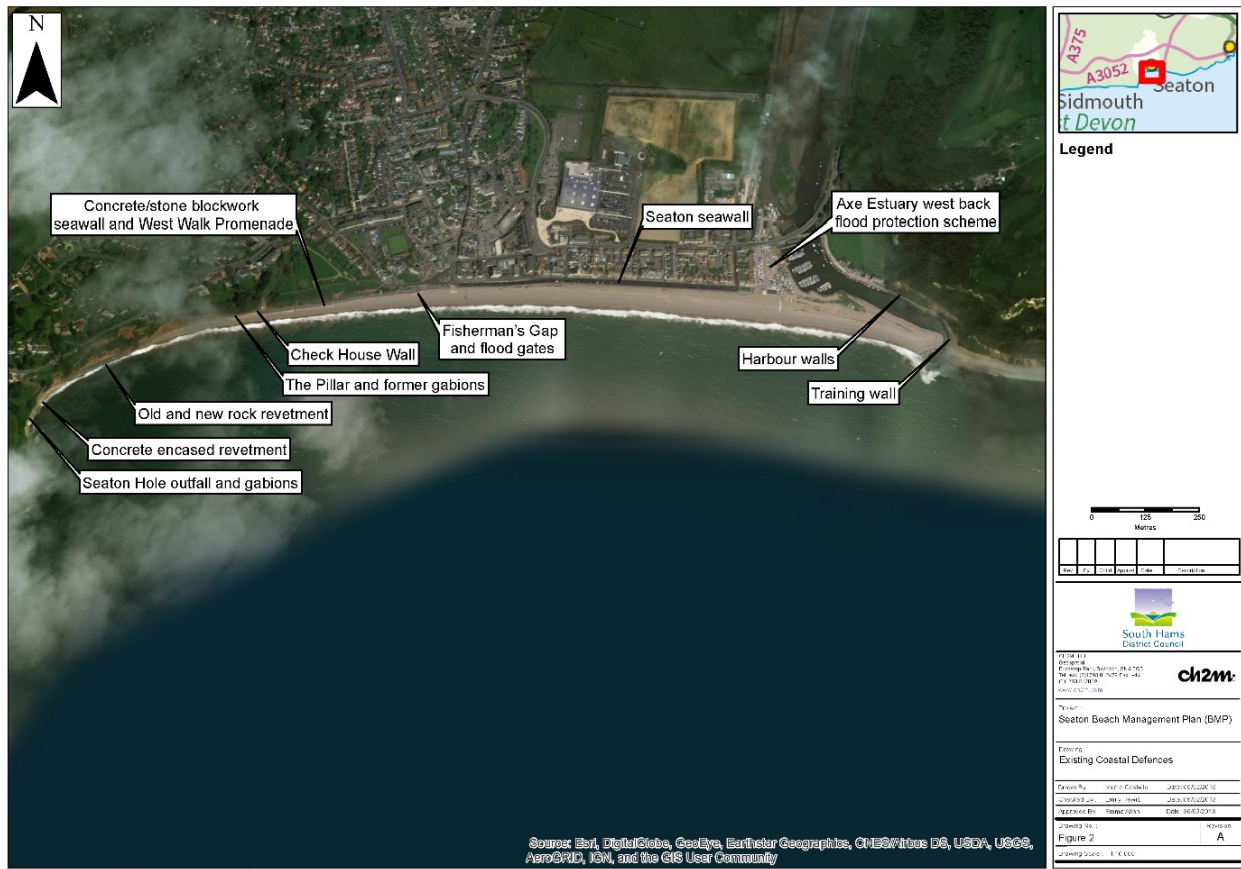
Figure 1-2 Existing coastal defences along the Seaton BMP frontage

The existing coastal defences are shown in Figure 1-2, with further details provided in Section 3.

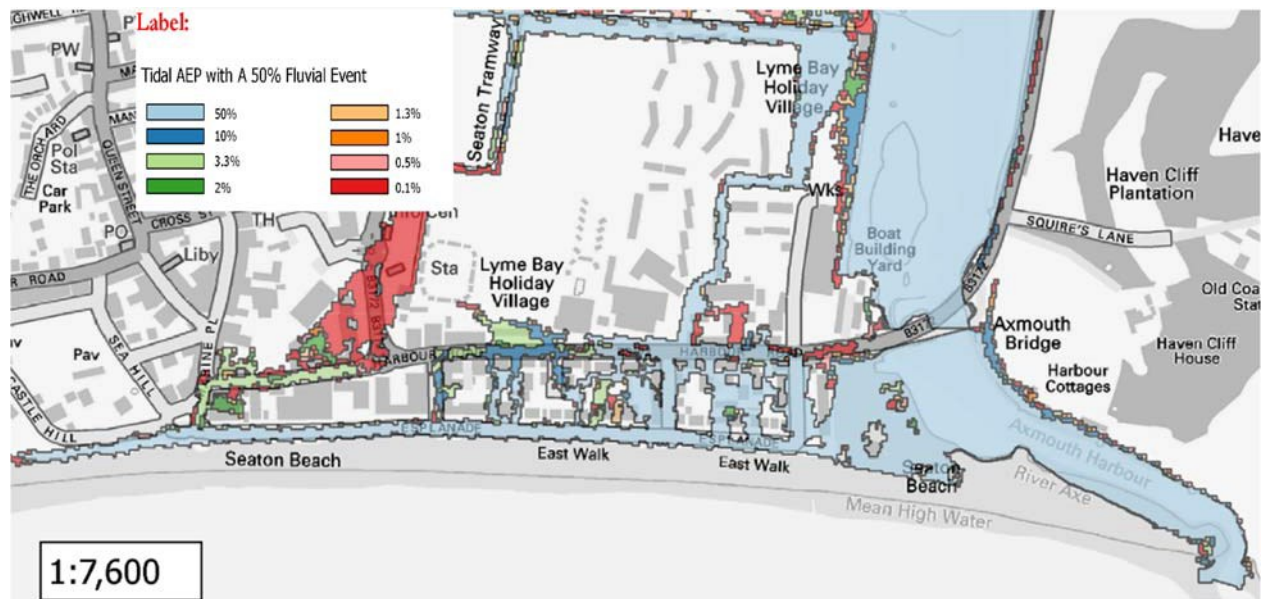
Figure 1-4 Present Day Flood Risk from Wave Overtopping of Coastal Defences Under a range of Return Periods
Source: CH2M, 2017a

Phase 2 project (refer to Section 1.7.5) shows the present-day flood risk from wave overtopping of coastal defences under a range of extreme return period events (refer to Figure 1-4). The analysis and results that inform the overtopping estimates are also discussed in Section 3.4.1.

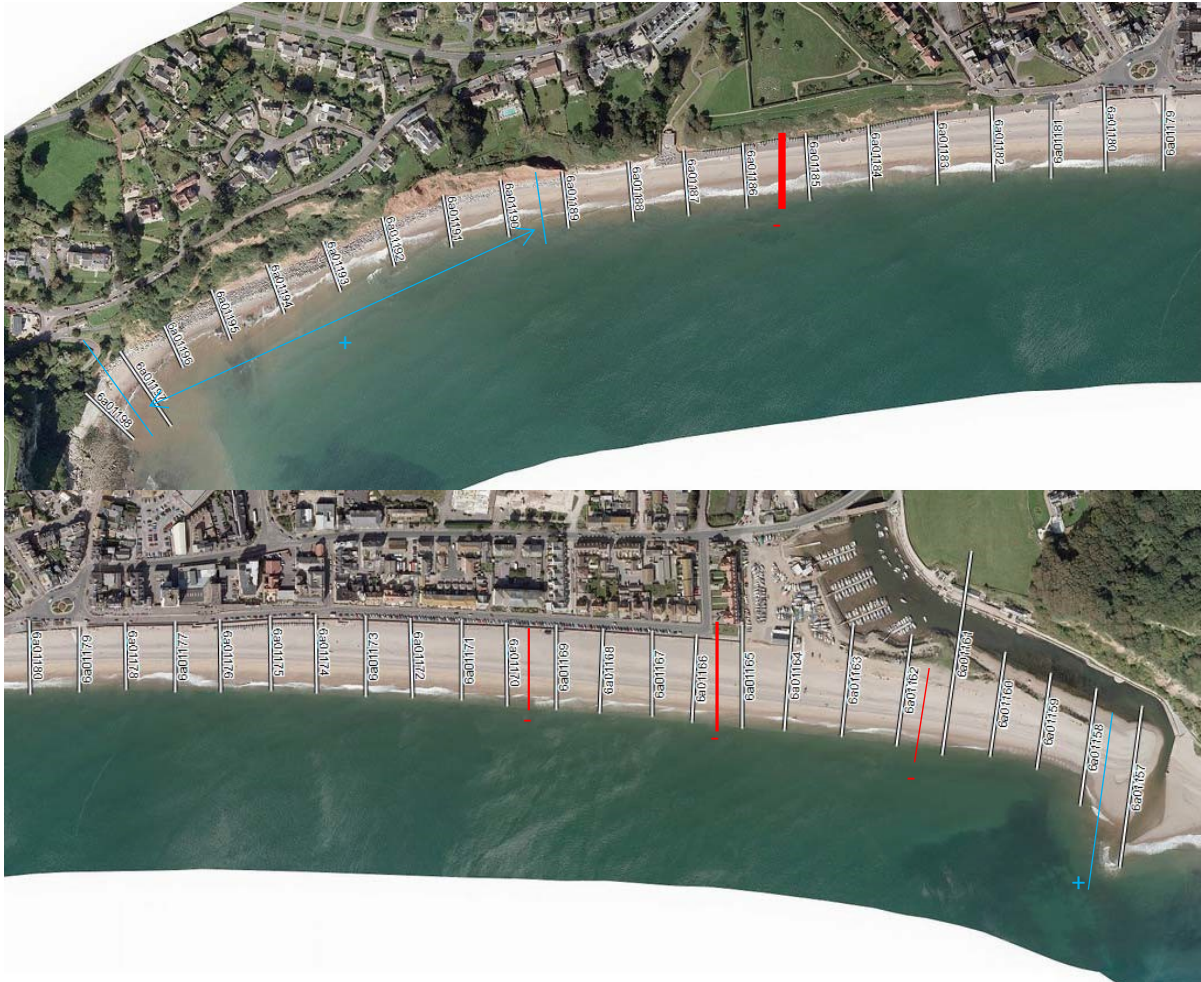
Figure 2-8 Map showing location of beach profiles with positive cross-sectional change shown in blue and negative cross-sectional change in red

A review of PCOs annual reporting on beach profile change has been undertaken for the coastline between Seaton Hole and Seaton Spit and is based on data collected between 2007 and 2017. The review compares the reported cross-sectional area change from one year to the next for the profiles between Seaton Hole and the Axe Estuary (profiles 6a01197 to 6a01157). The key findings summarised in Figure 2-8 and below.

- There is a clear trend of **negative cross-sectional area change** (i.e. erosion) during years;
 - 2007-2008.
 - 2009-2010.
 - 2011-2014.
 - 2015-2016.
- There is a clear trend of positive cross-sectional area change (i.e. accretion) during years;
 - 2008-2009.

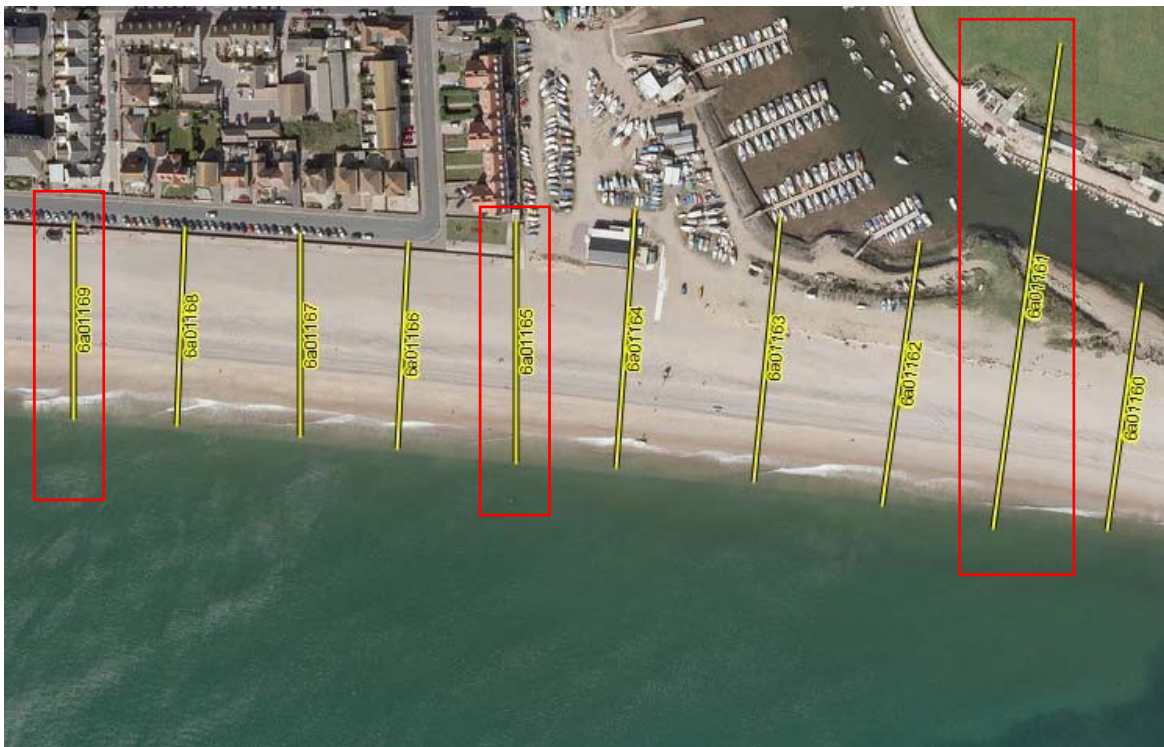
- Profile 6a01185 (opposite the shelter, see Figure 2.9); and
 - Profiles 6a01169, 6a01165 and 6a0161 (eastern end of Seaton to the spit), see Figure 2.10.

Figure 2.10 Map showing locations of eroding profiles at eastern the end of Seaton, including 6a01169, 6a01165 and 6a01161

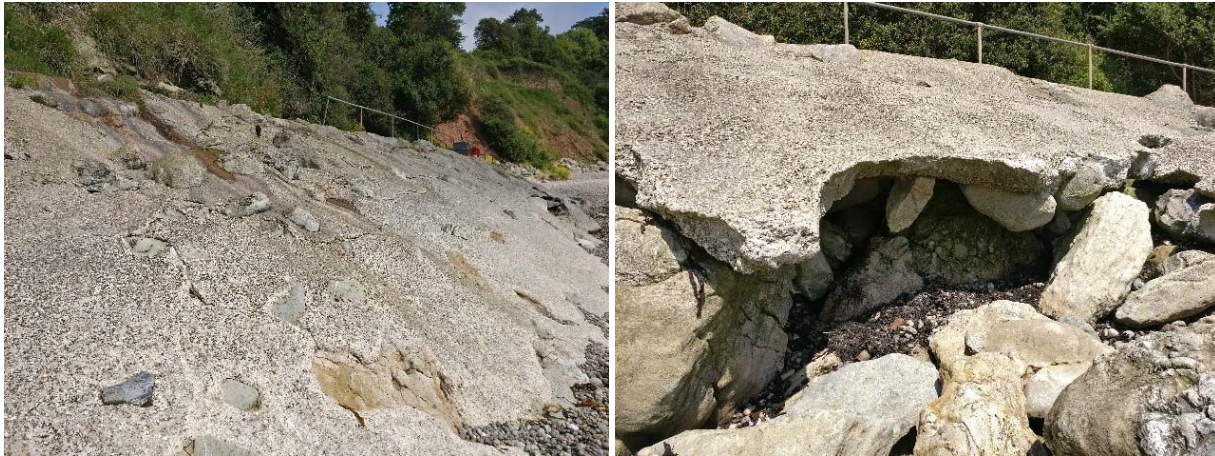
Figure 3-2 Seaton Hole concrete encased revetment

The Seaton Hole concrete encased revetment was first constructed in the 1970s using scree material from the base of the White Cliffs. The scree was later encased in concrete to prevent their displacement during wave attack.

Source: Photograph taken during visual inspection and condition assessment on the 14th June 2017, facing northwest

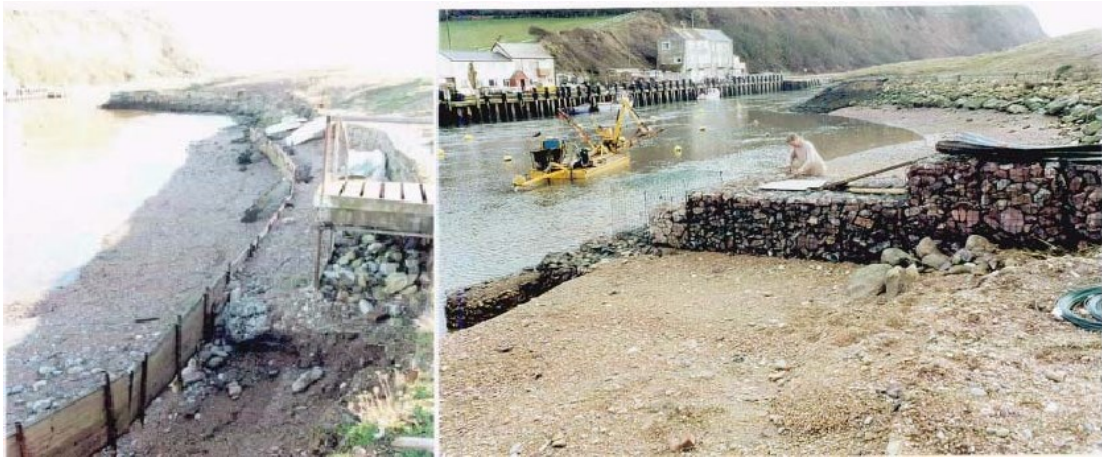
Figure 3-10 Photos of the protective fencing undermined and the construction of the gabion groyne
Source: Axmouth Harbour Management Company Ltd, 2003

Between 2001 and 2003, the defences within the harbour basin were revised to address erosion issues, with the final structure involving reno mattresses and gabions (Axmouth Harbour Management Company Ltd, 2003). The defences are shown in Figure 3-10 and Figure 3-11.

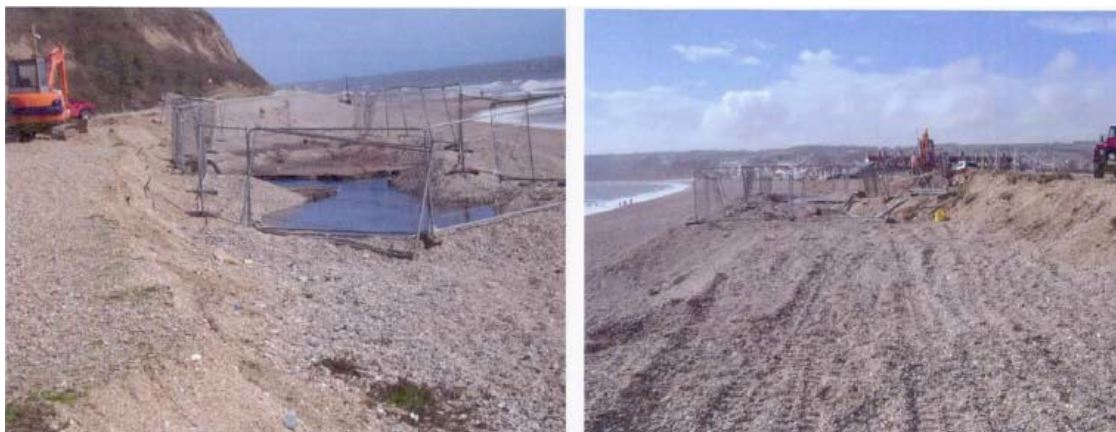
Figure 3-13 Trench for disposal of dredge material 2009/2010
Source: Author unknown 2, no date specified

Since 2008, suction dredging has been used to remove the silt from the estuary. Subsequently, dredged material has been pumped into and disposed of within a series of trenches dug into the shingle spit; this includes an eastern trench located 130m west of the distal end of the spit, used between 1978/1979 and 2008, and more recently a trench in front of the Axe Yacht Club that has been used since 2008. The locations of the trenches are shown in Figure 3-12, with the open trench in the spit shown in Figure 3-13. Between the 1970s and 2015, the spit has reportedly been widened and raised two meters above the former shingle bank crest level (CH2M, 2015a).

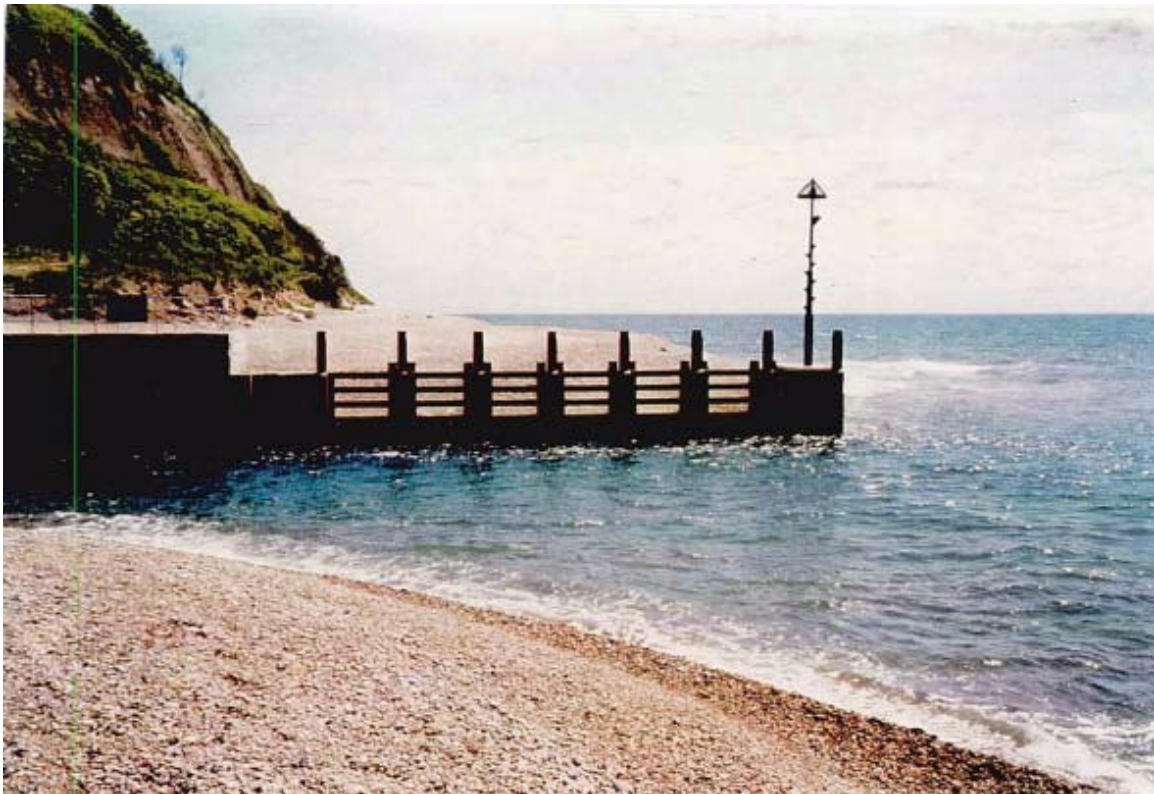
Figure 3-16 Axmouth Harbour Arm extension
Source: Axe Harbour Management Company, 1997

Further refurbishment of the Axmouth Harbour walls was undertaken between 1998 and 2001, with a new 20m Harbour Arm extension constructed in May 2001 (Pritchard, 2006). The extension at the river mouth consisted of a lower level cellular structure, backfilled with concrete and supported by timber fendering and breastwork. The design was undertaken by Posford Duvivier and the general arrangement is shown in Figure 3-15 and Figure 3-16.
