Defences Baseline

East Devon District
Council

August 2017

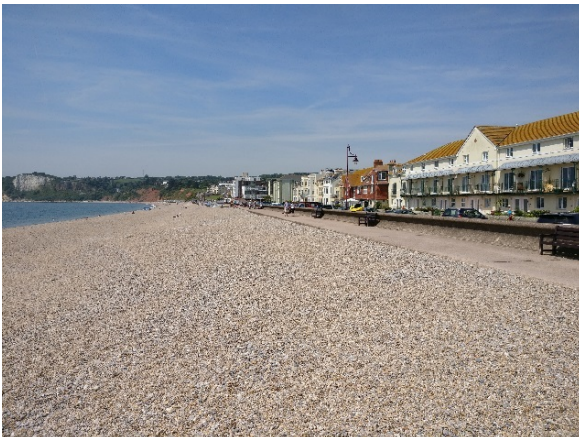
Beach levels increase further east

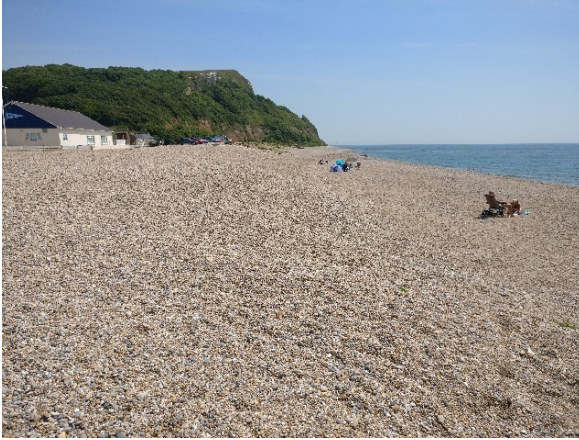
Wide, shallow-sloped beach fronting Axe Yacht Club

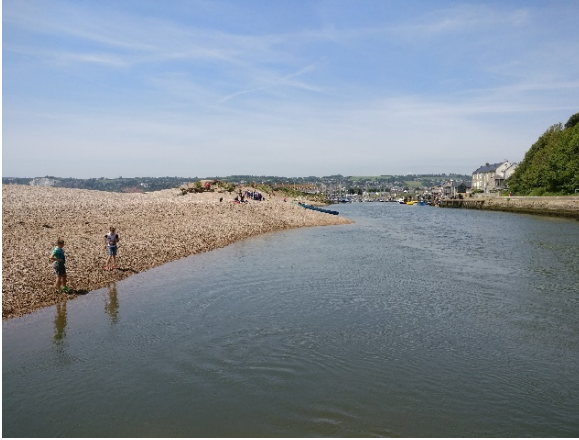
Natural spit formation at the mouth of the River Axe

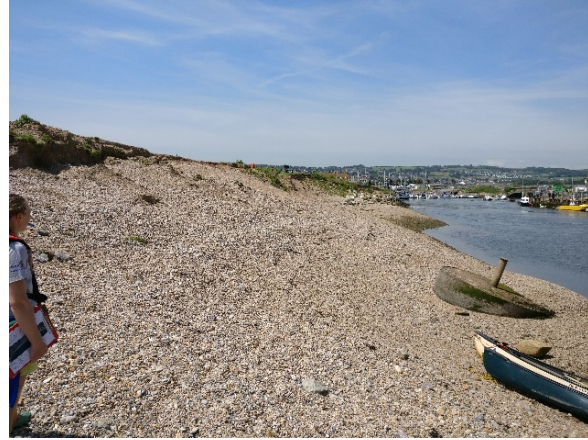
The back of the spit formed of a steeply-sloped gravel beach

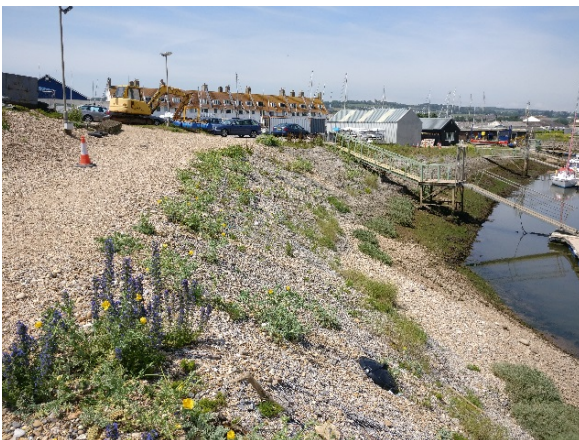
The benign wave conditions have allowed vegetation growth

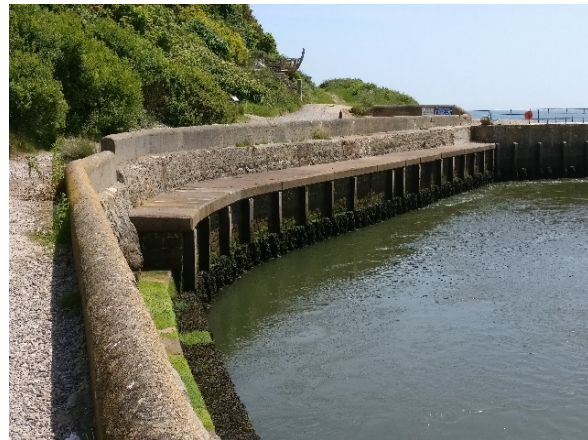
Concrete platform connected to the seawall close to the river mouth
