Defences Baseline

East Devon District
Council

August 2017

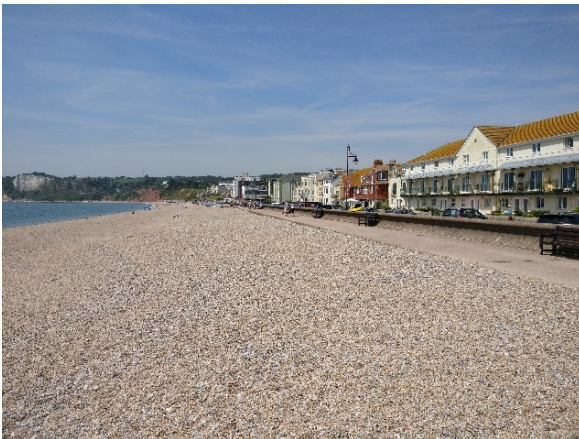
Beach levels increase further east
